FINAL REPORT

**investigation of railway accident – derailment of wagons from DFT № 30592 between the stations
Yana and Kremikovtsi on 26.07.2022**

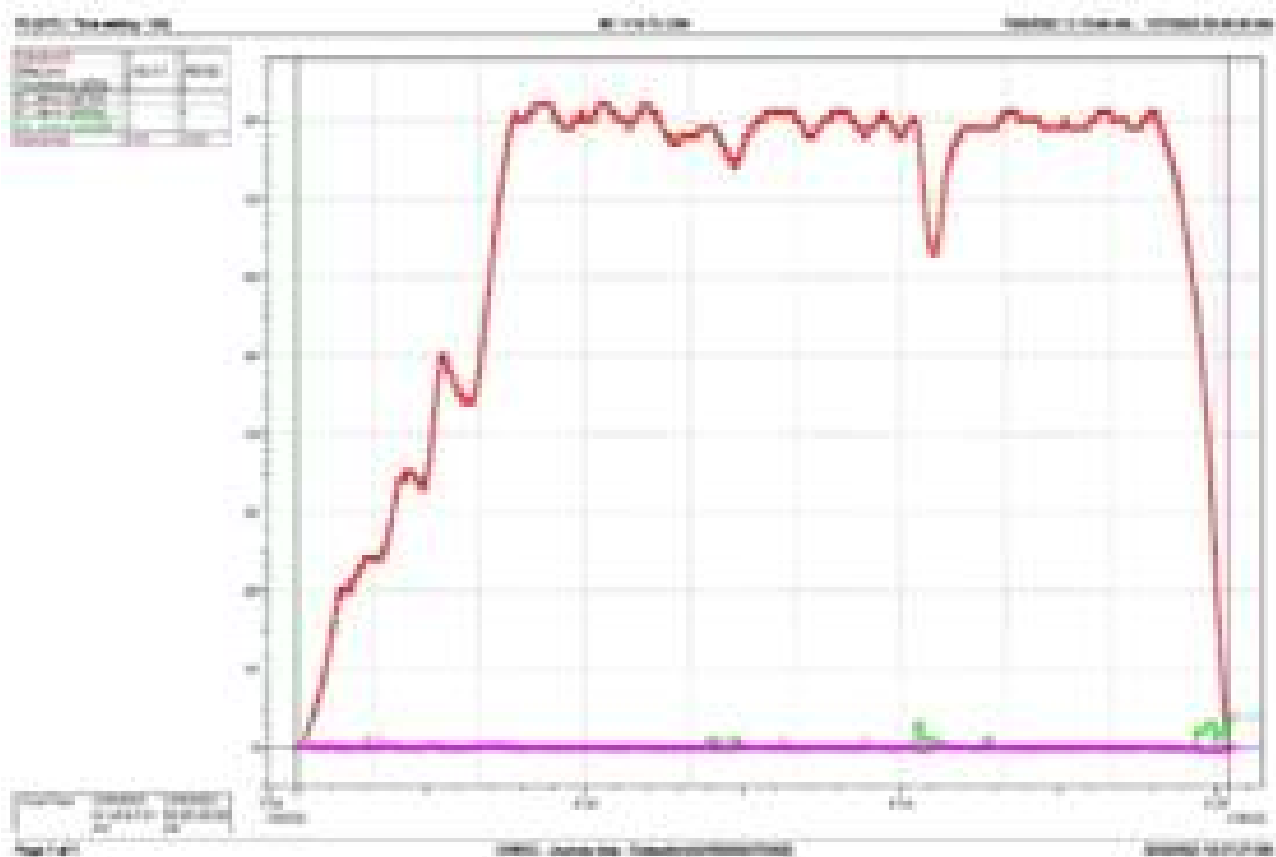
Fig. 4.1. Movement of DFT № 10596 from Dimitrovgrad to Parvomay station.

During the movement from Dimitrovgrad station to Plovdiv marshalling yard, the train ran as DFT No. 10596. It departed from Dimitrovgrad station at 07:50:51 a.m. (fig. 4.1) and arrived at Plovdiv marshalling yard at 12:24:46 p.m. (fig. 4.2). During its journey from Dimitrovgrad station to Plovdiv marshalling yard, the train ran according to the schedule.

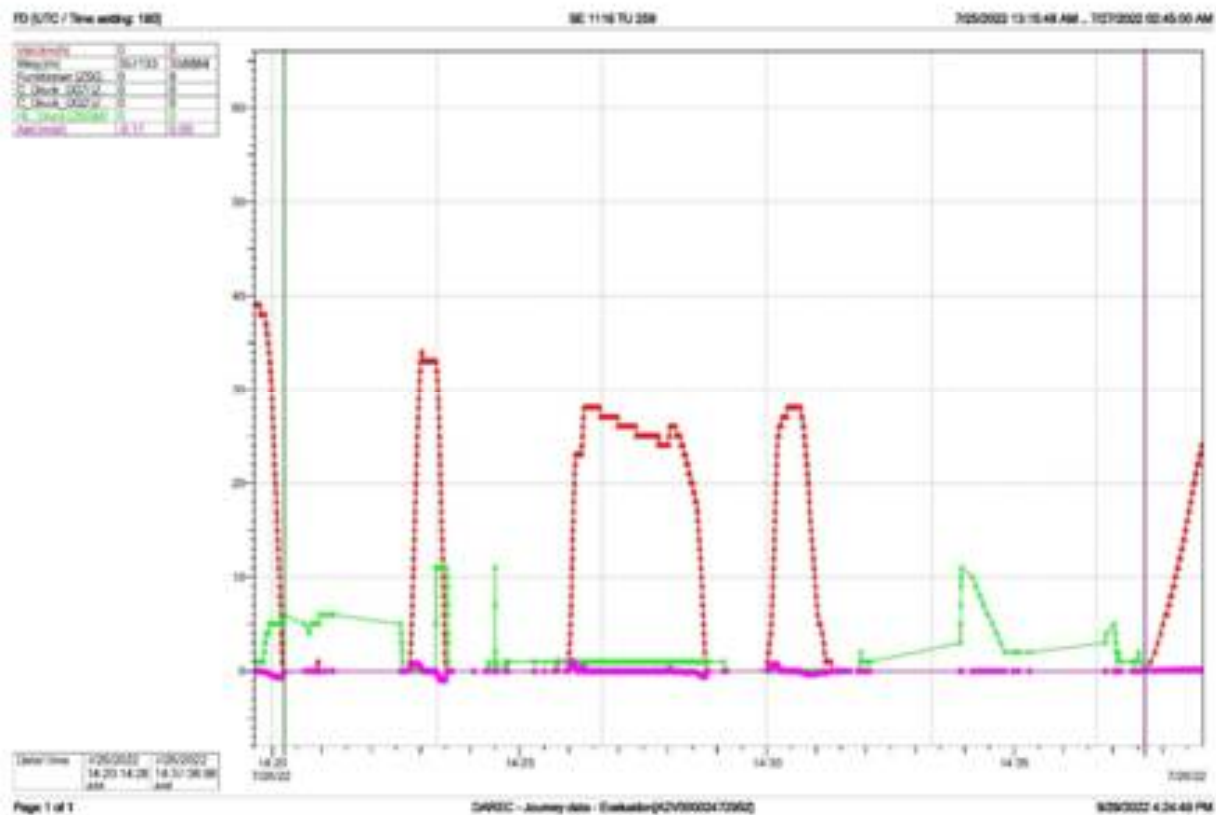
Fig. 4.3. Movement and stay of the locomotives in Karlovo station.

DFT № 30592 departed from Karlovo station at 14:37:38 p.m. (fig. 4.3).

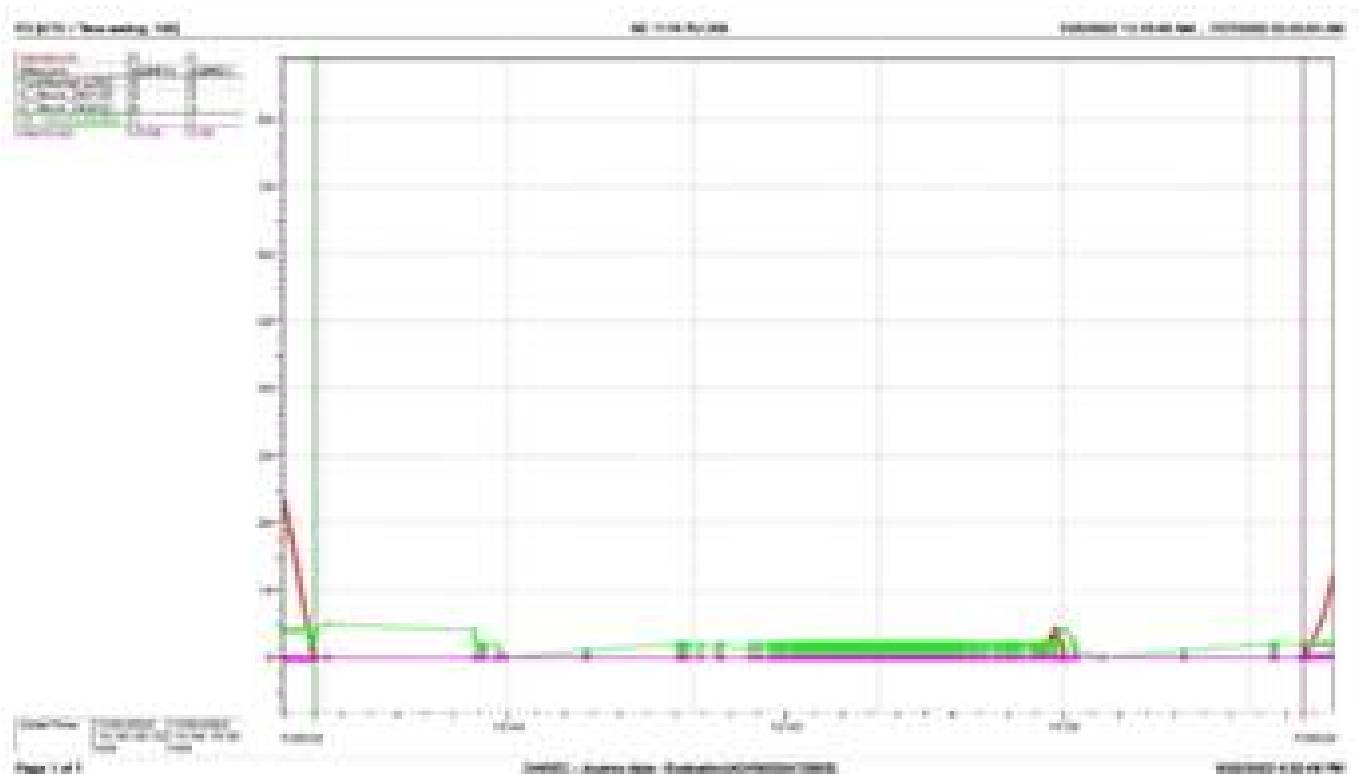
Fig. 4.4. Stay of DFT № 30592 in Pirdop station.

The train arrived in Pirdop station at 15:36:31 p.m. It stayed in the station for 17 minutes and 49 seconds and departed at 15:54:19 p.m. (fig. 4.4).
