REPUBLIC OF BULGARIA
NATIONAL AIR, MARITIME AND RAILWAY TRANSPORT
ACCIDENTS INVESTIGATION BOARD (NAMRTAIB)

FINAL REPORT

**Investigation of railway accident – fire in locomotive № 91520044169-8, servicing fast train
№ 2610 in Mezdra South station on 06.01.2023**

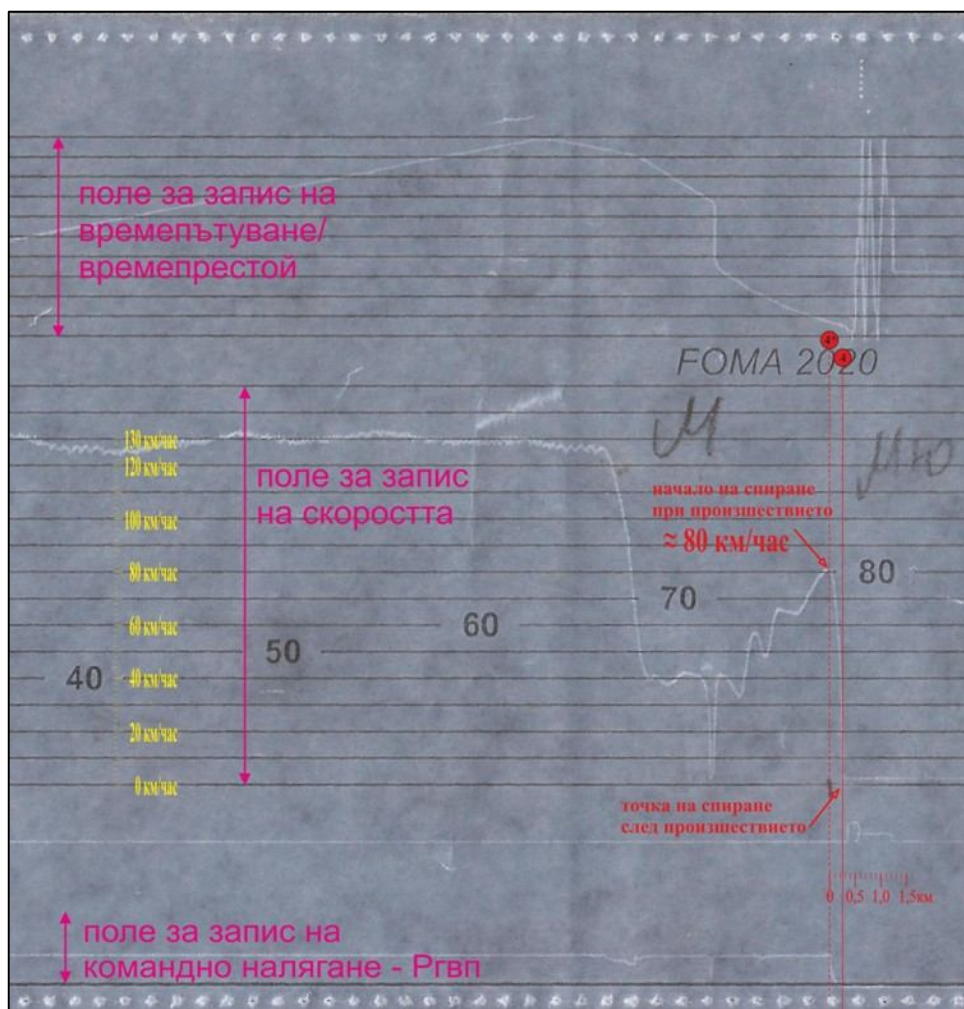
Fig. 4.4. Speedometer tape of locomotive № 91520044169-8.

In the next Fig. 4.4 is shown an enlarged graphic image of the parameters of locomotive No91520044169-8, from the speedometer tape of the locomotive during the movement of FT No2610 immediately before the accident.

The start of stopping is at the point marked ④* at a driving speed of about 80 km/h, and reaching zero speed is at the point marked ④. According to the additionally added distance scale in red colour, the stopping distance of the train is 250 meters.

From the above graphs, no over speeding by the locomotive is found, therefore it is not relevant to the accident that occurred.

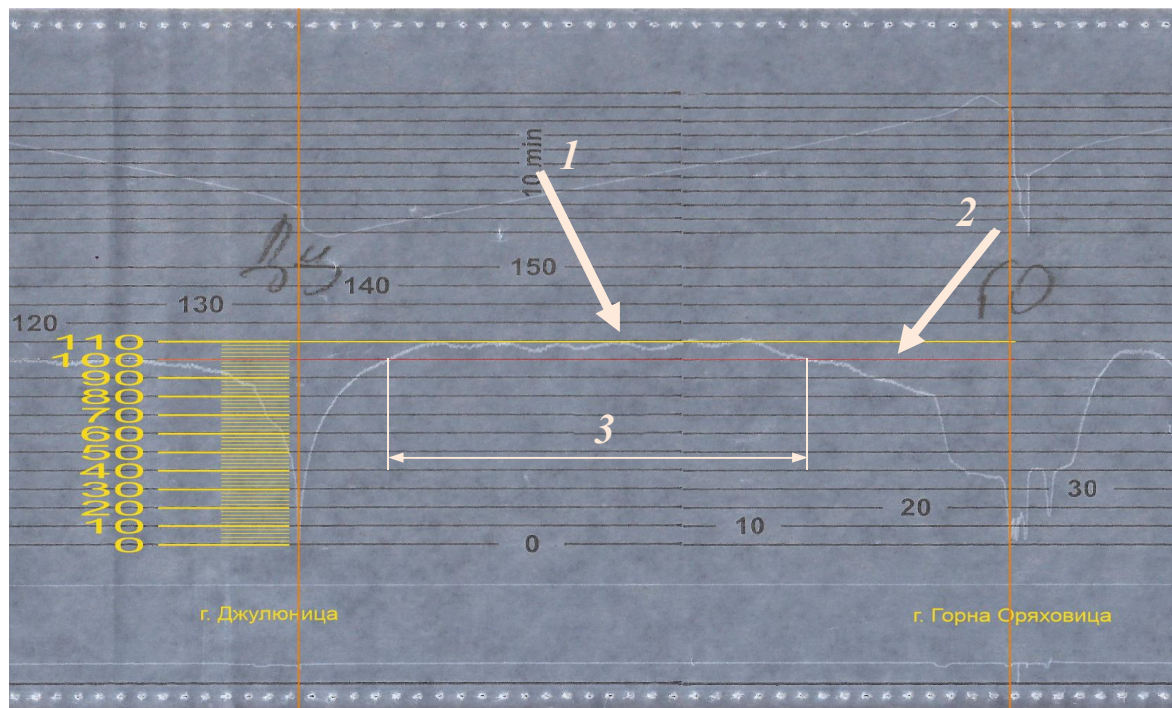
Fig. 4.5. Diagram of the movement of FT № 2610 along Dzhuliunitsa - Gorna Oryahovitsa interstation.

The train arrived at Dzhulyunitsa station at 08:08 a.m. and, after a one-minute delay, it departed at 08:09 a.m. (Fig. 4.5). Along Dzhulyunitsa - Gorna Oryahovitsa interstation FT No 2610 moved with a maximum speed of 110 km/h, which is permissible for this train in the indicated interstation (fig. 4.5, item 1). At the same time, the maximum permissible speed of diesel locomotive No 92520007126-2 attached to the train is 100 km/h, i.e. in the interstation Djulyunitsa - Gorna Oryahovitsa FT No. 2610 exceeded the speed of movement by up to 10 km/h (fig. 4.5, pos. 2) and travelled 9500 meters at a speed higher than the permissible speed for the coupled diesel locomotive (fig. 4.5, item 3).

- As part of FT No. 2610, diesel locomotive No. 92520007126-2, which has a design speed of 100 km/h, is attached between train locomotive No. 91520044169-8 and the first coach of the train at Varna station. In the section from Varna station to Dzhuliunitsa station, the maximum permissible speed according to the train schedule is 100 km/h and it is respected. In the interstation Dzhuliunitsa - Gorna Oryahovitsa FT No. 2610 moves with a maximum speed of 110 km/h, which is permissible for the train in the interstation (fig. 4.5, item 1). The maximum permissible speed of the diesel locomotive No. 92520007126-2 attached to the train is 100 km/h, with which the permissible speed of movement is exceeded by up to 10 km/h (Fig. 4.5, item 2). The locomotive crew was not provided with a document to limit the speed of the train.

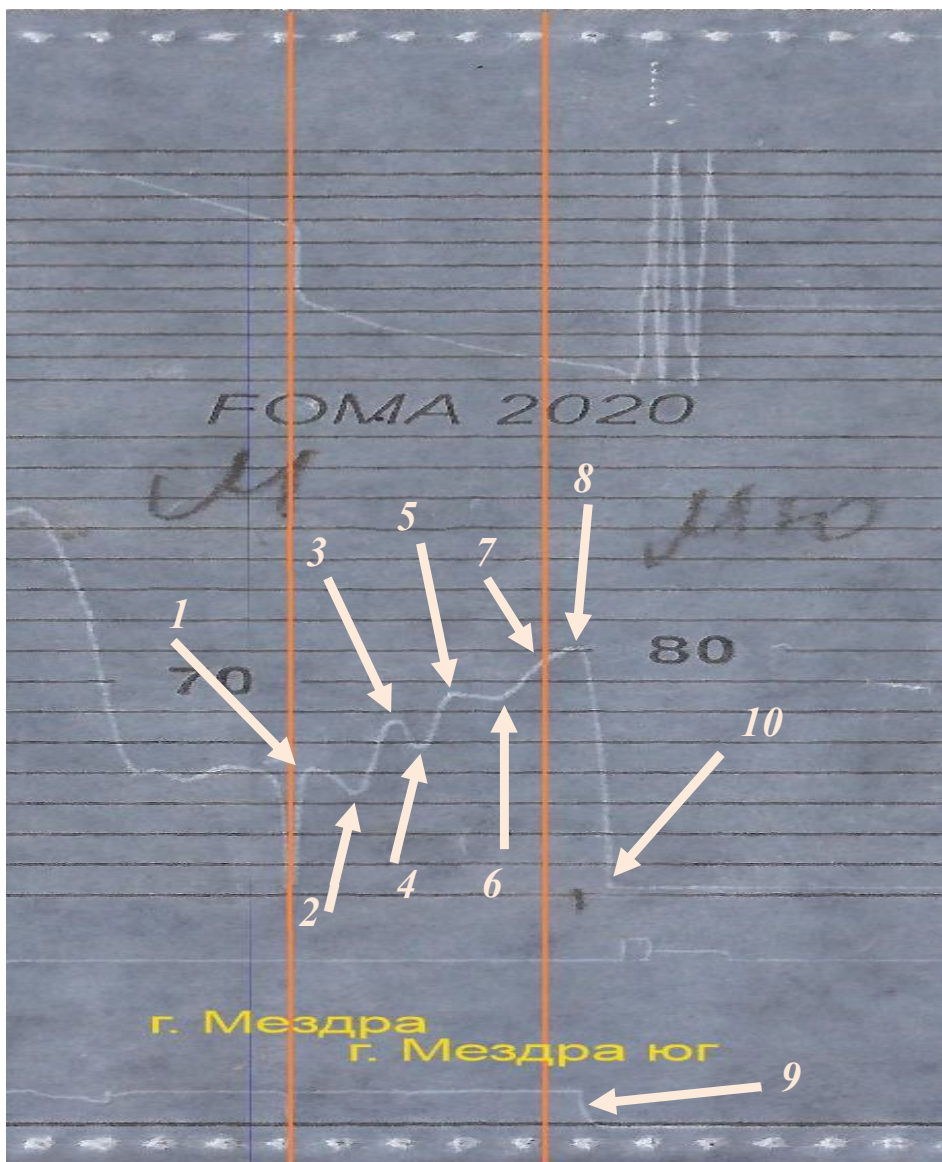
Fig. 4.6. Diagram of movement of FT № 2610 along Mezdra-Mezdra South interstation.

FT No. 2610 departed from Mezdra station at 10:46 a.m. after a stay of 3 minutes and 40 seconds. The train accelerated, reaching a speed of 42 km/h in about 45 seconds and traveling about 200 meters (Fig. 4.6, item 1). That was followed by a decrease in speed to about 33 km/h for about 30 seconds, and the distance covered was 300 meters (Fig. 4.6, item 2). The train again increased its speed to 57 km/h in 35 seconds, it travelled 350 meters (Fig. 4.6, pos. 3) and again followed a decrease to 48 km/h in 150 meters for 15 seconds (Fig. 4.6, pos. 4). The third time, the train increased its speed to 66 km/h in 20 seconds, traveling about 280 meters (Fig. 4.6, item 5). Then the speed decreased to 64 km/h in 20 seconds, traveling 320 meters (Fig. 4.6, pos. 6). After the last decrease, the speed started to increase again, reaching 80 km/h, and the train travelled 400 meters in 30 seconds (Fig. 4.6, item 8). That was the maximum speed that the train reached after leaving Mezdra station. The train passed through the Mezdra South station in traction mode at a speed of 76 km/h, during which the speed continued to increase to 80 km/h (Fig. 4.6, item 7). This is also confirmed by the reading of the selsin (the sensor) reading the position of the controller, whose arrow remained at position 26 (Fig. 4.7). 100 meters after reaching the maximum speed, the pressure in the main air conduct decreased from 5.0 to 0.0 bar, i.e., a quick stop with the automatic train brake was made (Fig. 4.6, item 9). About 90 meters after the stop, the speed started to decrease and after another 200 meters it reached 0 km/h and the train stopped (Fig. 4.6, item 10).

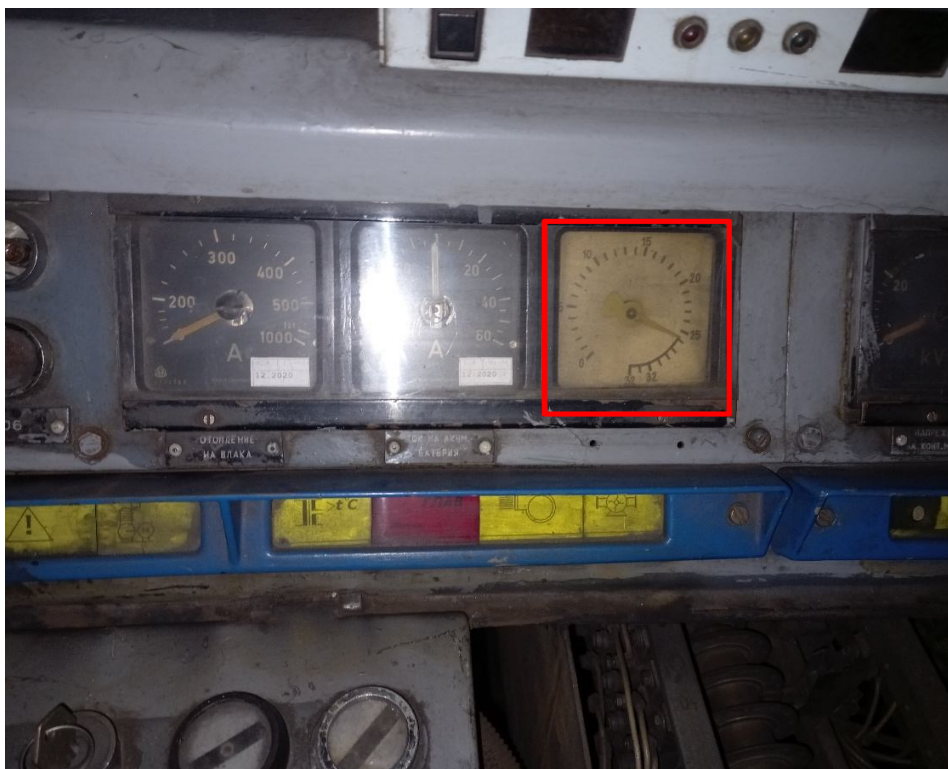
Fig. 4.7.

Given the fact that before the fire occurred, locomotive No. 91520044169-8 was working in high positions (before Mezdra station it was continuously moving at a speed of 130 km/h, with a high tractive force, or current load - fig. 4.7), it could be assumed that insufficient cooling of the rectifier cabinets or the oil circuit was also a probable cause of the fire.

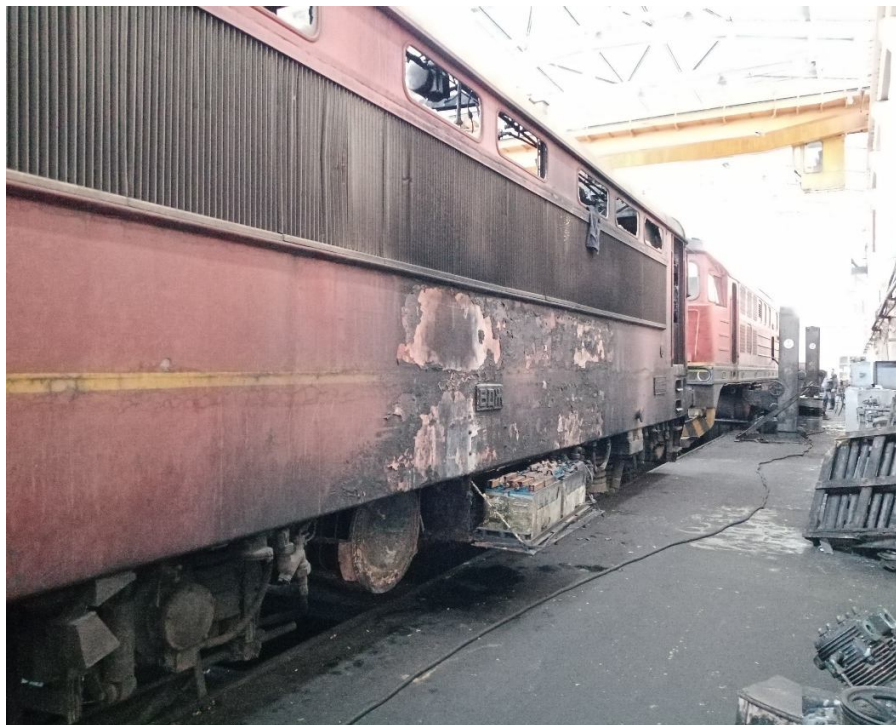
Fig. 4.9.

From the inspection of the external part of the locomotive, it was found that there were traces of burning in the middle of the body shell around the storage batteries on the left side in the direction of the train movement (Fig. 4.9). On the other side of the body shell, no traces of burning were found (Fig. 4.10). By order of the Investigation Commission, the locomotive was jacked up and the bogies separated. That enabled an inspection of the underside of the body shell as well as the bogies with the traction motors and power cables. The Commission found traces of burning on the underside of the body shell on the frame beams and sheet metal separating the engine compartment from the underframe of the locomotive (Fig. 4.11). It was also found that the insulation of the power cables feeding the traction motors was burnt (Fig. 4.12). The traces proved that in that part the combustion was external, caused by a lateral source, and the power cables of the traction motors could not be considered as the source of the ignition. An inspection was also carried out of the bogies together with the traction motor power supply terminal boxes, and it was also ruled out that the ignition could not be traced to that part of the locomotive (Fig. 4.11). The rectifier blocks were removed from the locomotive for a better and comprehensive inspection, as they are often the source of ignitions in these locomotives. The Commission inspected these facilities and found that there were damages in their lower part, which were caused by external sources, and for the most part the rectifiers were in good condition (Figs. 4.13 and 4.14).

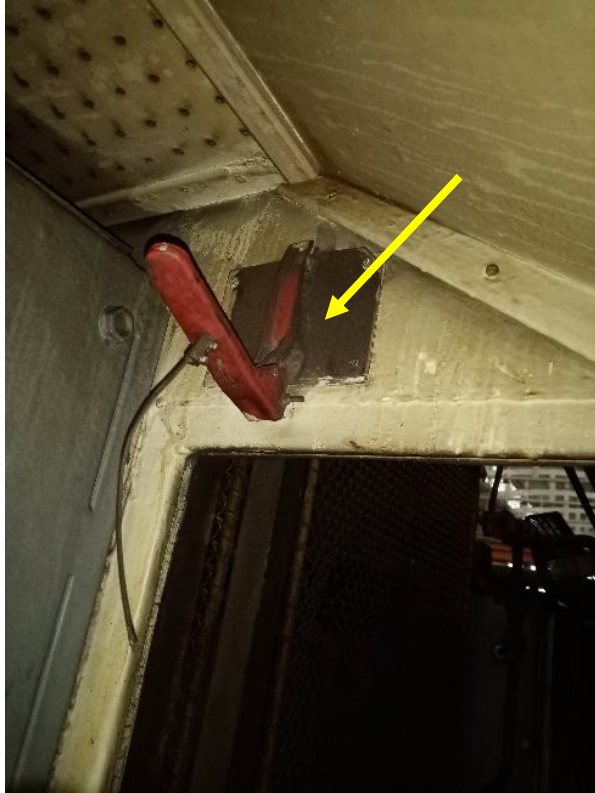
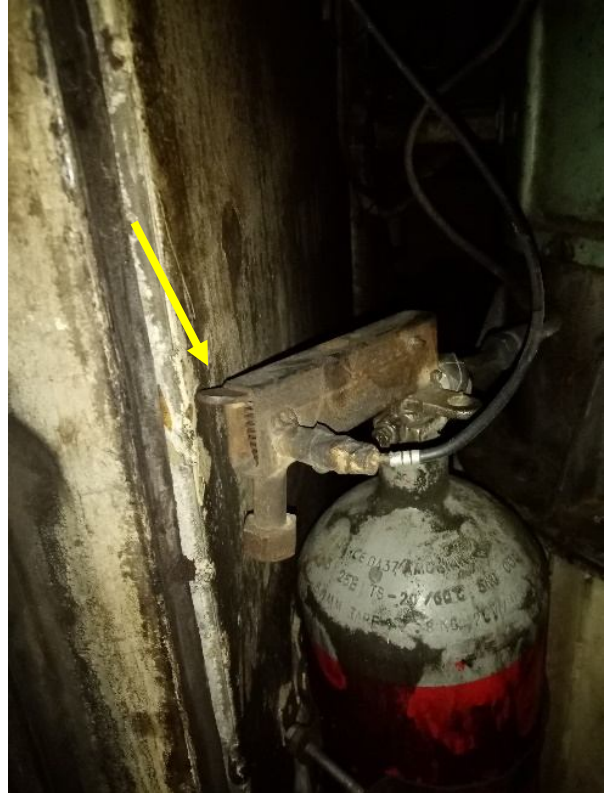
Fig. 4.15.

After carrying out the inspections on the outside of the locomotive, as well as the dismantled assemblies, the Commission proceeded to inspections in the engine compartment. First of all, it was established that the fire-extinguishing installation of the locomotive was activated by the locomotive crew (Fig. 4.15, item 1 and item 2), but it did not actually work, because no traces of fire-extinguishing powder were found in the engine compartment, with which it was loaded (Fig. 4.16).

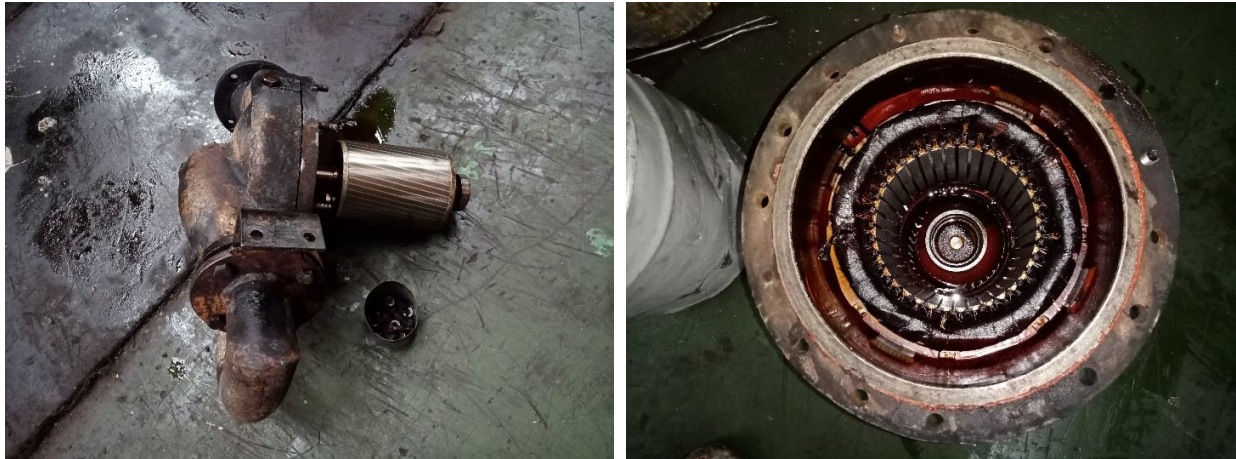
Fig. 4.18.

The Investigation Commission thoroughly inspected the removed motor-pump and demanded the measurement of the capacitors of both motor-pumps. From the inspection, it was established that the motor-pump was functional and there were no visible damages on it (fig. 4.18). During the measurement of the capacitors, it was found that their parameters did not correspond to their nominal values laid down in the technical documentation. The thickness of the copper membrane of the baroscopes was also measured and found to be 0.8 mm (Fig. 4.19). From the observations and measurements carried out, it can be concluded that the engine-pumps, and in particular the one on the side of the second traction group, did not work in normal mode with their nominal parameters and the oil flow rate was reduced. That caused the temperature of the transformer oil to rise, which at one point ignited and ignited the remaining combustibles in that area. Eventually, the rubber joint connecting the motor-pump to the traction transformer ignited, spilling and igniting the remaining transformer oil, which in turn helped fuel the fire. The traction transformer oil low pressure protection in the face of the baroscopes with (thickened copper diaphragms) also did not activate to signal that the motor-pumps were running at reduced flow.

- Recommendation 4, proposes that BDZ PS EOOD within TI to carry out checks on the serviceability of the baroscopes to control the operation of the engine-pumps, as well as the condition of their starting capacitors;

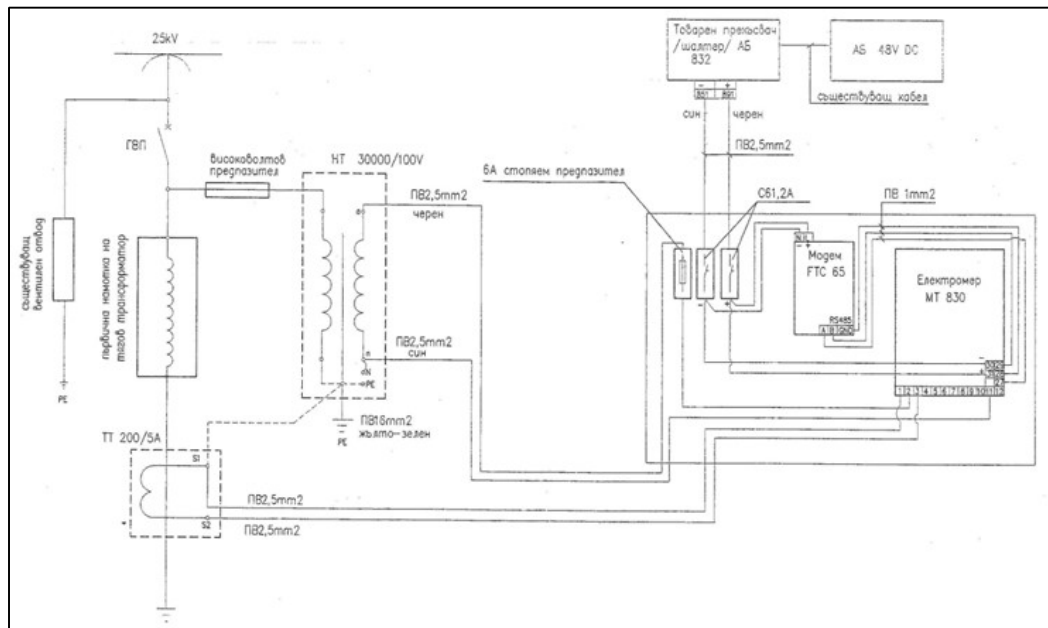
Fig. 4.24. Principal scheme of electronic electrical meter.

However, based on the findings, a significant number of ignitions of locomotives series 44 occurred after the so-called "*upgrading*" consisting in the installation of a new electronic electricity meter and given the area where the fire occurred, it could be assumed that the ignition may have occurred in the area of the measuring voltage transformer of the electricity meter. In fig. 4.24 is shown the basic circuit diagram of the electricity meter.

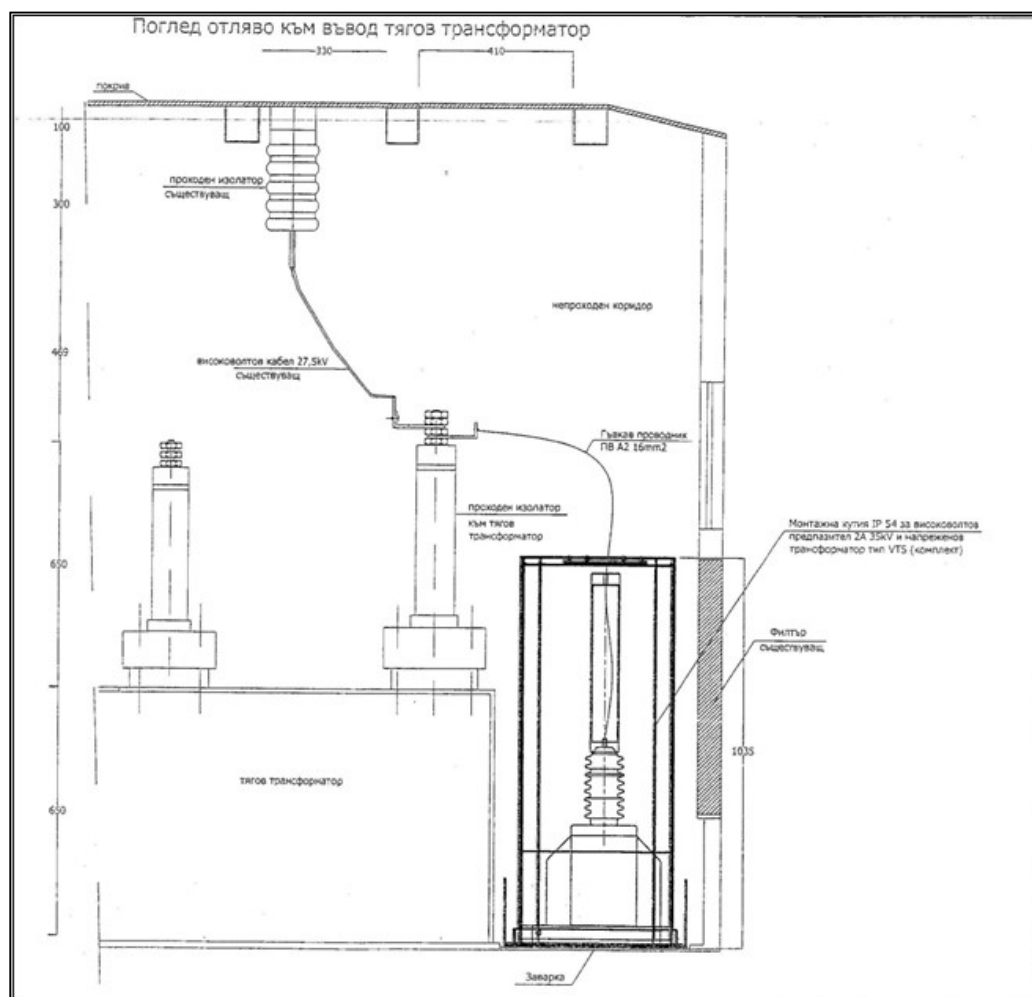
Fig. 4.25. Location and connection of the measuring voltage transformer of electrical meter.

On fig. 4.25 is shown the topology (location and connection) of the measuring voltage transformer of the electrical meter.

A possible cause of the fire in locomotive No 91520044169-8 is the occurrence of a short circuit/"disconnection" at one end of the flexible conductor PV A2 16 mm². Similar to previous ignitions, this could cause an electrical arc to earthed housing parts in this high-voltage area and the available, albeit minimal amounts of oil (e.g. transformer oil or from the compressors) could easily ignite. A certain amount of transformer oil leaked through the established burnt rubber flexible connection to the oil pump of the second cooling circuit, which resulted in the significant fire of the locomotive.

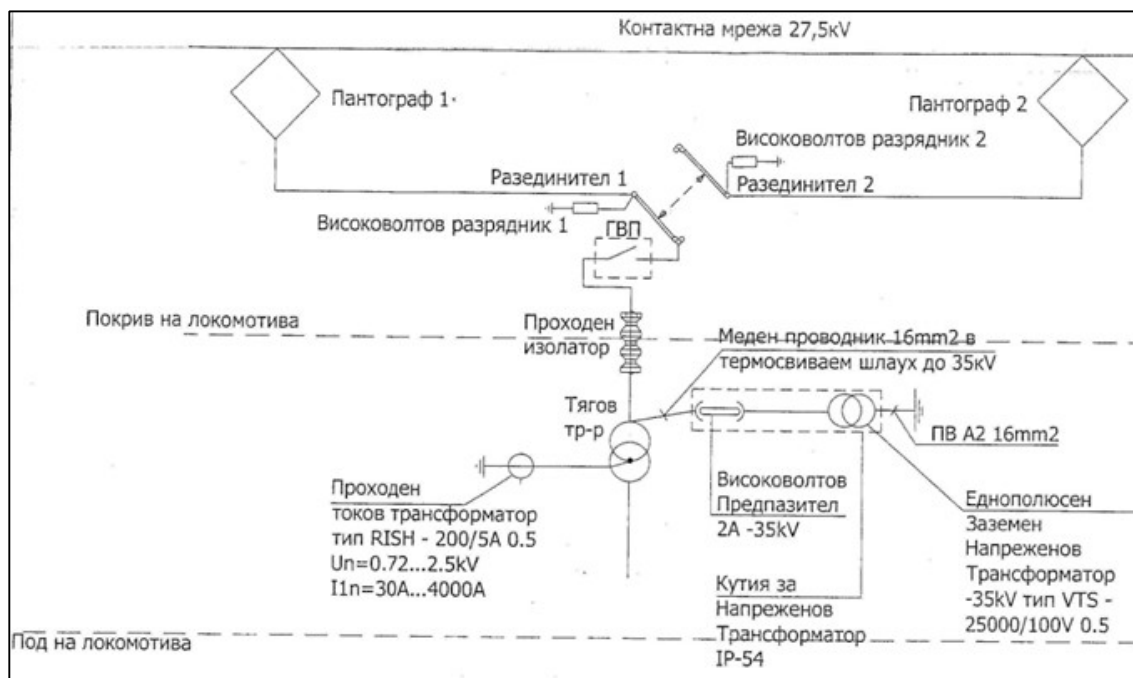
Fig. 4.26. Single linear scheme of the electronic electrical meter.

On fig. 4.26 is displayed the s.c. „single linear scheme” of the electronic electrical meter.
