RAILWAY ACCIDENT AND INCIDENT INVESTIGATION DIVISION

Number: 010-138/2008/402

Date: 27 November 2008

## FINAL REPORT ON THE INVESTIGATION INTO THE RAILWAY ACCIDENT AT THE CEŠČA VASPRI NOVEM MESTU LEVEL CROSSING ON 20 AUGUST 2008

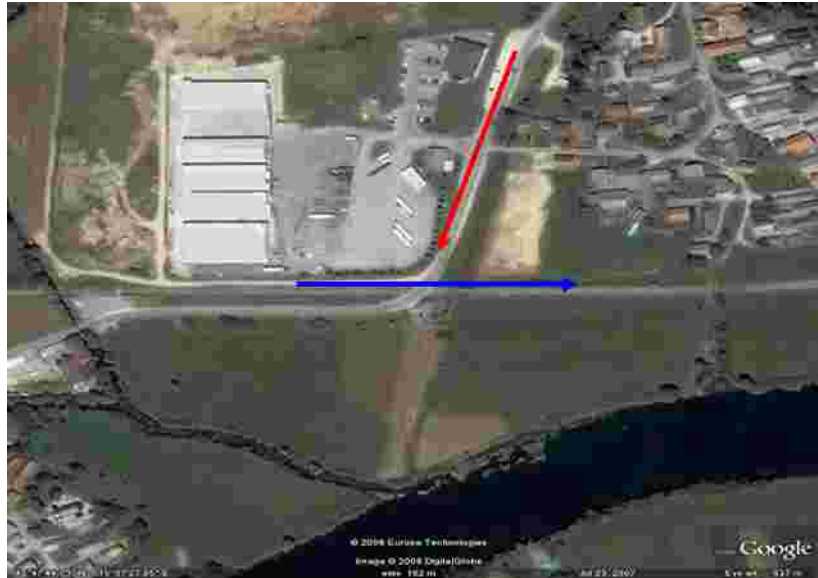
Figure no. 1: Bird's eye-view of the travelling direction of the car and the train

The red arrow shows the local road and the direction in which the road vehicle was moving, and the blue arrow shows the railway line and the direction in which the train was moving.

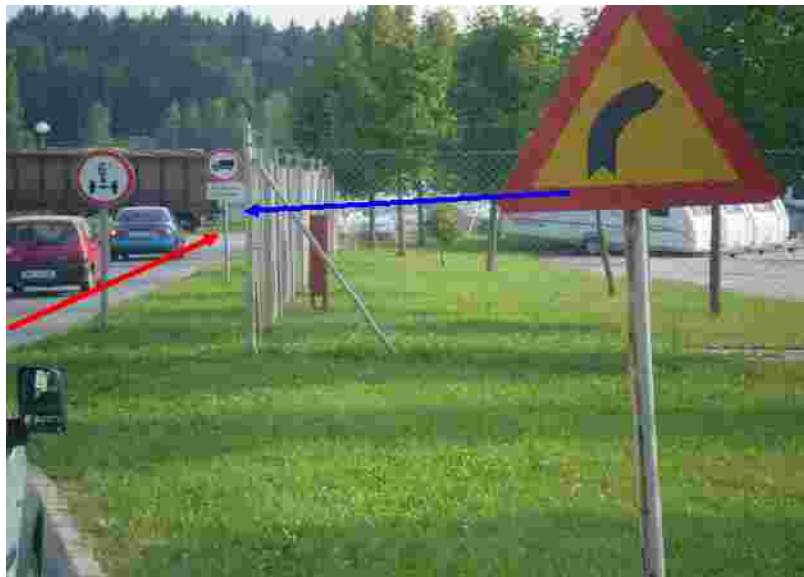
After the collision, the road freight vehicle, being pushed by the train, hit the metal railing of a railway bridge, sustaining further damage; because of the collision forces, one vehicle occupant fell out of the vehicle and died.

Figure no. 2: The red arrow shows the direction of the travelling road freight vehicle while the blue arrow shows the direction of the travelling train.
