**SPECIALIZED UNIT FOR INVESTIGATIONS OF ACCIDENTS AND INCIDENTS IN
RAILWAY TRANSPORT AT MTITC**

FINAL REPORT

**From
investigation of a railway accident – fire occurred
in
electric locomotive №43310.9 while IDFT № 40772 moves between stations
Belovo and Kostenets on August 11, 2019**

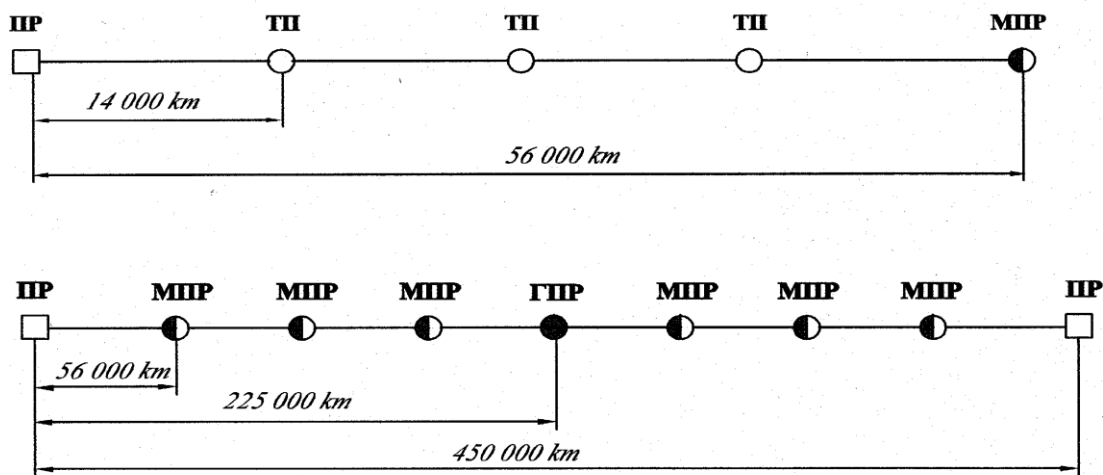
Fig. 7

Fig.7 and 7a show schematically and tabular BRM of loc. 43310.

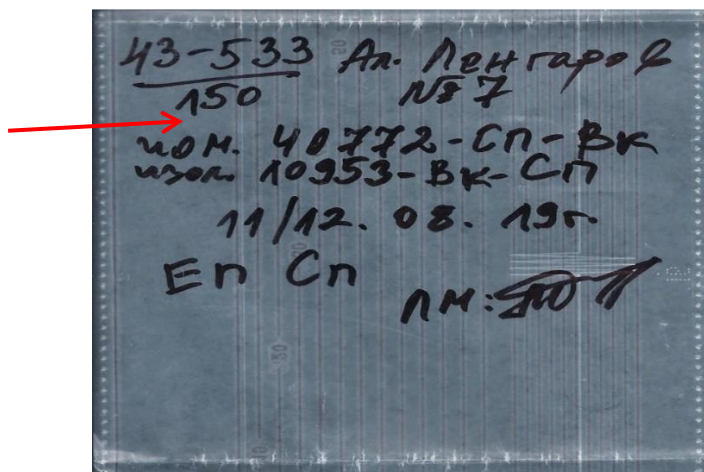
For this reason, the speedometer strip of the head locomotive № 43533 is used for the movement of the train composition prior to the accident to be analyzed. Fig. 12 shows the inscribed

portion of the strip, and the strip itself, scaled, with markers and markings is shown in Fig. 7. Although it is used a speedometer belt for a maximum speed of up to 120 km/h, the speedometer of the locomotive is designed for a maximum speed of movement up to 150 km/h (as shown in the upper left corner of Fig. 6 with a red arrow). For this reason, all the speed values recorded by the stylus in Fig. 7 should be scaled by a factor of $1.5 / 1.2 = 1.25$.

Locomotive № 43533 is equipped with a speedometer installation to record speed in the range from 0 to 150 km / h.

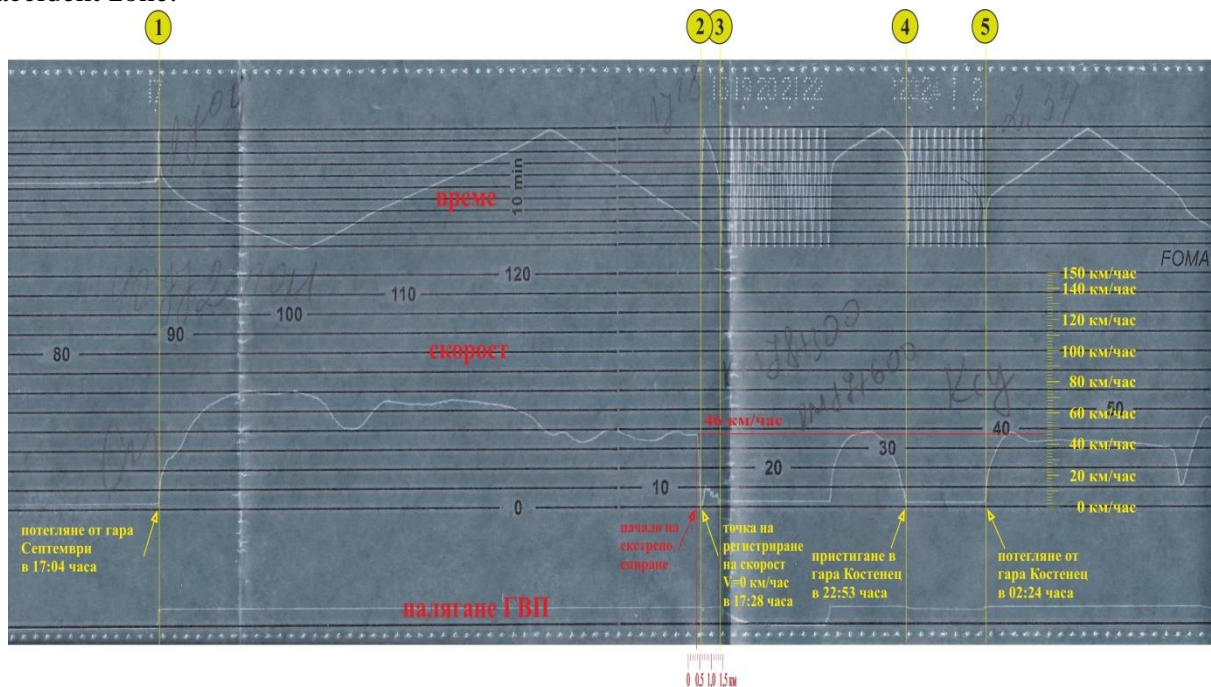
In Fig.13 is shown a graphical representation of the speedometer belt of locomotive № 43533 in the accident zone.

Marker 1 (Fig.13) - the train leaves Septemvri station at 17:04 hrs.

Given the train length - 550.45 m and the location of the three locomotives, the distance from the sensor of locomotive № 43533 and locomotive № 43310 is 583.45 m, i.e. the records of Fig. 13 refer to locomotive № 43310 by adding these 583.45 meters.

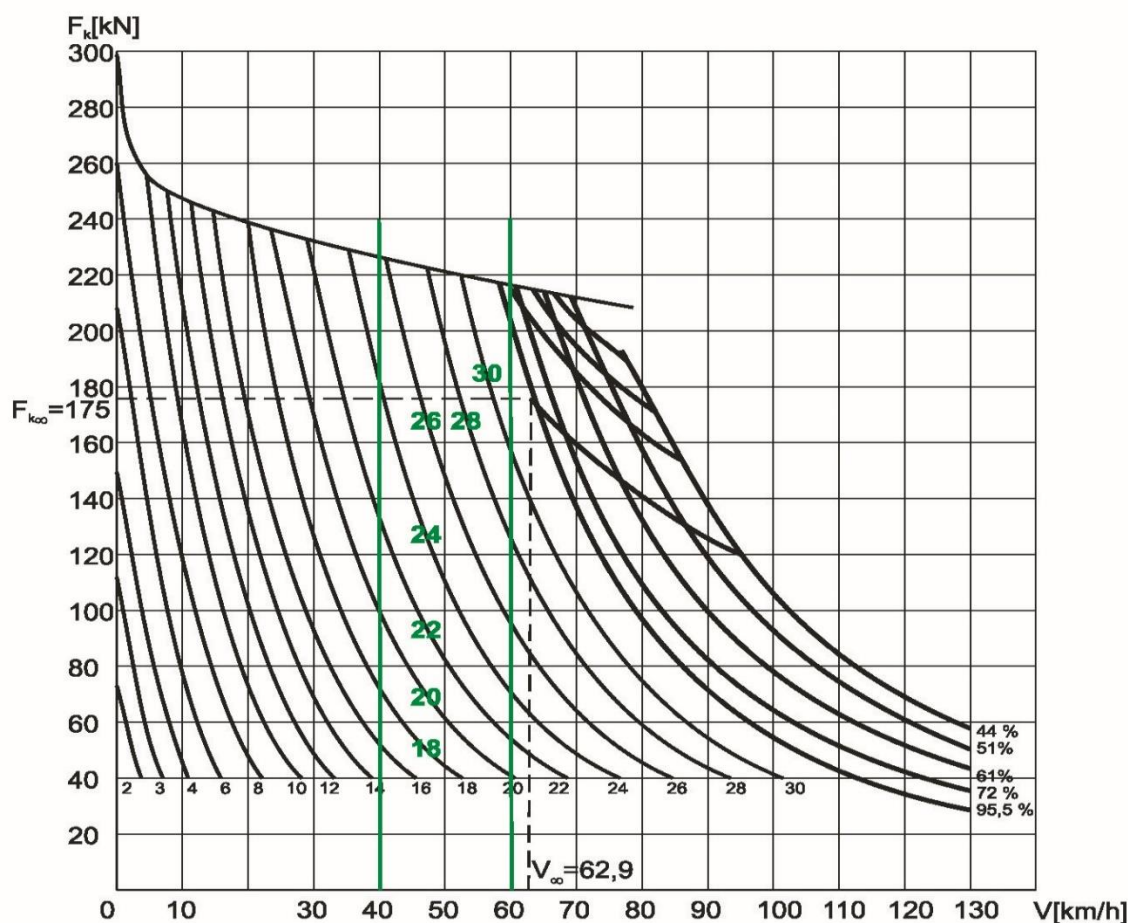
Fig. 14

From the traction characteristic of the locomotive, it can be established that traction positions between the 18th and the 32nd, were possible to be used when operating in Septemvri - Belovo section at speeds between 50 and 75 km/h which is directly relevant to the possibility of a circular fire occurring on one of the traction engines of the locomotive.

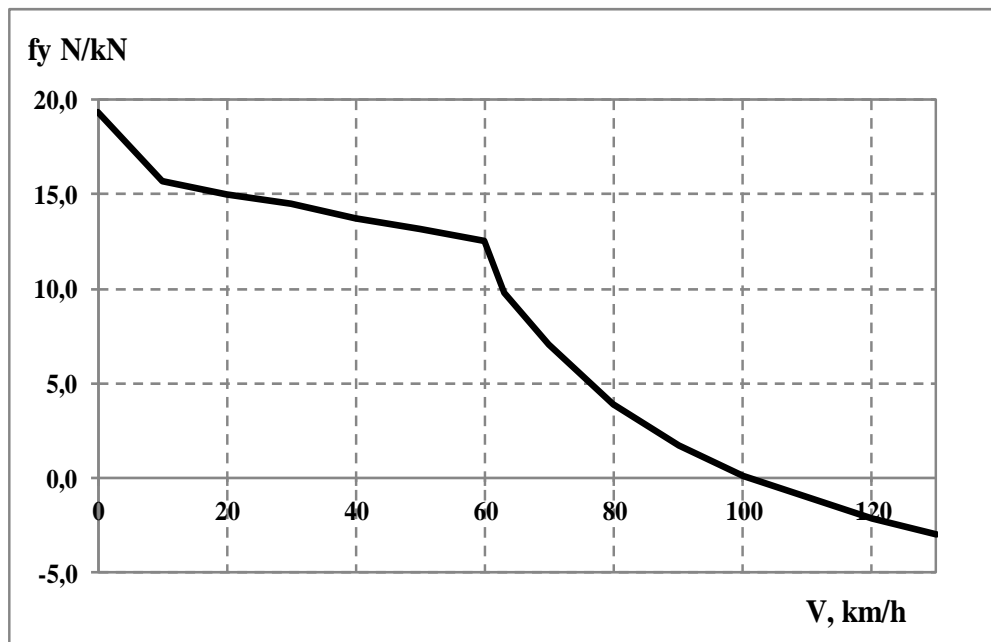
Fig. 15

If it is provisionally assumed that, without operating in a multi-unit system, all three locomotives in the composition are approximately equally loaded in the ascents of train № 40772 route, then the maximum possible speed of the composition in the largest ascents (20 ‰ - see. Fig. 17) is slightly above the estimated speed of 62.9 km/h.

The specific accelerating force of a single locomotive for the composition is shown in Fig. 15.

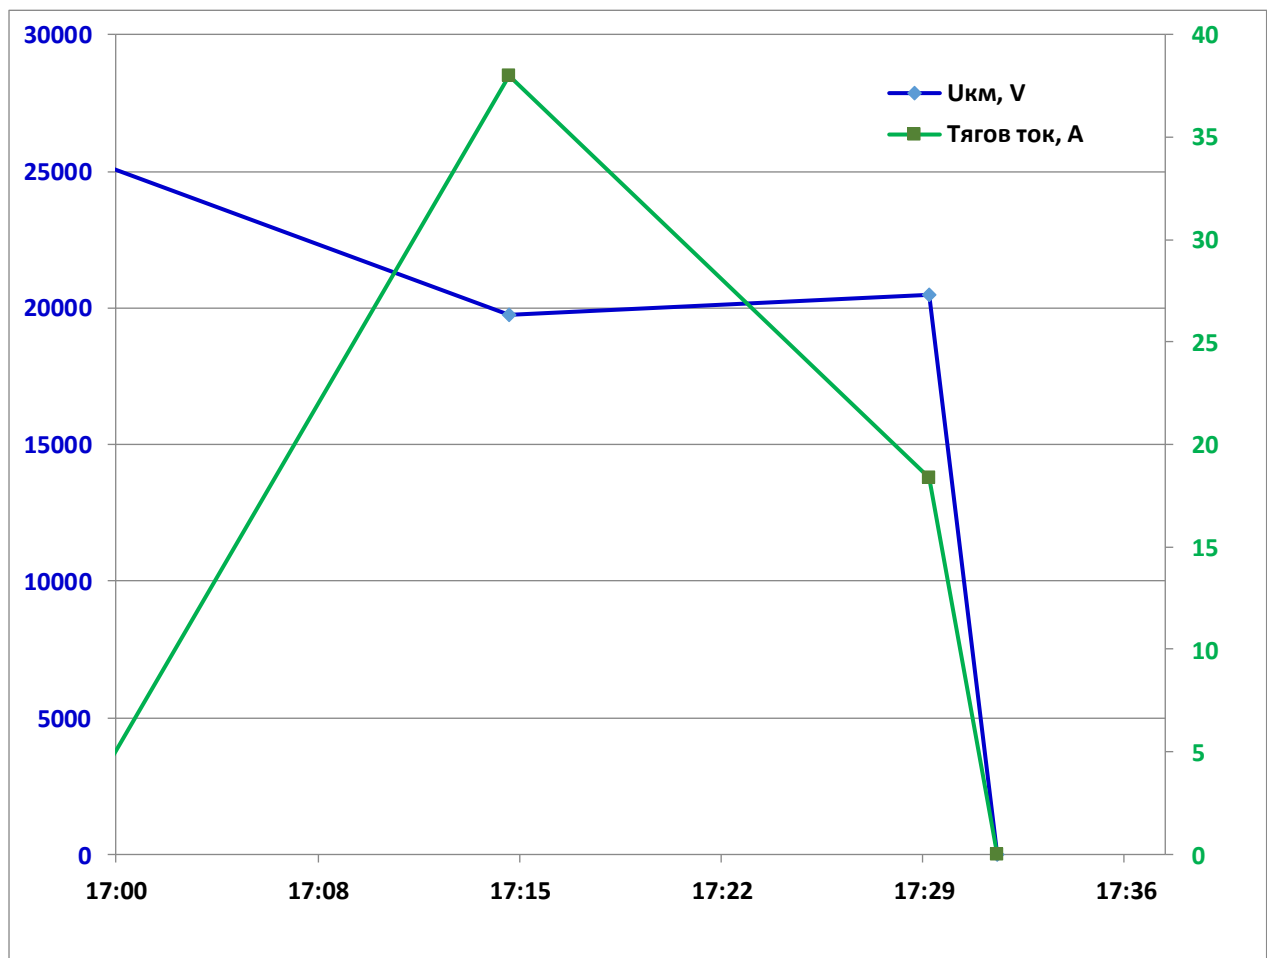
Fig. 16 shows the diagrams of the voltage in the contact network and the traction current taken as a record from the electrometer of locomotive № 43310 in the interval 17:00 ÷ 17:32 hours in a 15 minutes step. As the period of averaging of the recorded parameter readings is considerable, it is practically impossible to make certain analyzes and valid assumptions about the power modes and the load of the burned locomotive.

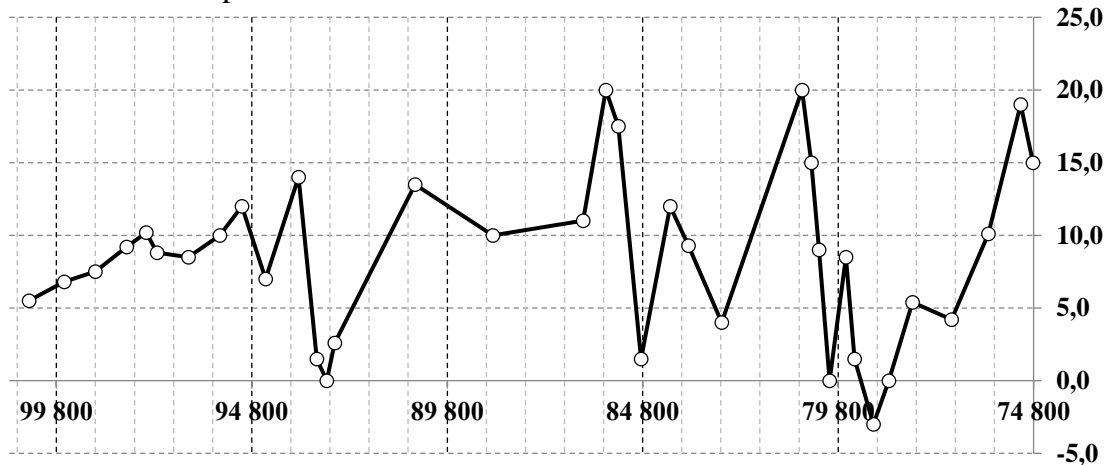
Fig. 17 shows the longitudinal profile of the railway in section Septemvri - Kostenets.
