DERAILMENT OF TRAIN 46676

on 16 June 2010

**on the Arlberg line
between Hintergasse and Braz stations**

Accident Investigation Report

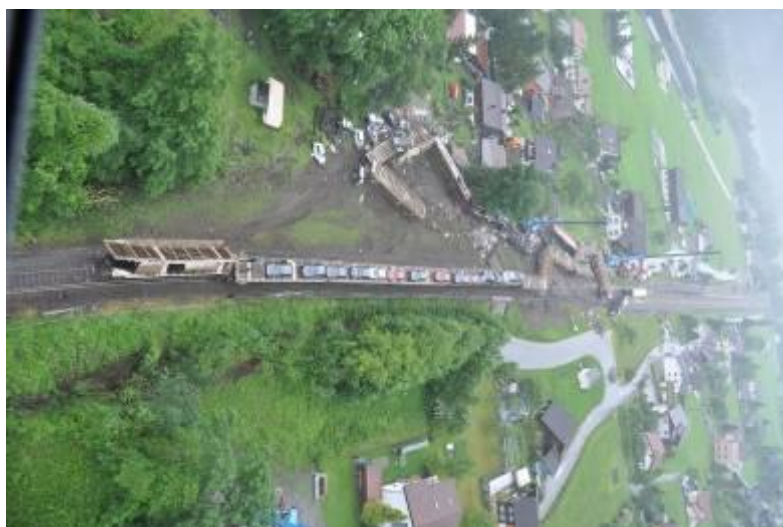
Figure 1 Location of derailment 2 in Braz station

The cause was the cable supporting the brake coupling between the two sections of the first wagon becoming detached. Hence the brake coupling swung down and caught against used rails stacked in the middle of the track. The impact pulled the coupling off the brake hose of the front section of the wagon. In consequence, the coupling together with the brake hose of the rear section of the wagon was thrown against the underframe of the following section of the wagon and become wedged in the underframe such that brake hose was kinked and prevented the air escaping from [the main brake pipe through] the following part of the train (15 ½ wagons). The gradient of up to 35 ‰ caused the unbraked 15 ½ wagons in the train to accelerate continuously. Some parts of the train derailed on the curves before Braz station at a speed of some 125 km/h. The locomotive and 13 wagons came off the formation and some finished up lying very close to private houses in Braz. The cargo (trade cars) was strewn over the area.

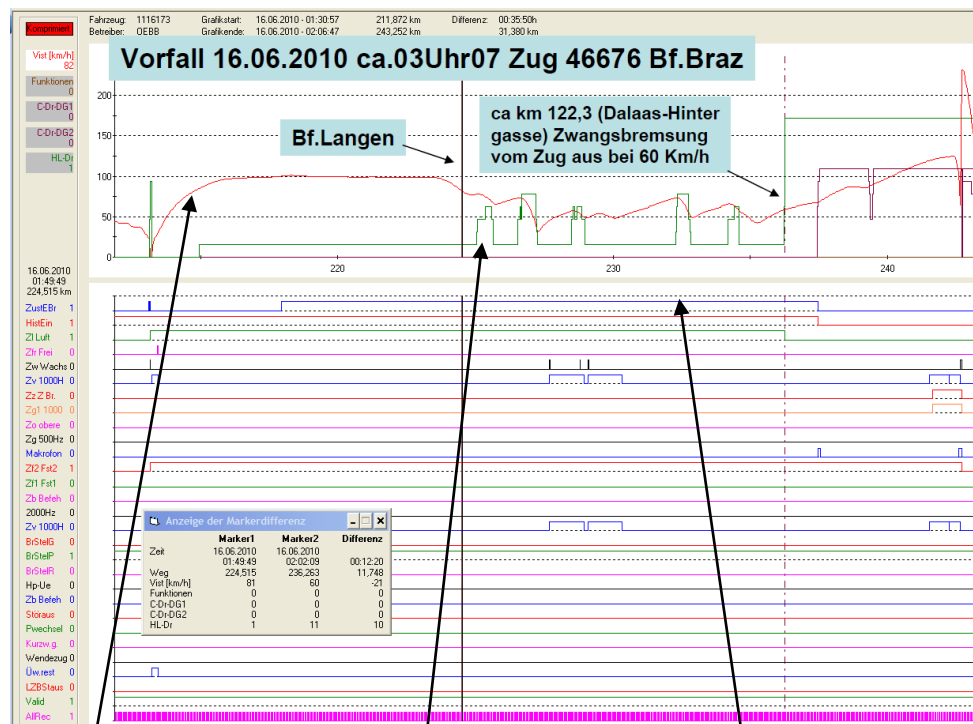
Figure 20 Analysis of the data from the recording equipment on the locomotive (1) (source: traction provider)

Vorfall 16.06.2010 ca. 03Uhr07 Zug 46676 Bf.Braz	Incident 16 06 2010 approx. 03:07 train 46676 Braz station
Ca km 122,3 (Dalaas-Hintergasse) Zwangsbremsung vom Zug aus bei 60 km/h	Approx 122.3 (Dalaas-Hintergasse) automatic braking of the train travelling at 60 km/h
Bf. Langen	Langen station

Some 7200 data elements were analysed in the evaluation of the journey of locomotive 1116 173-4 from Landeck station to the point at which train 46676 derailed. A high degree of consistency with the journey taken by the locomotive on that section of line was noted.

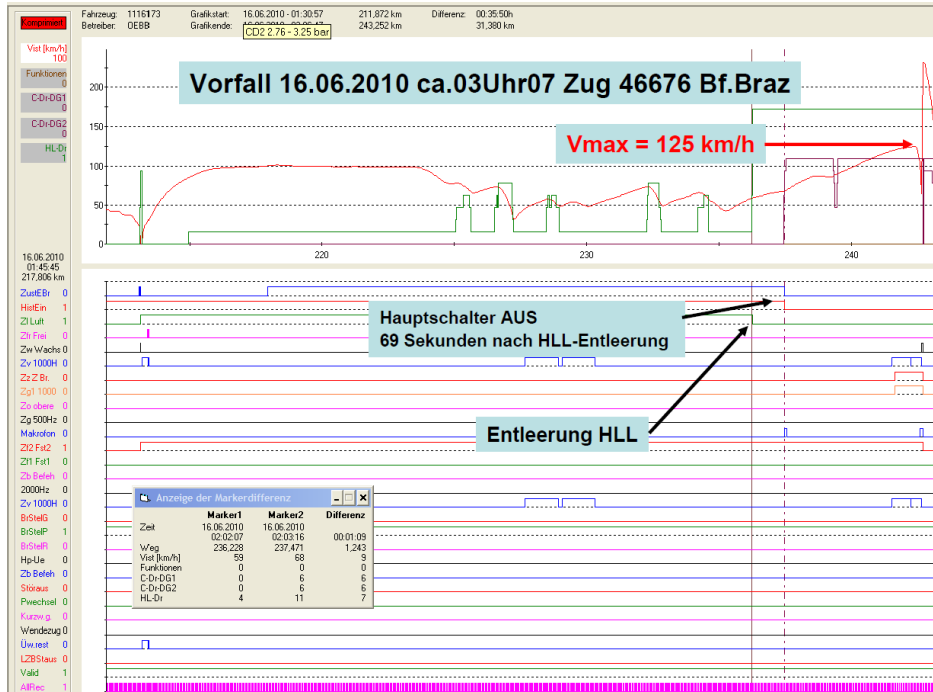
Figure 21 Analysis of the data from the recording equipment on the locomotive (2)
 (source: traction provider)

Vorfall 16.06.2010 ca. 03Uhr07 Zug 46676 Bf.Braz	Incident 16 06 2010 approx. 03:07 train 46676 Braz station
Vmax = 125 km/h	Maximum speed 125 km/h
Hauptschalter AUS 69 Sekunden nach HLL-Entleerung	Master controller OFF 69 seconds after the emptying of the main brake pipe
Entleerung HLL	Main brake pipe empties

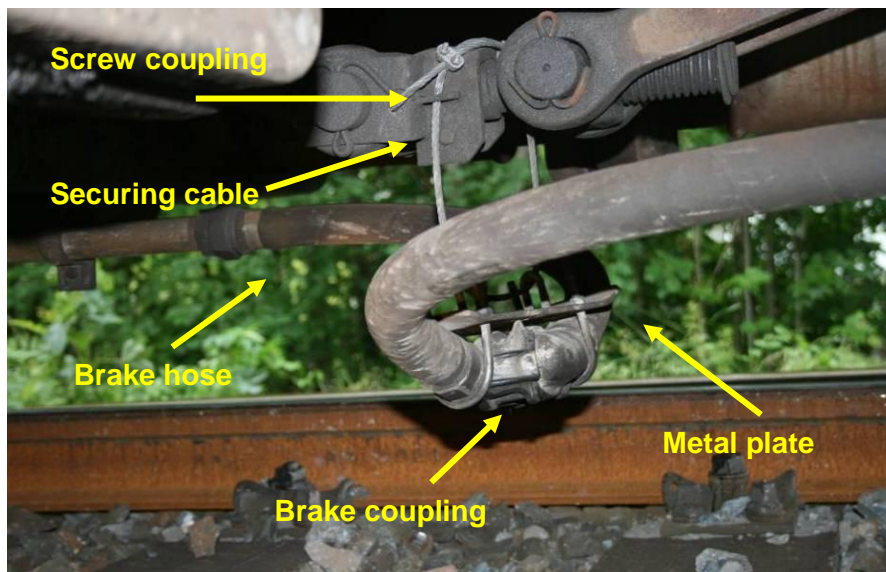
Figure 34 Brake coupling in the middle of the vehicle

The main brake pipe is linked between the two sections of the wagon by brake hoses and brake couplings. The design of the wagon with the bridge in the middle dictates that a securing cable is used to provide safe support for the main brake pipe. A metal plate with two U-bolts is bolted above the brake coupling. A cable (length \approx 970 mm, \varnothing 6.42 mm, details from the construction drawings) is led through a loop on this metal plate. The cable passes over the screw coupling in an "O" form and is secured with a cable grip.

According to the GCU Appendix 10, no part of the brake coupling system (whether connected or disconnected) must hang within 140 mm of rail level. This 140 mm dimension is a workshop dimension and must be adhered to in the maintenance of wagons in workshops.

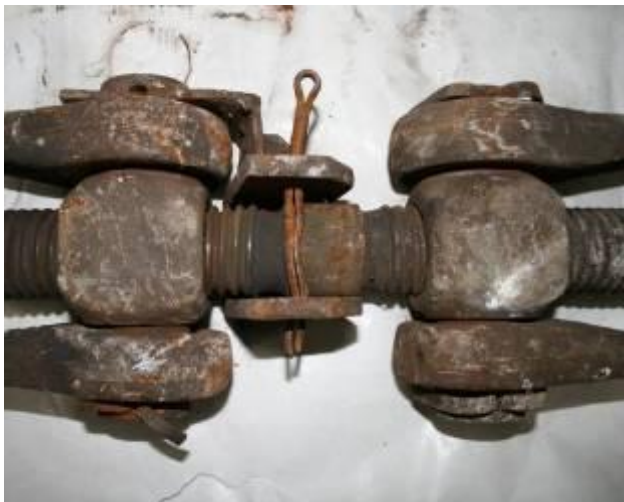
Figure 43 Anti-rotation device

The brake coupling was then no longer supported by the securing cable and now hung completely below rail level. The securing cable itself only was now held loosely in the hole in the anti-rotation device of the coupling screw and the retaining loops of the metal plate until it fell off in Dalaas station. The cable was recovered at km 120.620.

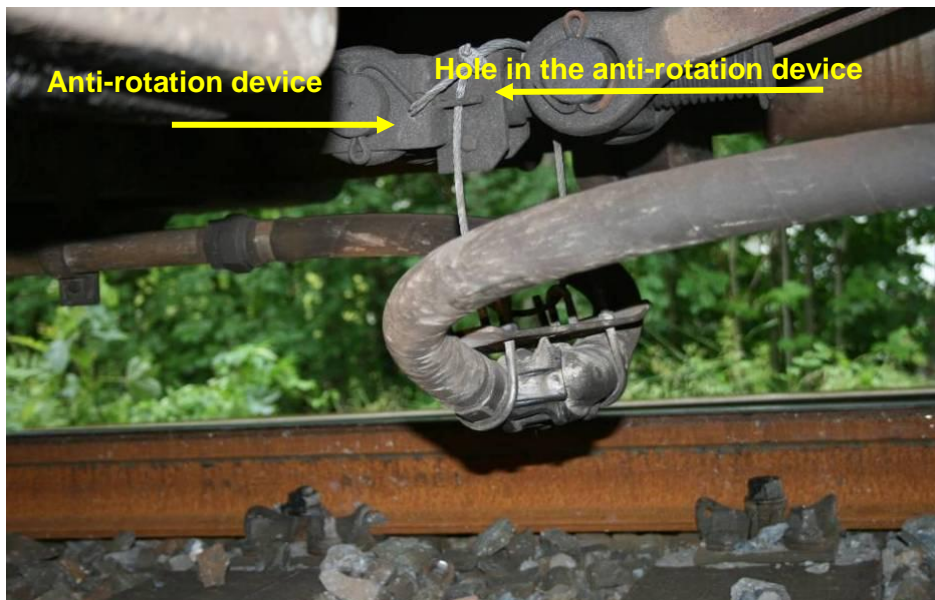
Figure 55 Anti-rotation device

The following illustrations make it easier to understand the technical reasons why the sites at which the securing cable and the cable grips were found were more than four kilometres apart.

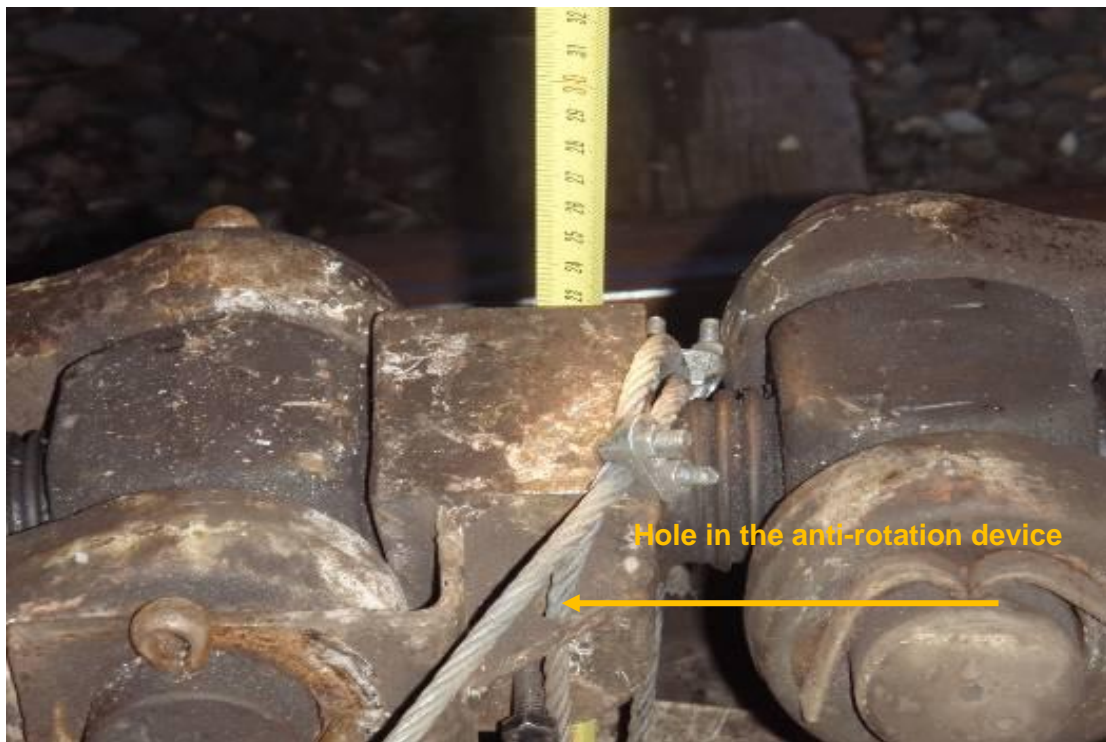
Figure 56 Hole in the anti-rotation device – detail

After the cable grip fell off at km 116.633, the securing cable itself just hung loosely in the hole through the anti-rotation device in the coupling spindle and the loops in the metal plate until it was completely pulled out in Dalaas station.
