**"AIRCRAFT, MARITIME AND RAILWAY ACCIDENT  
INVESTIGATION UNIT" DIRECTORATE  
(AMRAIU)**

**FINAL REPORT**

technical investigation of railway accident, which took place on 20.07.2011 around 17:20 hrs.  
with train № 2615, served by electrical locomotive № 44.089.1 in the stage Shunting Post (SP)  
Lesichery - Resen.

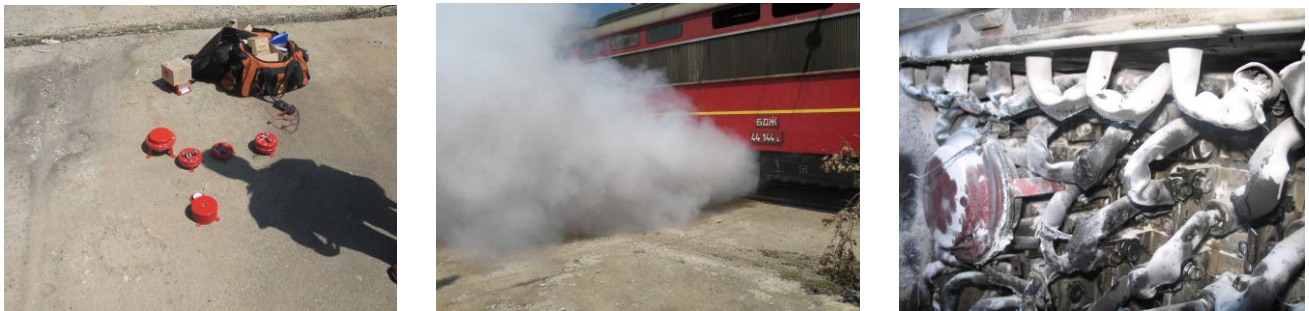
Additional materials on the case were requested and it was also proposed to make a fire and technical expertise of the electric locomotive and expert opinion on the possible technical reason for the accident. To clarify the investigated event, members of the Commission participated in an experiment conducted in the Poduyane locomotive depot to study the effective extinguishing of the experimentally lit inside rectifier cabinets with "R - C" groups in the locomotive of the same series. Various types of modern aerosol fire extinguishing generators have been tested in confined spaces. The experiment was prompted by the fact that the extinguishing agent of the extinguishing installation of the locomotive is not reaching the outbreak of fire inside the cabinets with the "R - C" groups.

*Moments from experiments carried out with different types of generators for aerosol extinguishing*
