MINISTRY OF TECHNOLOGY AND INDUSTRY TRANSPORTATION SAFETY BUREAU

FINAL REPORT (EXTRACTION)

2022-0381-5 (HU-10217)

Railway accident / Level crossing accident Mindszent - Hódmezővásárhelyi Népkert, 5th April 2022

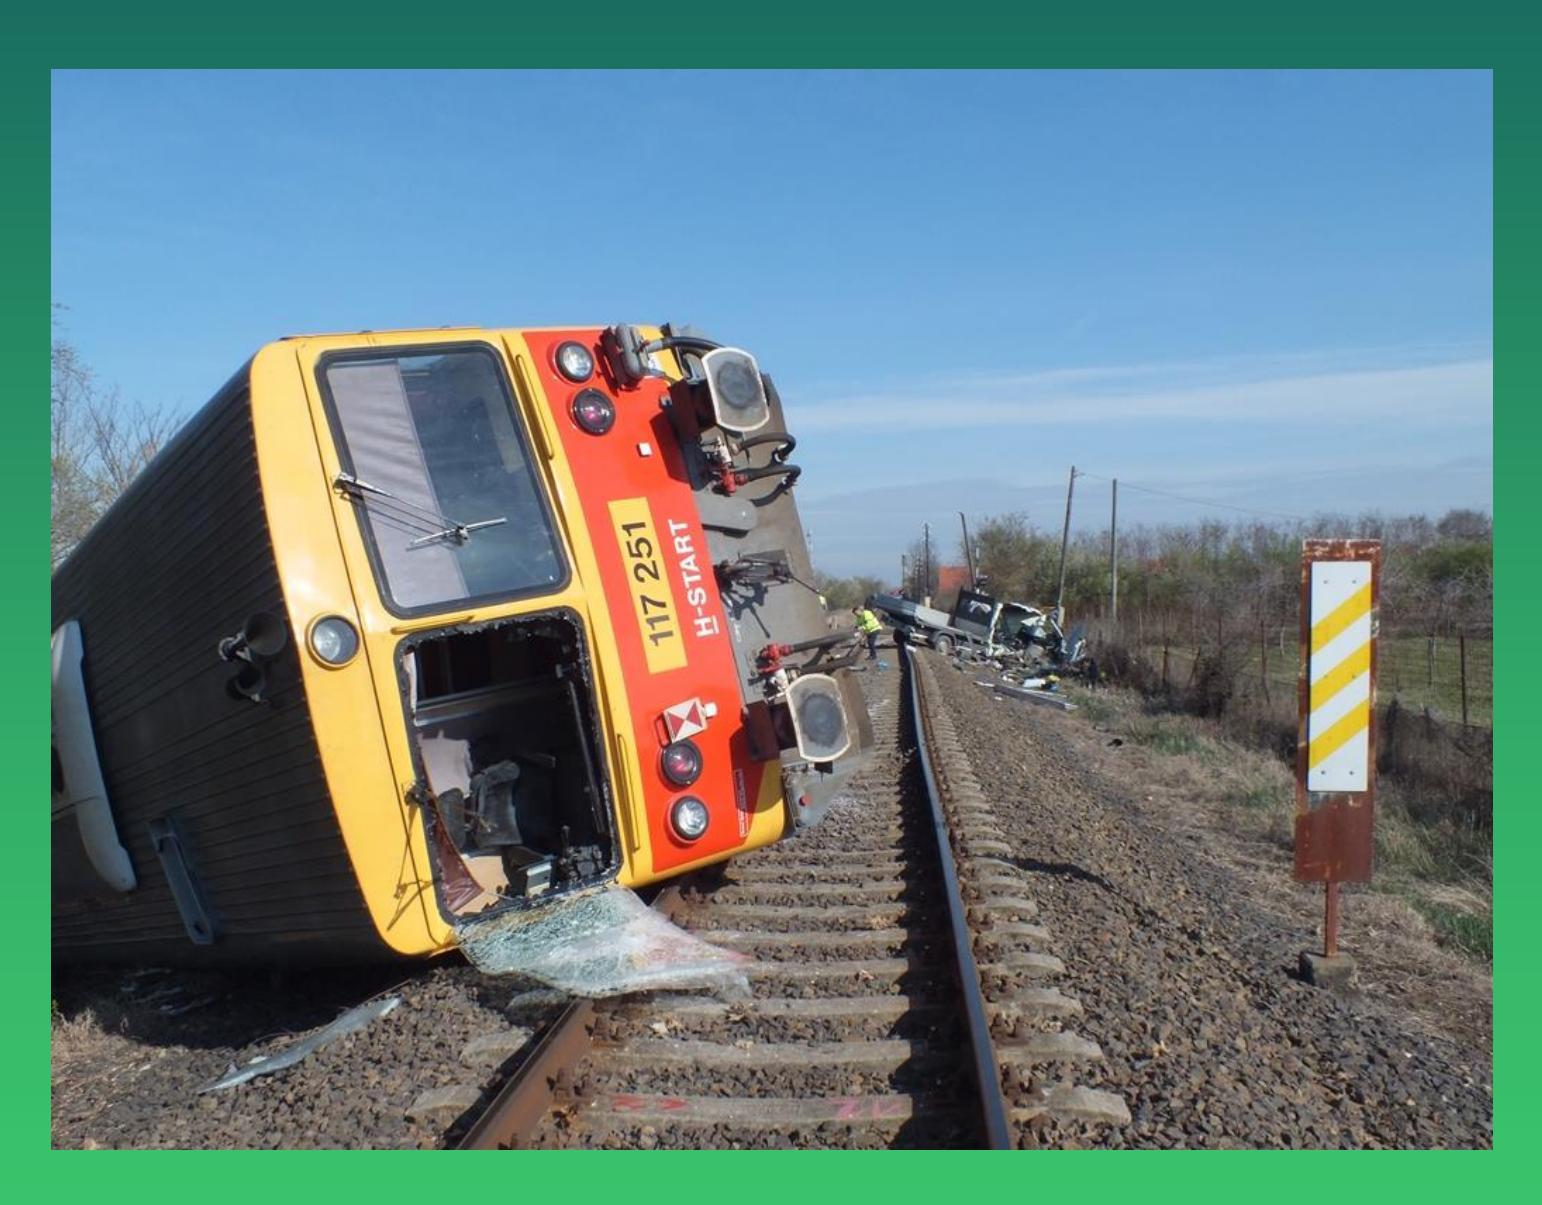
- the covers of the mounting holes in the floor, which have sharp, angled edges, fell between the seats (Figure 1);
- oil was leaking into the passenger compartment through some mechanical openings that opened during the accident, and the oil must have been at a high temperature due to the engine and propulsion system;
- the driver's cab's door;
- the seat pans of two seats, and;
- a number of smaller parts and accessories.

Figure 1: Mounting holes in the floor, and loose covers

These parts could have caused injury to passengers or aggravate injuries they suffered from other causes.

The covers built into the floor cannot be fixed, i.e. their displacement is a design feature. The seat covers can be fixed, i.e. their displacement is a maintenance and operational deficiency.
