# RAILWAY ACCIDENT INVESTIGATION UNIT IRELAND

## INVESTIGATION REPORT

**Investigation into SPADs on IÉ Network,  
from January 2012 to June 2015**

**RAIU Report No: R2016 – R001**

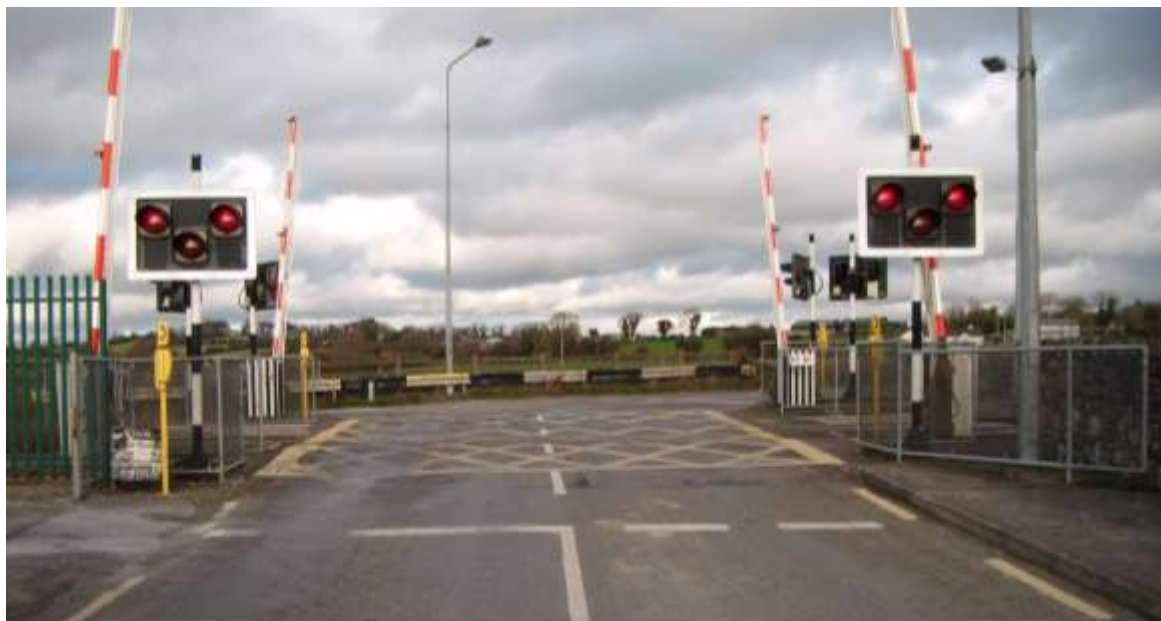
**Figure 21 – Level Crossing XT061**

168 A closed circuit television (CCTV) level crossing, Level Crossing XT061, is located 109 m west of Millstreet Station, en route to Rathmore Station, see Figure 20; it is located a short distance from the end of Millstreet Station platform). This type of level crossing prevents access by means of two full barriers that block the flow of road traffic. The level crossing is protected by traffic light signals, audible warning devices and the full barriers. The operation of the lights and sirens followed by the lowering of the barriers is initiated automatically as the train approaches the level crossing. The barriers rise automatically once the train has passed. The level crossing equipment is supervised by a Signaller in CTC; see Figure 21 for a photograph of Level Crossing XT061 with the barriers raised.

169 No factors in relation to the operation of the level crossing were found to have contributed to the incident.

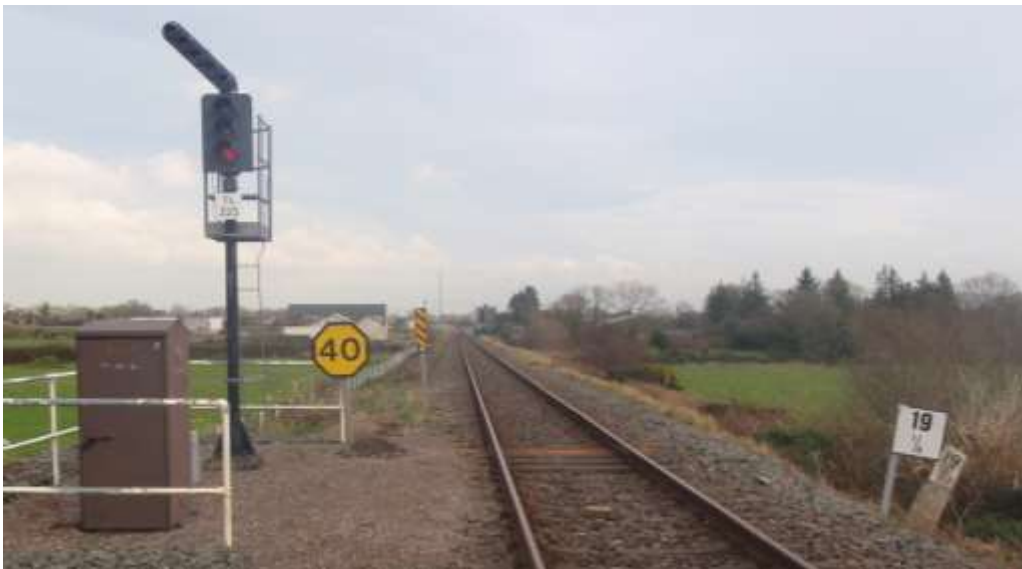
**Figure 22 – Signal TL223 with route indicator and adjacent speed board**

190 Signal TL223 is a three aspect signal mounted on a standard height pole situated on the left hand side of the track close to 19 ¼ MP. It is capable of displaying single yellow, green and red aspects; and has a *route indicator*, see Figure 22. TL223 clears to a green aspect on request from the CTC Signalman after the barriers of Level Crossing XT061 are lowered; the level crossing is not *approach released*. There is a 40 mph (64 km/h) speed board located behind the signal.

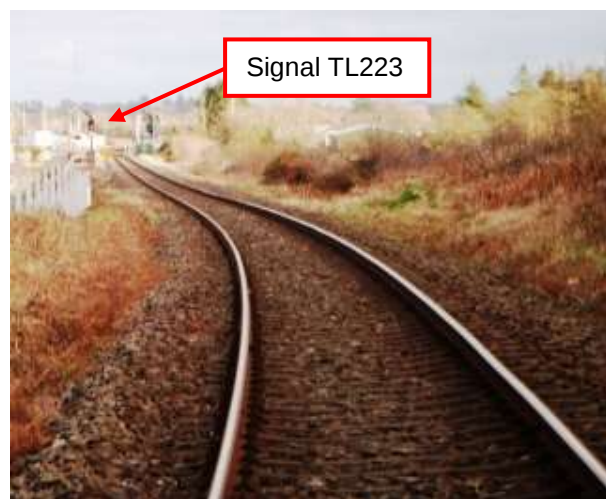
**Figure 23 – View of Signal TL223 on curve**

191 On the driver's approach of Signal TL223, the signal comes into view, across a curve, from a distance of 435 m, Figure 23. There is then a clear view of Signal TL223 on the straight line from a distance of 370 m. The minimum required sighting distance for a line speed of 80 mph (128 km/h), as set out in I-SIG-2043 (discussed in paragraphs 30 - 34), is 286 m; therefore the actual sighting distance of 370 m exceeds the requirements set out in the standard.

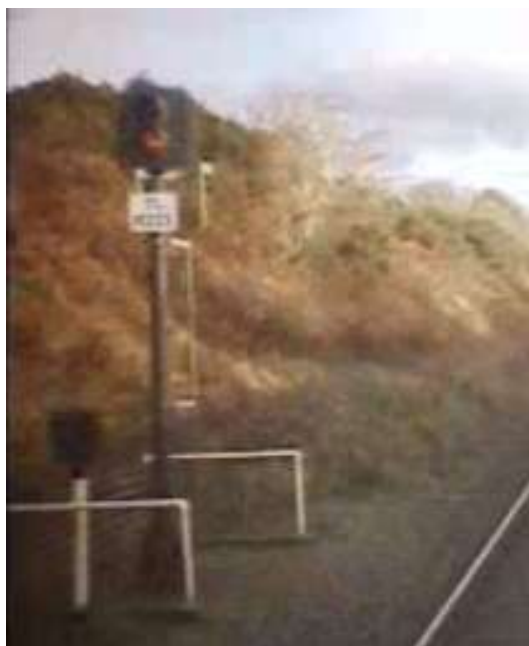
**Figure 25 – Train A303 CCTV download, showing Signal TLR223 displaying a yellow aspect**

193 The aspects displayed on the day of the incident, as outlined in the sequence of events, was confirmed by forward facing CCTV on board Train A303 i.e. that Signal TLR223 was displaying a yellow aspect (see Figure 25), and Signal TL223 was displaying a red aspect as Train A303 approached the signals (see Figure 26).

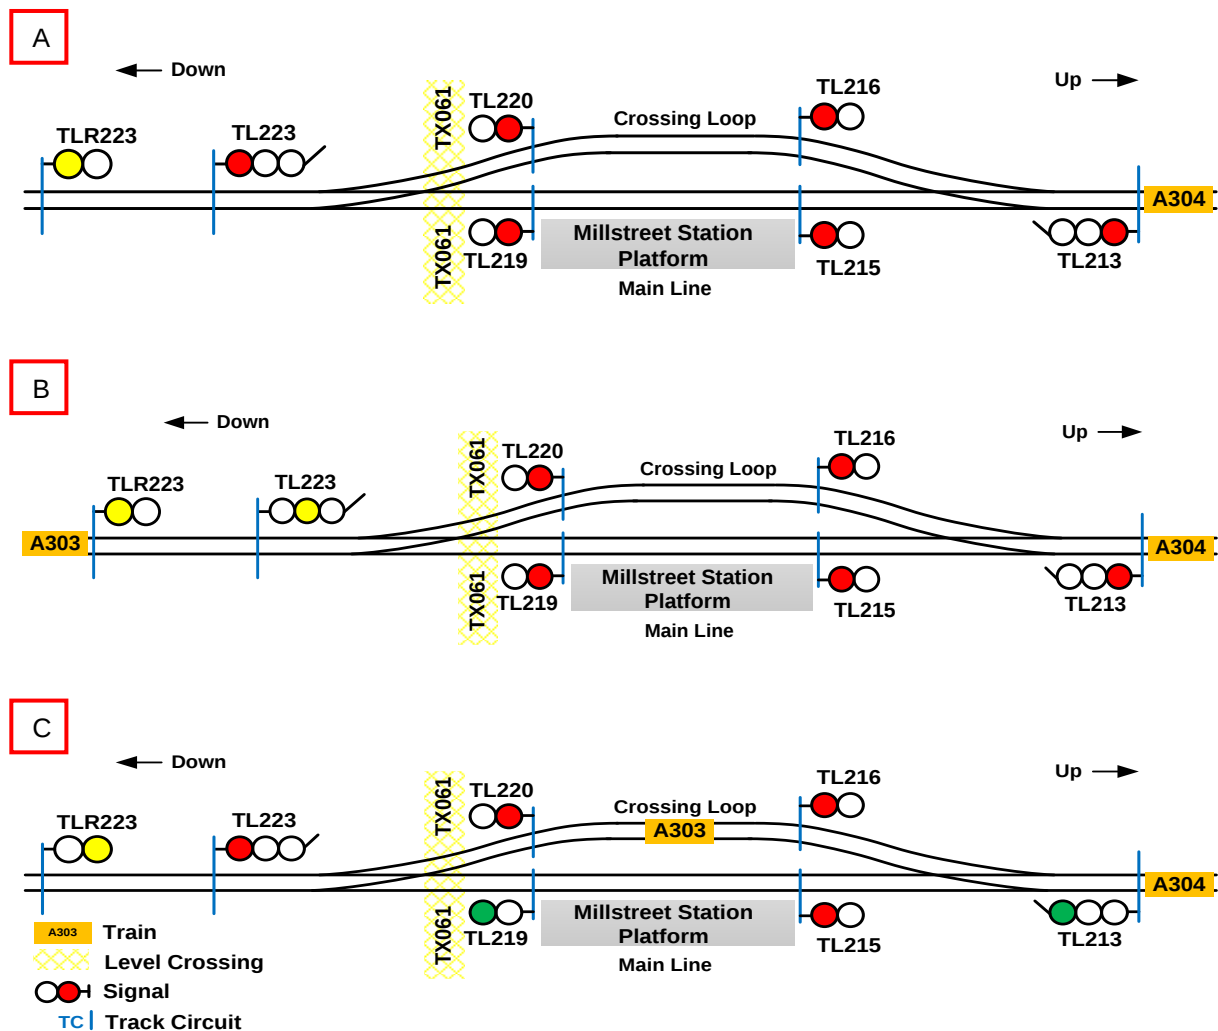
Figure 30 – Alternative sequence

222 IÉ calculated, given the timings on the day of the incident, that the delay to Train A304 would have been reduced if Train A304 had been held at Signal TL213 (see Figure 30 A) the signal protecting the platform; to wait for the arrival of Train A303.

223 On the arrival of Train A303, it would be given the route directly into the crossing loop, while still holding Train A304 at Signal TL213 (see Figure 30 B&C). Once on the crossing loop, Train A304 could be routed onto Millstreet Station Platform and continue towards Tralee; Train A303 could carry out a shunt movement onto Millstreet Station Platform and continue towards Heuston.

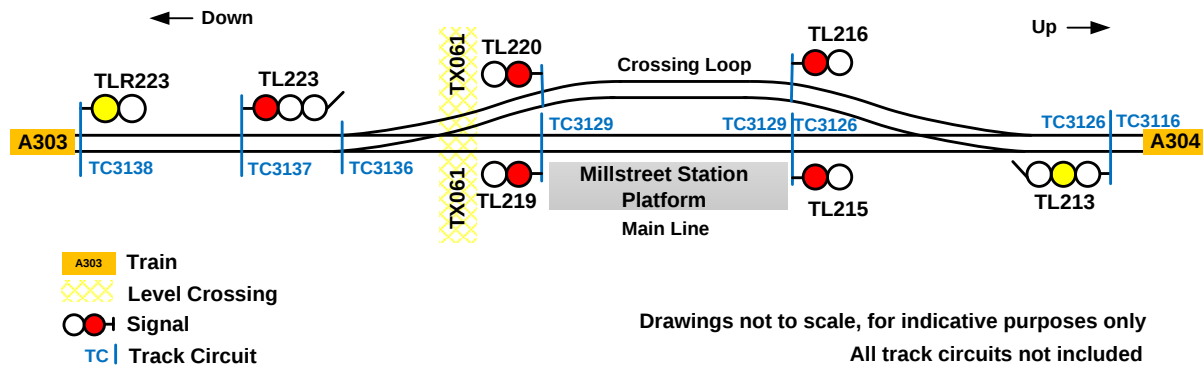
**Figure 32 – TLR223 displaying a cautionary aspect & TL213 displaying a cautionary aspect**

246 At approximately 13:11 hrs, Train A303 approaches Signal TLR223 in the up direction at the permitted line speed. Signal TLR223 is displaying a single yellow aspect (this is a cautionary proceed aspect, meaning the driver should be prepared to stop at the next signal, Signal TL223, which is displaying a red aspect). Train A303 was travelling at 68 mph (108 km/h) as it approached Signal TLR223. Signal TLR223 and TL223 are displaying yellow and red aspects, respectively, as Signal TL213 is displaying a yellow aspect, to allow Train A304 proceed into Millstreet Station Platform, see Figure 32.

247 Driver A303 did not have CAWS in cab and did not use any form EPT, such as RTC, to remind himself that the next signal, Signal TL223, would be displaying a red aspect.

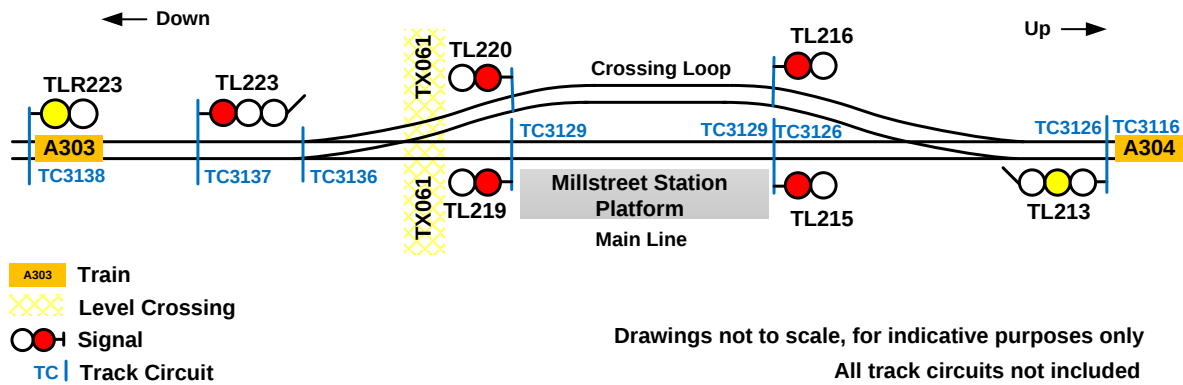
**Figure 34 – Train A303 travelling past Signal TLR223 displaying a cautionary aspect**

249 At 13:11:30 hrs Train A303, travels past Signal TLR223 displaying a single yellow aspect (cautionary), see Figure 34. An initial brake application is made by Driver A303 with the train reducing to 62 mph (99 km/h).

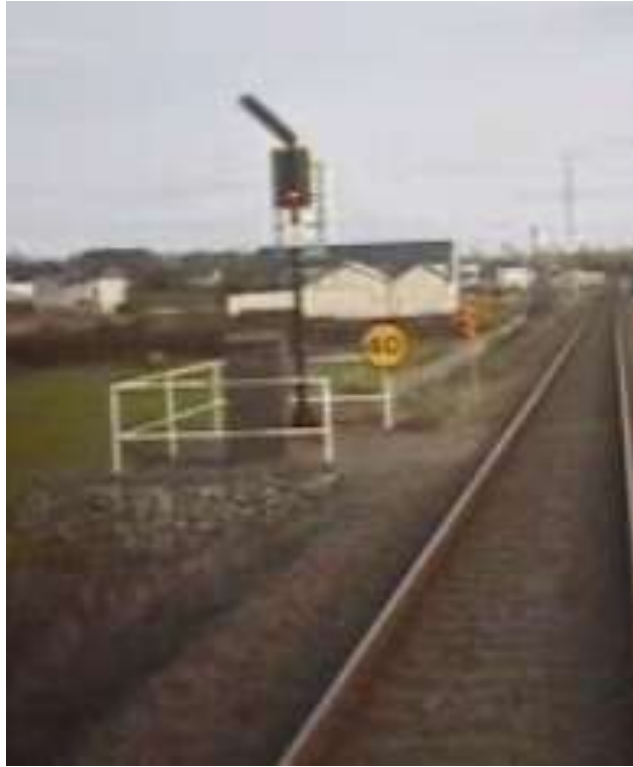
Figure 36 – Signal TL223 & speed board

253 Driver A303 applied the brake 12 m before Signal TL223, to adhere to the speed board located behind Signal TL223, see Figure 36.

278 Both Signal TLR223 and Signal TL223 met the sighting requirements set out in I-SIG-2043 (paragraphs 190 - 192). However, it is noted, although I-SIG-2043 addresses PSR boards ahead of signals, it does not appear to address TSR boards or distractions positioned directly behind signals. As a result, it appears that the positioning of a speed board placed behind Signal TL223 is not regarded as a risk, in terms of I-SIG-2043, this will be further discussed in Part 12 of this report.

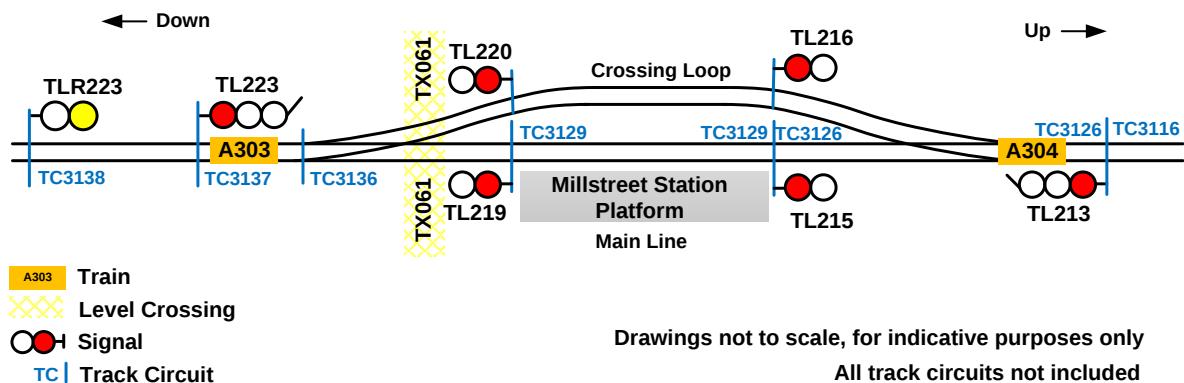
Figure 37 – Train A303 passing Signal TL223 displaying a red (danger) aspect

254 At 13:14 hrs Train A303 passes Signal TL223 at danger (red aspect); entering TC3137, see Figure 37. Train A303 is travelling at 39 mph (62 km/h) as it passes Signal TL223. Driver A303 reduces the speed to 26 mph (42 km/h) at the platform ramp.

313 The immediate cause of the SPAD was that Driver A303 did not see that Signal TL223 was displaying a stop aspect and continued driving towards Millstreet Station as if Signal TL223 was displaying a proceed aspect.

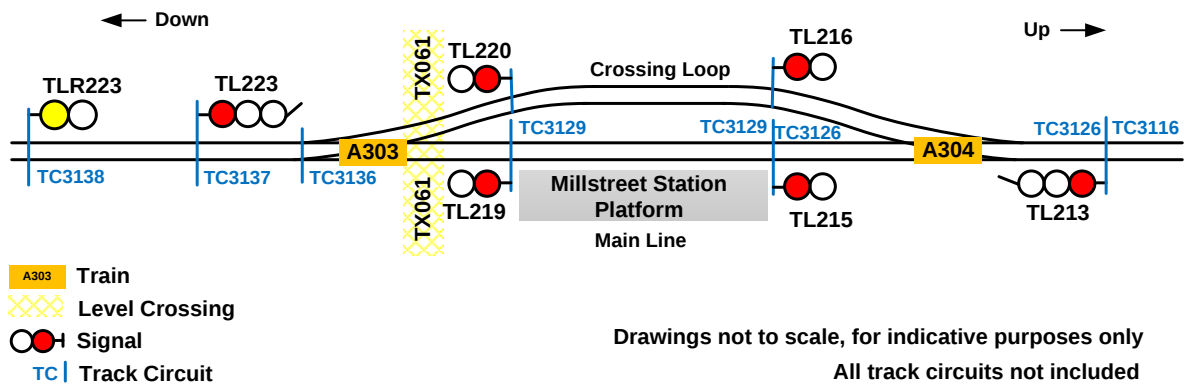
Figure 38 – Train A303 entering TC3136 section

255 At 13:13:00 hrs, the SPAD alarm activated at CTC for Millstreet Station, and is acknowledged by the CTC Signaller at 13:13:05 hrs. At 13:13:12 hrs the CTC Signaller makes a general call for both trains to stop. However when he initiated the call, he used the instructions “General call to Up Tralee – stop your train immediately!” and “Down train also stop immediately!”. As the call is being made Train A303 enters TC3136, see Figure 38.

307 The communications of the CTC Signaller were calm and direct (paragraph 255), where he made a general call to both drivers to immediately stop the trains; and the drivers immediately applied the brakes. However, it was noted, that some of the communications were not in line with safety critical communication requirements, e.g. he identified the trains as up and down trains instead of using the required ID numbers (paragraph 255).

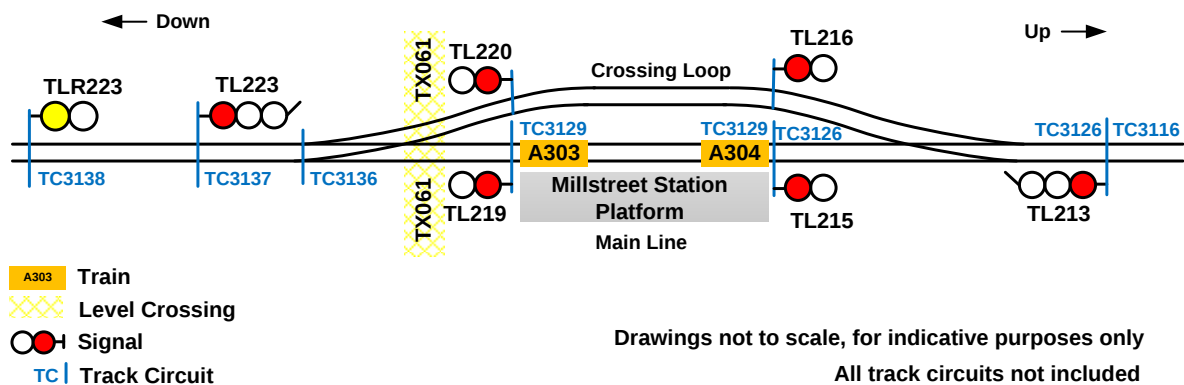
Figure 39 – Train A303 and Train A304 occupying TC3129 on Millstreet Station Platform

257 Driver A303 and Driver A304 apply the emergency brakes and the trains begin to come to a stop while occupying TC3129. Train A304 comes to a stop three seconds before Train A303. Train A303 and Train A304 are positioned 175 m apart after both coming to a stop on Millstreet Station Platform, see Figure 39.

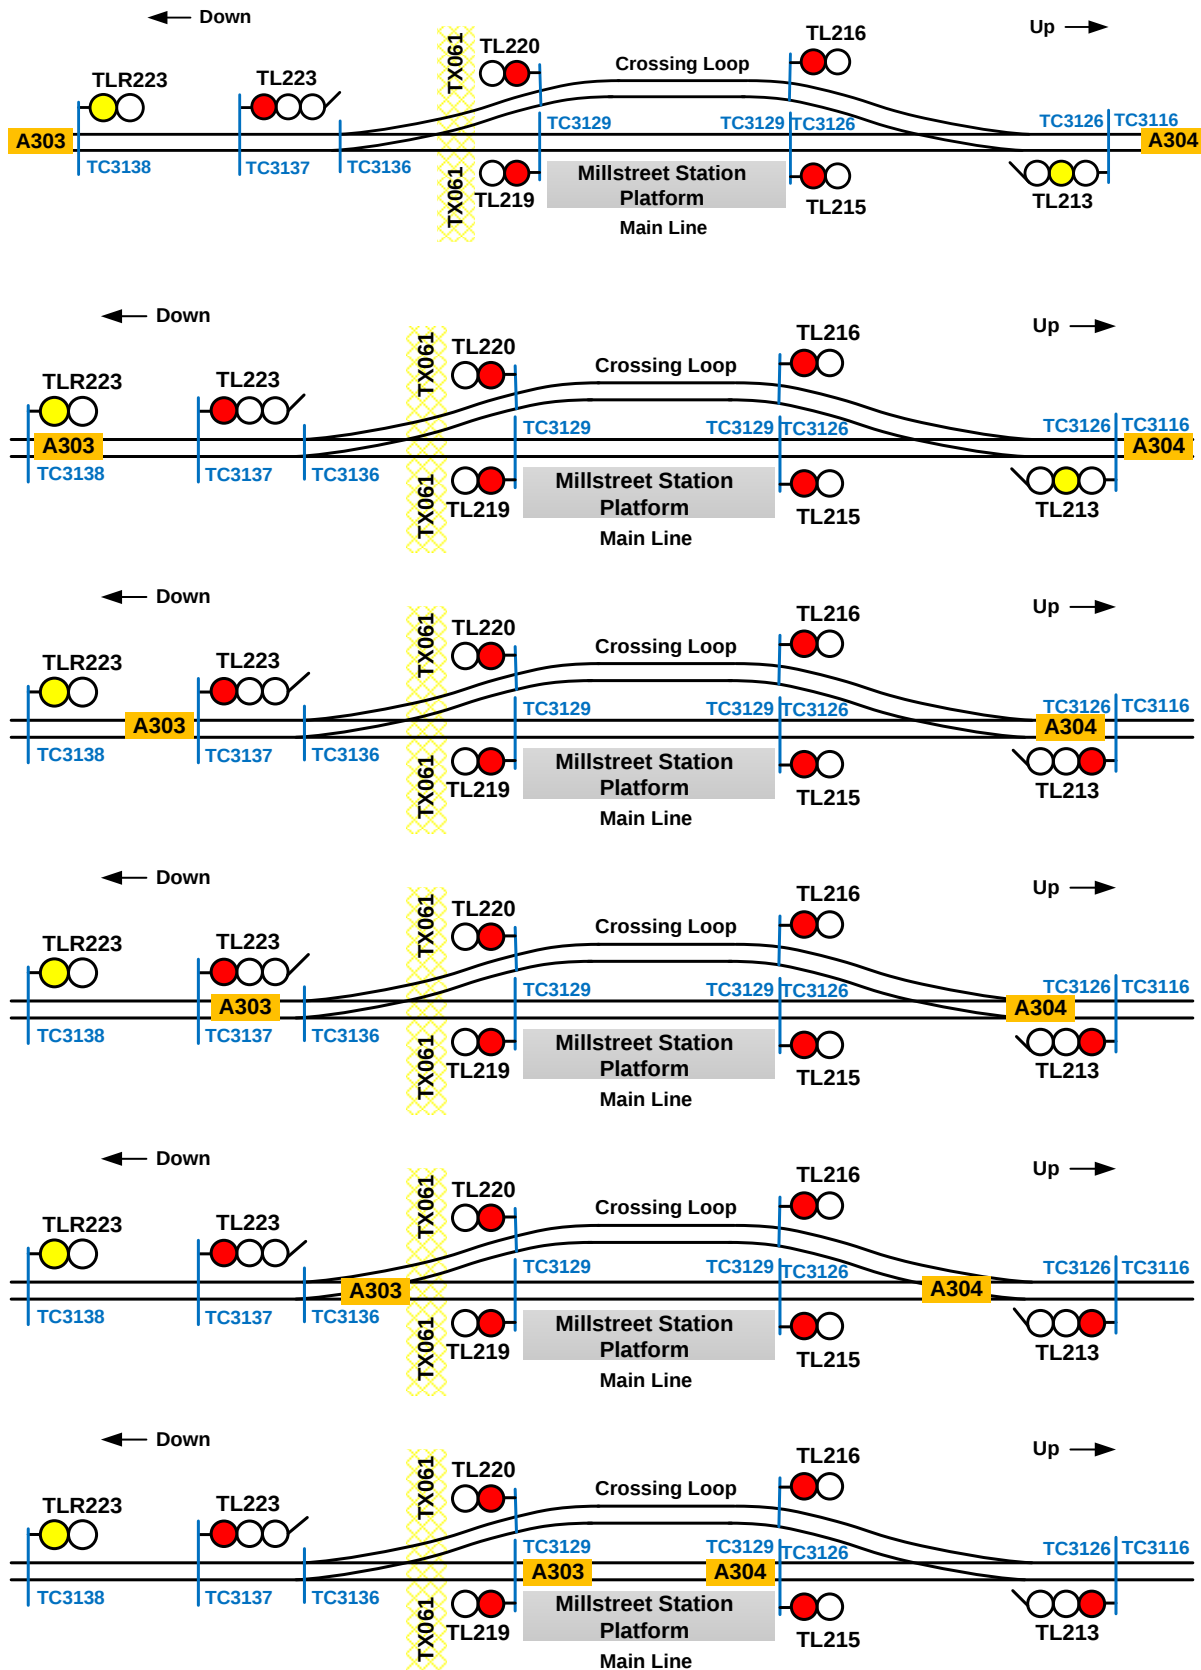
Figure 40 – Sequence of events during the incident

258 Driver A303 thinks that Driver A304 passed a signal at danger. He then thinks that he may have seen a yellow signal at TLR223 and realises he must have passed Signal TL223 at danger.

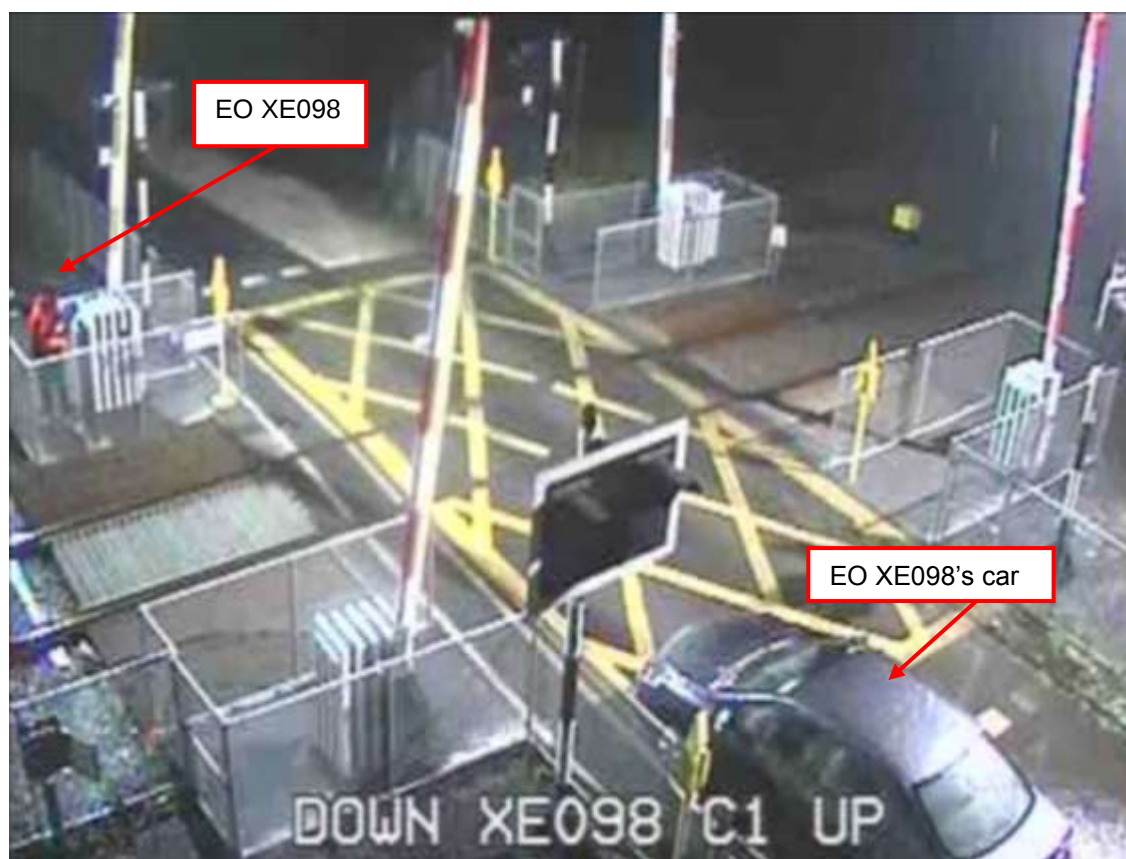
**Figure 41 – EO XE098 at Level Crossing XE098**

323 The EO at Level Crossing XE098 (EO098) was in the process of taking manual control of Level Crossing XE098, see Figure 41.

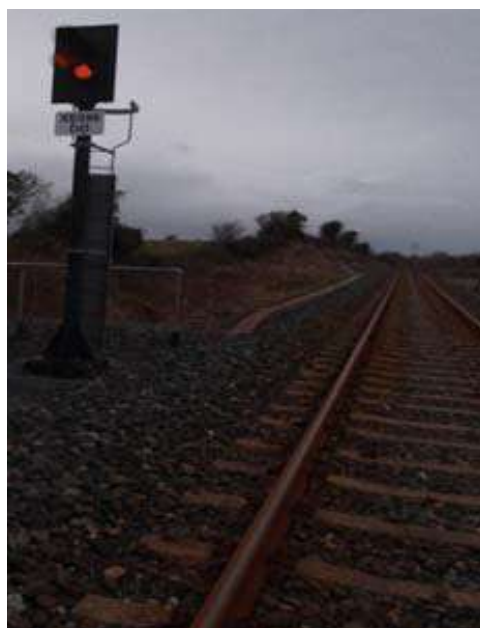
Figure 46 – Signal XE098DD

324 Driver A780 assumed that a similar situation would occur at next level crossing at Gortavogher (Level Crossing XE098). However, Signals XE098DD and XE098DS were not displaying any aspect and Train A780 passed Signal XE098DD without seeing the signal and only became aware of the situation when he saw the reflection of the Signal XE098DS and saw the lights of the Level Crossing XE098, However, it was too late to stop the train.

351 The signal in rear of Signal XE098DS is Signal XE098DD. It is a two aspect signal mounted on a standard height pole and situated on the left hand side of the line at 35 miles 461yds. It is capable of displaying single yellow and green aspects, see Figure 46. It is located 1,188 m before Signal XE098DS.

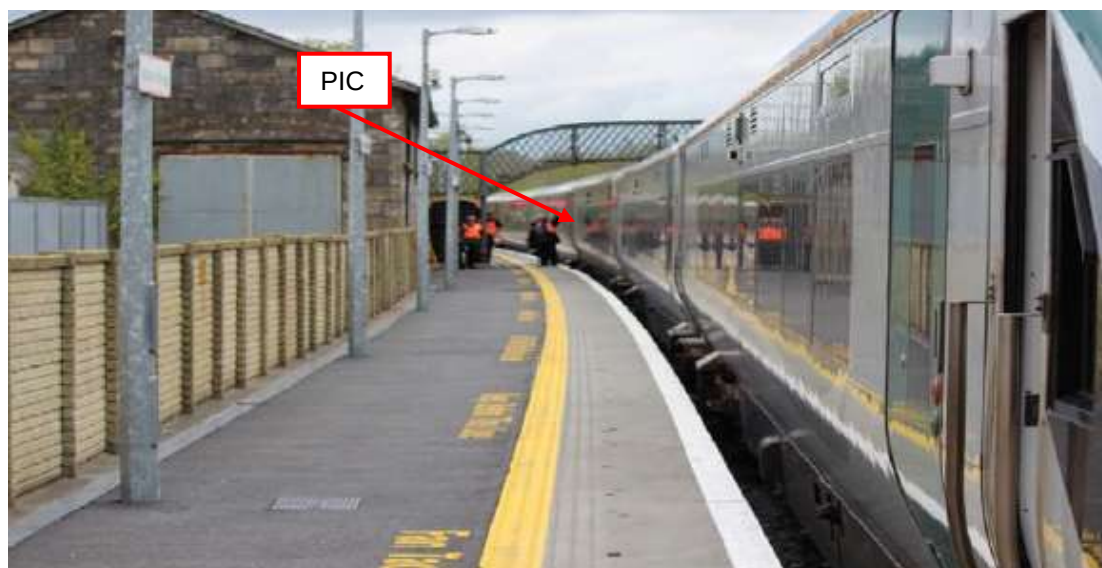
**Figure 61 – Curved platform & driver's view of PIC**

454 The driver should also be able to acknowledge the 'Station Work Complete' and 'Ready to Start' signals given by the PIC, see Figure 61, for a view of the PIC taken adjacent to the driving cab. The 'Station Work Complete' and 'Ready to Start' indications will be discussed in paragraphs 457 - 463.

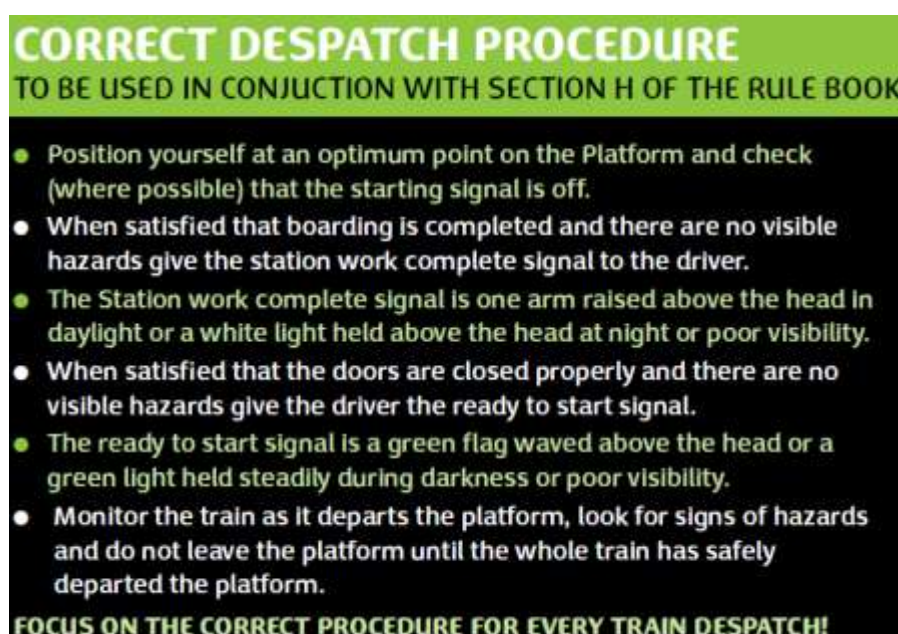
Figure 63 – Platform Train Interface & Despatch Procedure Prompt Card

312 It is noted that the PIC Millstreet made efforts to stop Train A303 when he saw that the two trains were arriving on the same platform. However, he did not adequately monitor Train A304 after the SPAD as he left the platform while the whole train had not departed the station (paragraph 263), this is not in line with the Prompt Card (Figure 31).

459 PICs are also provided with a Prompt Card (as discussed briefly in paragraph 225) which should be used in conjunction with Section H of IÉ’s Rule Book. This Prompt Card sets out the correct procedure for despatching trains, see Figure 63. The correct despatch procedure includes that the PIC should “check (where possible) that the starting signal is off<sup>9</sup>”.

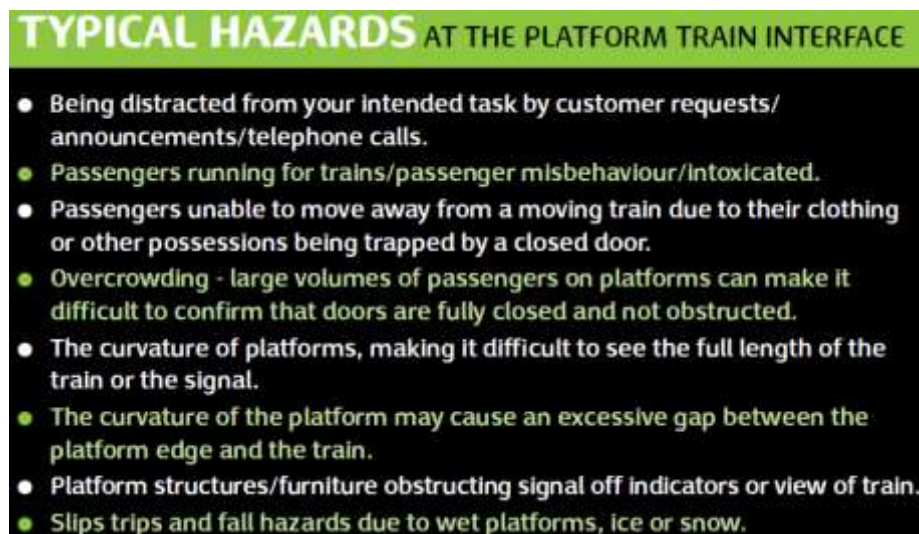
Figure 64 – Typical Hazards

460 The Prompt Card also identifies a number of 'Typical Hazards' at the platform train interface and 'Tips to Reduce Risks' when despatching trains, see Figure 64 and Figure 65, respectively.

461 One of the hazards includes the difficulty of seeing the signal, although this is specific to curved platforms. And one of the tips includes 'ensure you have a clear view of... the starting signal'.

462 The 'danger aspect' (red signal) has not been specifically identified as a hazard or the risk associated with giving the 'Ready to Start' signal against a danger aspect has also not been identified.

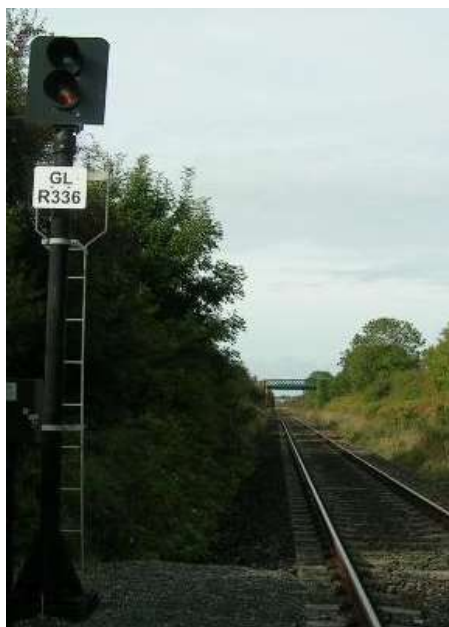
**Figure 67 – Signal GLR336**

530 The driver (Driver A708) booked on duty at 16:00 hrs and read his notices for the day. He then worked the 17:07 hrs passenger service from Athlone to Galway (Train A708). Driver A708 approached Signal GLR336 (see Figure 67) on a yellow aspect which indicated that the next signal, Signal GL336 (see Figure 68), would be at danger. The driver applied the train brakes to reduce speed with the intention of stopping at Signal GL336, however, due to the strong sunlight he did not see Signal GL336 until he was too close to stop at the signal, and past Signal GL336 at danger by approximately 66 yards (60 m).

532 IÉ assigned an SRR of 16 to the SPAD. IÉ's internal investigation 'Report of the Investigation into the Signal GL336 passed at danger, 26<sup>th</sup> October 2012' published on the 23<sup>rd</sup> December 2012 found that the sunlight (from the setting sun, which was low in the sky) was very strong and the windscreen was smudged and that these together affected Driver A708's view of Signal GL336. IÉ internal investigation report (Synergi Ref – 18209) published on the 23<sup>rd</sup> December 2012 identified the immediate cause as Driver A708 failing to control his train in accordance with the restrictive aspect (yellow signal) in Signal GLR336 and passed GL336 at danger. Underlying causes were identified as: the very strong sunlight at the time (with the sun shade on the 2800 DMU driving cars not being able to be lowered enough to block out strong sunlight) and the windscreen of the cab being smudged, which both this affected his view of Signal GL336; and Driver A708 failing to react to the yellow aspect in Signal GLR336 and applying the train brakes accordingly.

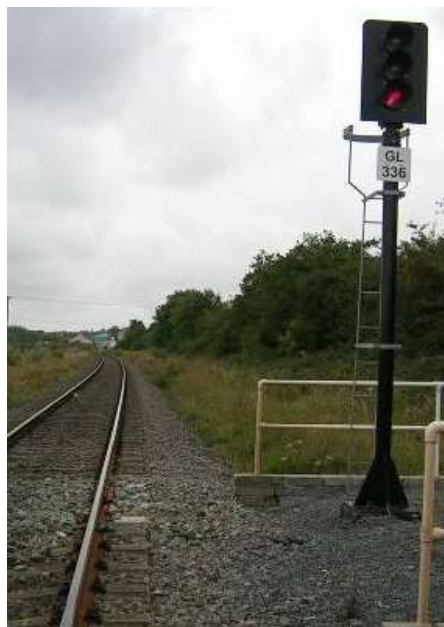
**Figure 68 – Signal GL336**

534 In addition to the IÉ findings, the RAIU review of the incident found that Driver A708 may have become distracted by a passenger taken ill earlier in the service, which is an unusual occurrence for a driver; and that Driver A708 had lost situational awareness in terms of the location of the signal due to the distraction of the strong sunlight.

533 As a result of the incident, Driver A708 was reclassified as a Category A driver and placed on a DD&SS with special emphasis on human factors and defensive driving (there were instances of over-speeding identified on the day of the SPAD during the investigation). Two recommendations resulted from this investigation, which included for the introduction of a more robust system to be put in place to deal with driving in strong sunlight (by adding to defensive driving presentation

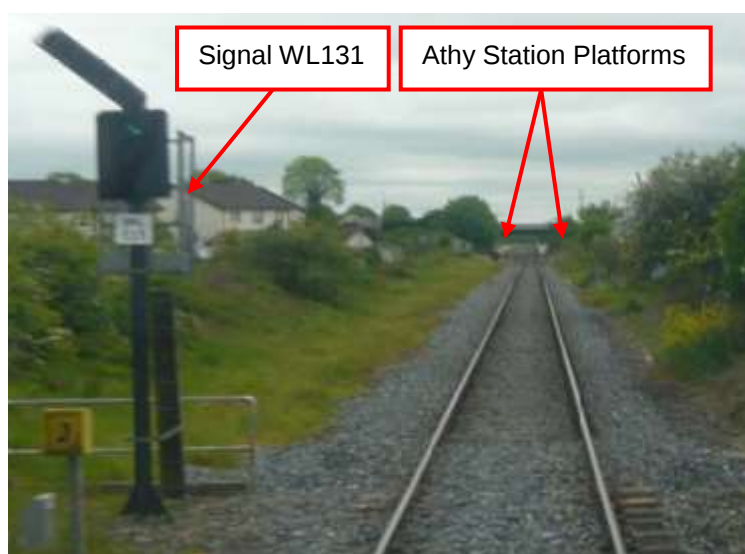
**Figure 69 – Signal WL131 with Athy Station in the distance**

540 Driver A500 then noticed that there was no train travelling in the opposite direction at Athy Station (see Figure 69); as he was expecting to see the 07:10 hrs passenger service from Waterford to Heuston, which was scheduled to cross his train in Athy. This prompted Driver A500 to check the scheduled running time for his train and he picked up his Working Time Table (WTT) which was open on the driving console. However, to read the WTT he needed to put on his reading glasses.

543 IÉ assigned an SRR of 18 to this SPAD. The internal IÉ investigation report determined that the immediate cause was that “the driver of A500 passed Signal WL131 at danger as he did not have his train under sufficient control approaching a red (stop) aspect” and that the underlying causes were that “The driver was consulting his WTT approaching Signal WL131 instead of giving his full attention to bringing his train under control” and that the “driver failed to prioritise his actions, instead of concentrating on Signal WL131 he was looking beyond the signal and querying why the train was not on the platform”.

545 The RAIU review of the incident found that Driver A500 had initially become distracted by the Patrolman, as it was the Patrolman who first mentioned the crossing point. He became further distracted when he could not see the other train and consulted with the WTT. Driver A500 had also lost situational awareness due to operating services where CAWS was in operation in the weeks previous to the day of the SPAD and this was the first day Driver A500 was driving in a non-CAWS area after a number of weeks of driving in a CAWS area, which contributed in him not responding to the cautionary aspect as required.

544 As a result of the incident Driver A500 was reclassified as a Category B Driver and placed on a DD&SS for a period of two years. In addition, the internal report recommended that the IÉ-RU Safety Manager was to publish a weekly circular notice reminding all staff whose duties require them to travel in the footplate should comply with driving cab protocol; and that IÉ-RU review the Professional Driving Handbook to ensure train operations in non-CAWS areas is adequately covered.

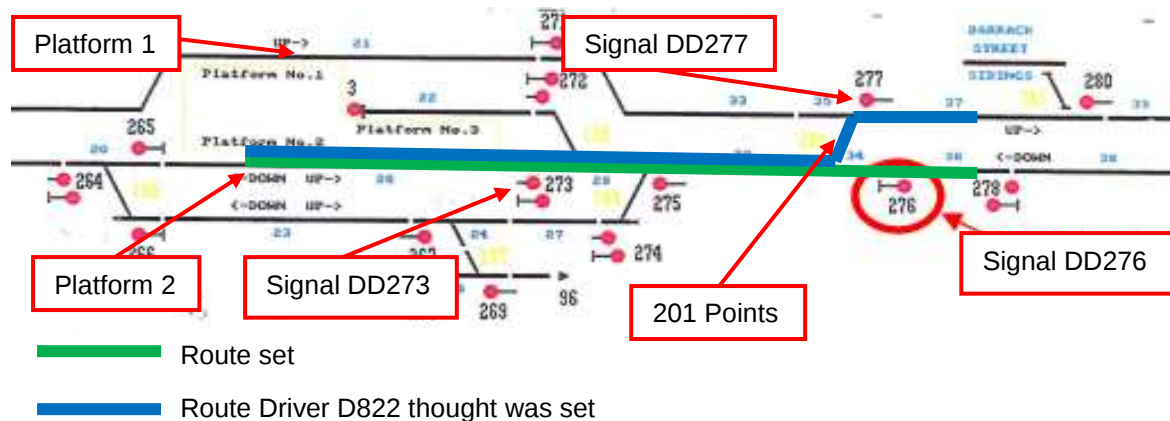
**Figure 70 – Set and assumed manoeuvres**

548 Driver D822 returned to his train on Platform 2. He thought that he was required to shunt over 201 Points and behind Signal DD277 to stable the train on Platform 1 (see blue line Figure 70), he had forgotten about the possession on Platform 1.

549 As a result, when Signal DD273 cleared, Driver D822 began the manoeuvre. As he approached Signal DD276, it was displaying two white lights in the vertical position, which means that the route is set to proceed to Signal DD276, (green line Figure 70). Driver A822 was not aware of this and still thought that he was about to traverse 201 Points and travel towards Signal DD277.

550 When Driver D822 past Points 201 without traversing them, he realised he was travelling towards Signal DD276, which was displaying a red aspect, the train was travelling at 35 mph (56.55 km/h). Driver D822 applied the full service and emergency brakes, but continued past Signal DD276 at danger by 75 m (it is noted in the report that Driver D822 stated that he only past Signal DD276 by a few inches).

554 The RAIU investigation found that Driver D822 had lost situational awareness as he had forgotten about the possession and he had not gained a clear understanding of the manoeuvre he was required to undertake, which resulted in him reverting to carrying out his normal manoeuvre, thus having an incorrect expectation of the signals.

553 As a result of this incident, Driver D822 was removed from driving duties. In addition, a review commenced related to the DD&SS (specifically the categorisation of drivers). The report made two other safety recommendations related to out-of-hours monitoring and DD&SSs.

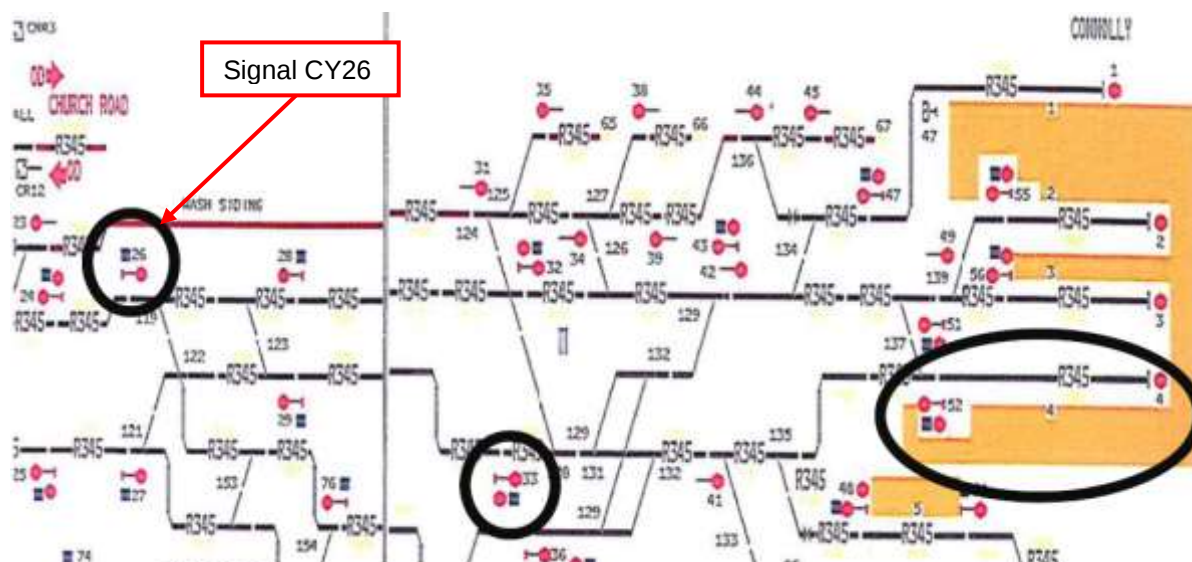
**Figure 71 – Layout at Connolly Station**

555 On the 3<sup>rd</sup> April 2014, Driver P709, signed on for duty fit and well rested at 17:30 hrs and operated services without incident. As Driver P709 approached Connolly Station, while operating the 22:05 hrs service from Drogheda to Connolly, he approached Signal CY18 which was displaying a red aspect, this cleared to yellow and Driver P709 proceeded towards Signal CY26. Signal CY26 and Signal CY33 were displaying red aspects, see Figure 71. Driver P709 acknowledged the CAWS downgrades for Signals CY18 and CY26.

556 Signals CY26 and CY33 can be viewed in tandem by drivers approaching the platforms at Connolly Station, see Figure 71. When Train P709 was 509 m from Signal CY26, Driver P709 commenced braking and continued to do so until he came to a stop 3 m past Signal CY26. Three seconds prior to the SPAD Signal CY33 had cleared to yellow, with the route indicator displaying that the route was set for Platform 4.

559 IÉ assigned an SRR of 14 to this SPAD. IÉ's internal Operational Occurrence Report (OOR) (Report No. R0903-2014-34) published on the 22<sup>nd</sup> August 2014 identified the immediate cause of the incident as Driver P709 failing to stop at Signal CY26 due to a lapse of concentration. The OOR identifies causal factors as Driver P709's personal issues and preoccupation with Signal CY33; it also notes incorrect prioritisation of signalling sequence by the signaller. The OOR identifies that the ability to view Signals CY26 and CY33 in tandem as an underlying factor.

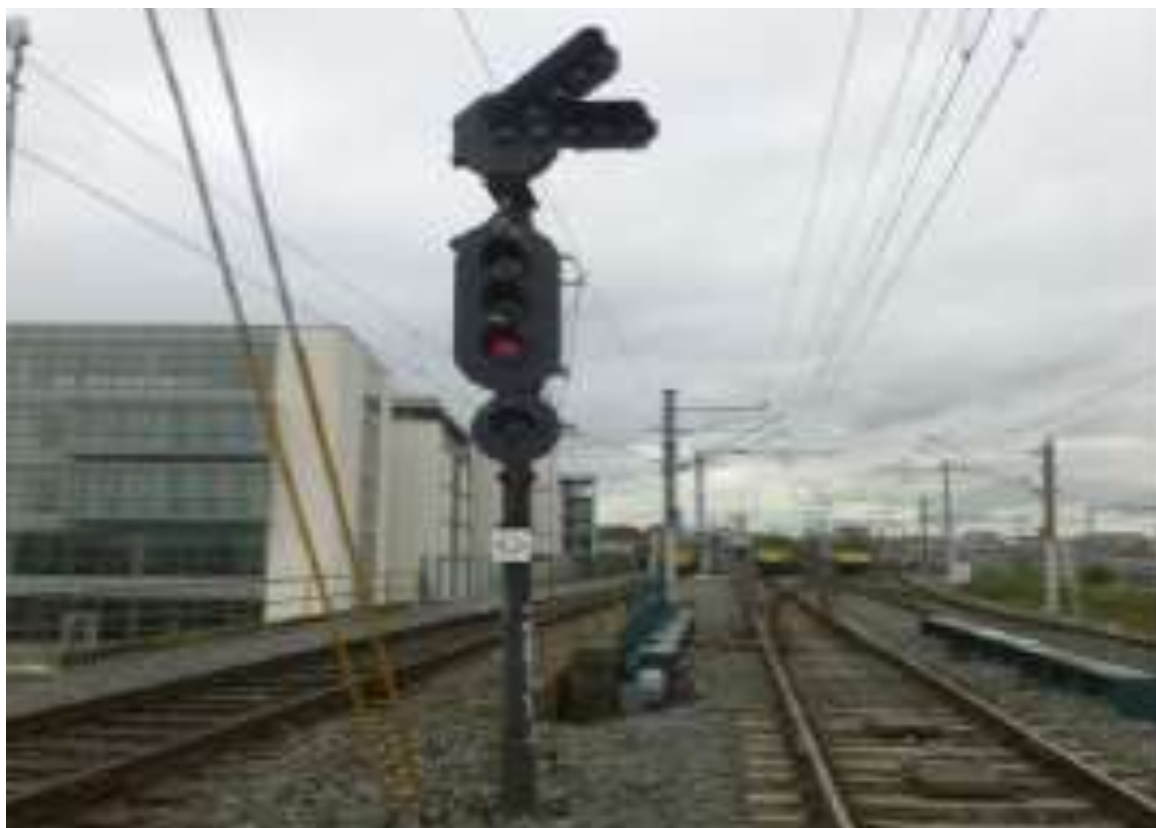
**Figure 72 – Signal CY26, with Signal CY33 in background**

562 The RAIU review of the incident found that the personal issues identified in the IÉ report did not contribute to the incident. Driver P709 had lost situational awareness and had an incorrect expectation as to the signal's aspect, as he was looking beyond the signal into Connolly Station.

560 As a result of the incident Driver P709 was reclassified as a Category B Driver and placed on a DD&SS for a period of two years. In addition, SET carried out some maintenance works on the signals in the area and signalmen were requested not to clear CY33 when CY26 is at danger, where possible.

561 The OOR made three recommendations, two which were related to staff reporting personal issues to line managers and staff attending the Chief Medical Officer (CMO). And one recommendation was related to changing, if appropriate, Signal CY32 and CY33 to approach release to prevent read through of signals.

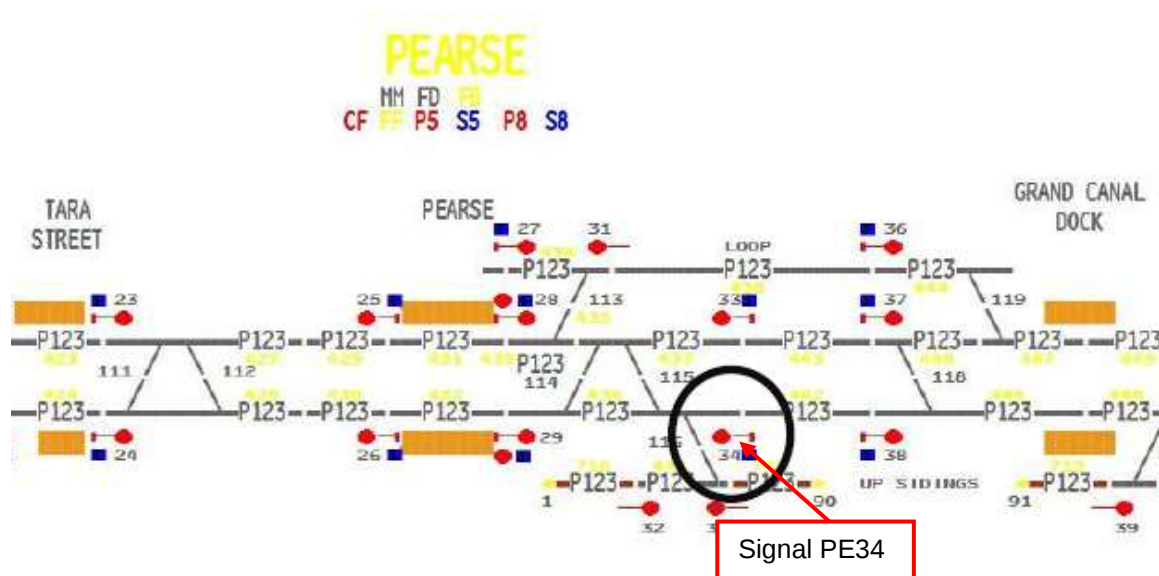
**Figure 73 – Signalling at Pearse Station**

570 On the approach to Pearse Station at 12:18:14 hrs, Driver A601 acknowledged the downgrade to red in the CAWS, while the train was travelling at 19 mph (30.4 km/h) and 193 metres in rear of Signal PE34, see Figure 73.

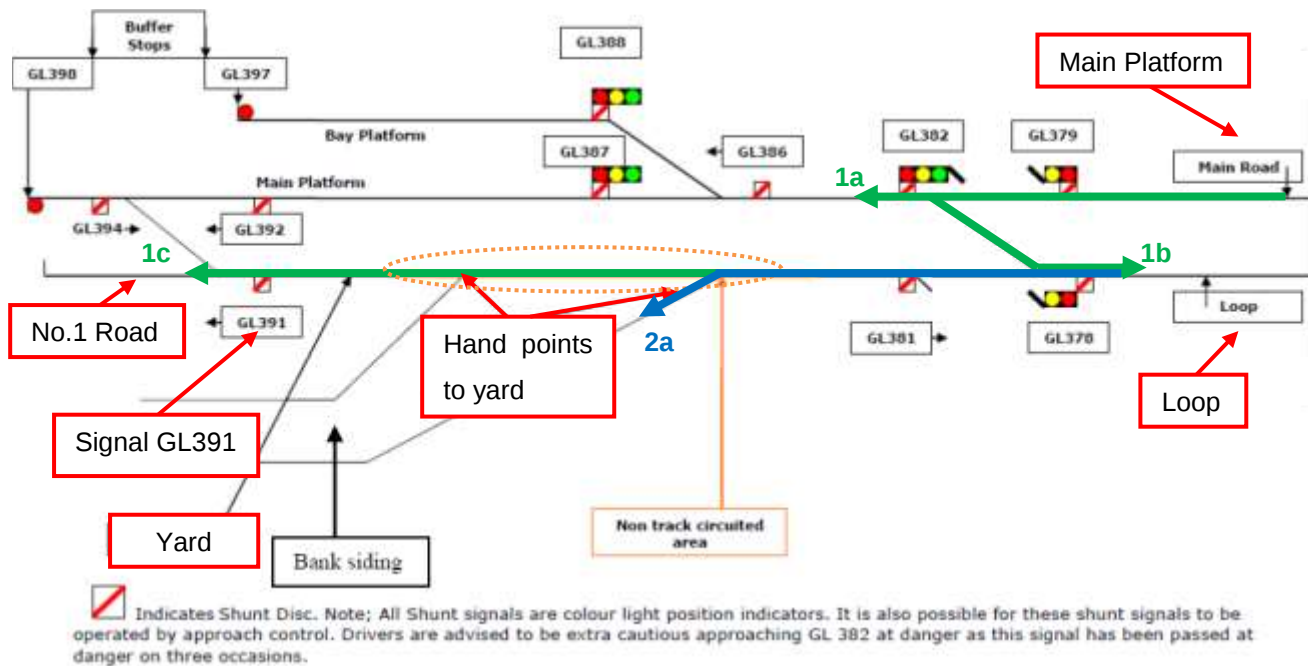
**Figure 74 – Ceannt Station (Galway) Layout**

578 The Galway Station Controller told the Galway Line Signaller (GLS) to set the route to allow Train A714 to from the main platform into the Loop and then down behind signal GL391 which is located on the No.1 Road (see green movements 1a, 1b & 1c, Figure 74). (Note: A train consist of less than seven pieces are stabled in the Yard, Train A714 consisted of seven carriages). As there was an area of non-circuited track (see Figure 74), the Galway Station Controller had set the hand points, located between signals GL378s and GL391, to the normal position, i.e. to the No.1 Road. The Galway Station Controller talked to Driver A714 on the Main Platform, mainly in relation to a change of driving shift; it cannot be established if a clear instruction was given for the movement of Train A714 onto No.1 Road.

579 The GLS was not familiar with the name 'No.1 Road', as he was more familiar with requests to place the train 'behind signal GL391'. As a result, the GLS thought the route was to be set into the Yard; and set the route from the Main Platform to signal GL378 on the Loop line at Galway (1a & 1b, Figure 74), and then cleared the route from signal GL378 to the Yard in Galway (blue route, 2a, Figure 74). As a result, the GLS did not clear the route into No.1 Road, and as a result, Signal GL391 remained at danger.

581 Driver A714 then proceeded to move the train, he had assumed that he was moving Train A714 into the Yard, he carried out the first movements as expected (1a & 1b, Figure 74). When Driver A714 approached the first set of handpoints, he was expecting the train to 'jolt' as it travelled over the handpoints into the Yard, he never felt the jolt and then remember it was a seven piece train and realised he was travelling to the No.1 Road. He then travelled over the second set of handpoints and passed Signal GL391 which remained at danger, and another 113 m towards the *stopblock* to stable the train. Driver A714 was unaware he had passed Signal GL391 at danger and returned to the Main Platform.

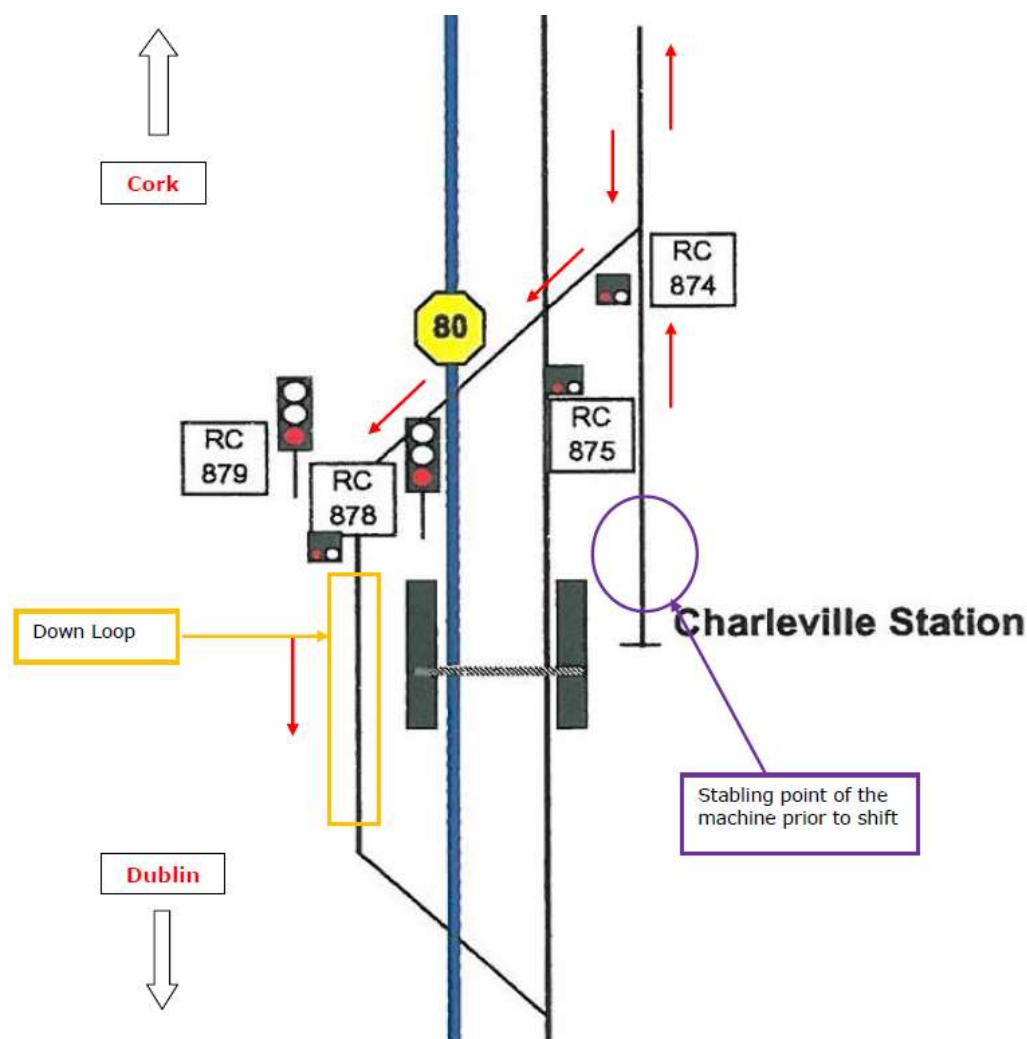
**Figure 75 – Charleville Station layout and proposed movement outlined in red arrows (from IÉ investigation report)**

605 The driver (Driver Y224), a Lloyd Rail staff member, received instructions from the Person in Charge of Possession (PICOP) in relation to moving the tamping machine from its stabling point onto the Down Loop prior to the possession being granted, see Figure 75.

---
