# RAILWAY ACCIDENT INVESTIGATION UNIT IRELAND

## INVESTIGATION REPORT

**Investigation into SPADs on IÉ Network,  
from January 2012 to June 2015**

**RAIU Report No: R2016 – R001**

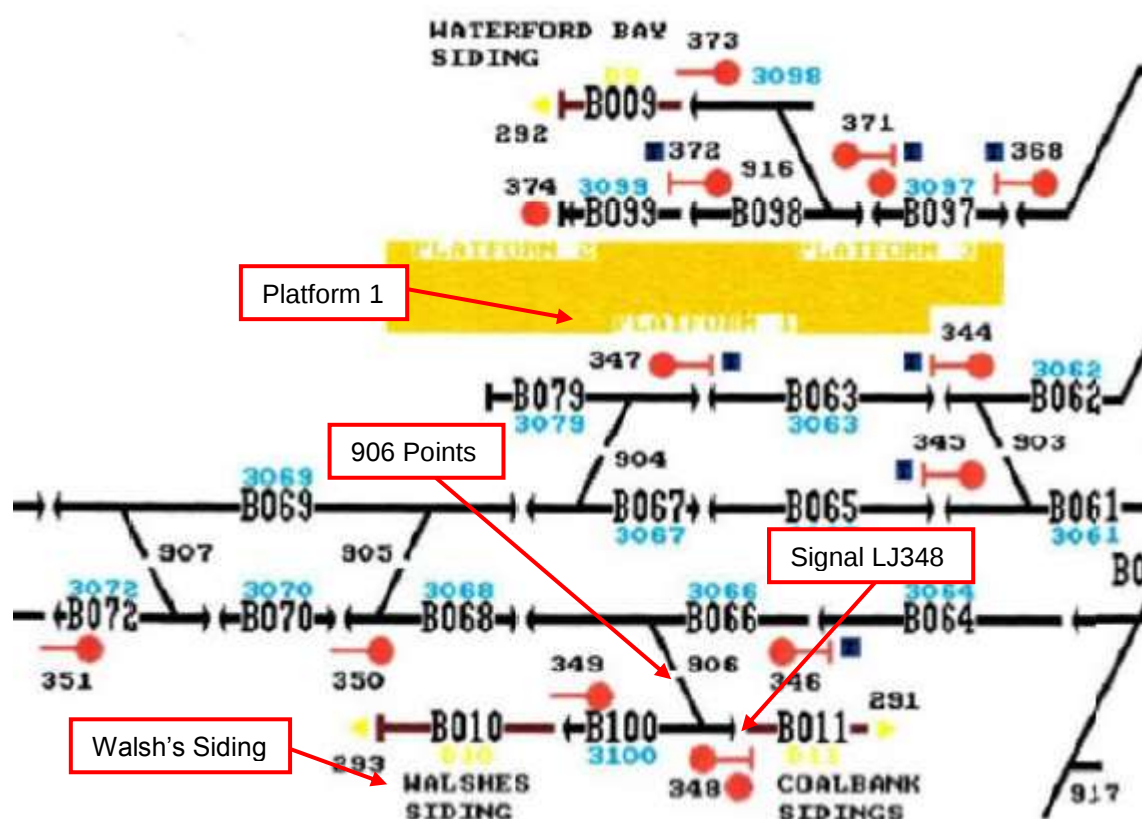
612 At approximately 05:50 hrs the Spoil Train Driver arrived at Platform 1 at Limerick Junction and carried out a number of train movements to move the Spoil Train towards Walsh's Siding (see Figure 76).

614 The Guard instructed the Spoil Train Driver using the Guard Driver Communication (GDC) (handset-radio) to propel into Walsh's Siding (where shunt radios are not available, guards and drivers are required to communicate through handsignals i.e. not the use of GDC). The Spoil Train Driver had propelled the Spoil Train into Walsh's Siding when the CTC Mainline Signaller rang advising him he had passed Signal LJ348 at danger. The Spoil Train Driver stopped the train.

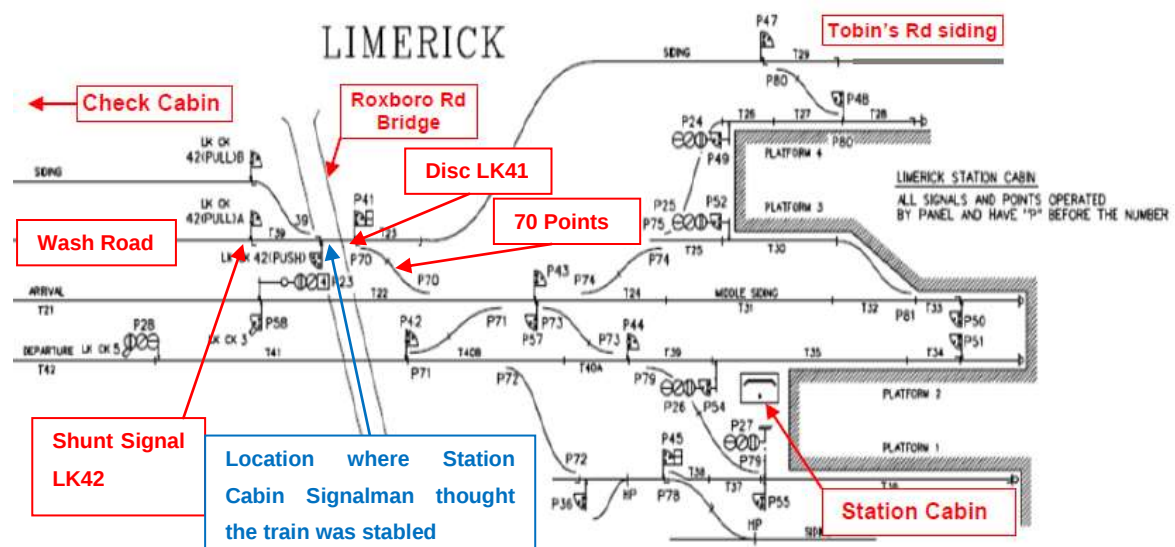
**Figure 77 – Limerick Station layout**

625 On the night of 23<sup>rd</sup> September 2014, a T3 possession was granted by the Station Cabin (see Figure 77 for location) to facilitate renewal works at Limerick Station; there were no issues reported prior to the possession being cancelled at 05:29 hrs. The possession works affected the stabling of the trains and the Signaller was informed of the movements to be undertaken. Due to a fault being detected by the SET department, the Station Cabin Signaller granted another T3 possession at 05:30 hrs to facilitate SET to carry out repairs to the panel at the Station Cabin.

626 At approximately 05:50 hrs, the driver (Pilot Driver) carrying out the shunting manoeuvre in preparation for the 06:25 hrs passenger service from Limerick to Limerick Junction, contacted the Station Cabin Signaller from the train's location on Tobin's Road Siding (see Figure 77) to request the route into the Station. The Station Cabin Signaller informed Pilot Driver that there was a fault in the Station Cabin and he would get back to him. Pilot Driver then saw the Limerick to Galway passenger service departing and re-contacted the Station Cabin Signaller to request the route. At this stage the Station Cabin Signaller said that he would request that the Check Cabin Signaller, located into the Check Cabin (see Figure 77) to request the route.

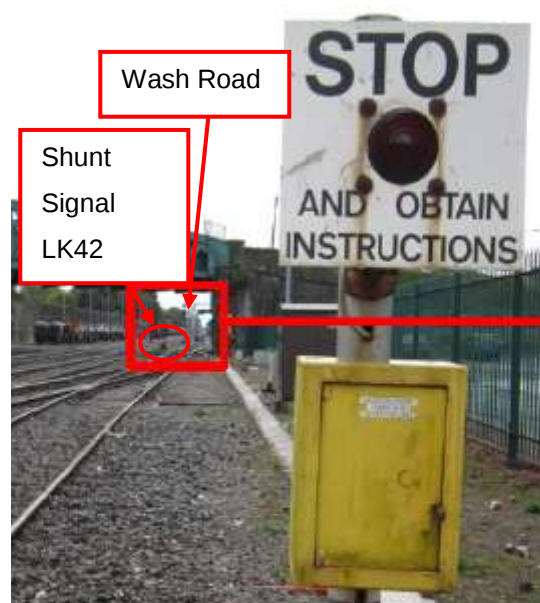
**Figure 78 – SAOIB & LK42 & Wash Road**

628 On seeing Shunt Signal LK42 set to proceed, the Pilot Driver re-contacted the Station Cabin Signalman. It is not clear what communications occurred between the Pilot Driver and the Station Cabin Signalman, but the Pilot Driver thought that he was authorised to travel into the Wash Road. However, 70 Points were not set and the Pilot Driver was not authorised to travel past the Stop & Obtain Instruction Board (SAOIB), which under the Rule Book has the same meaning as a stop signal and permission must be granted by an authorised person for drivers to pass these boards, see Figure 78. As a result, the Pilot Driver travelled past the SAOIB and 70 Points which were in the reverse position and proceeded into the Wash Road.

629 When SET completed repairs to the panel in the Station Signal Cabin, the Station Cabin Signalman commenced completing the route for the train when he noticed that the train was not on Tobin's Road, and saw that there was no detection on 70 Points; he then requested SET to examine. SET found that the points had been run through. When Pilot Driver changed driving cab ends, he noticed the gapping points and contacted the Station Cabin Signal.

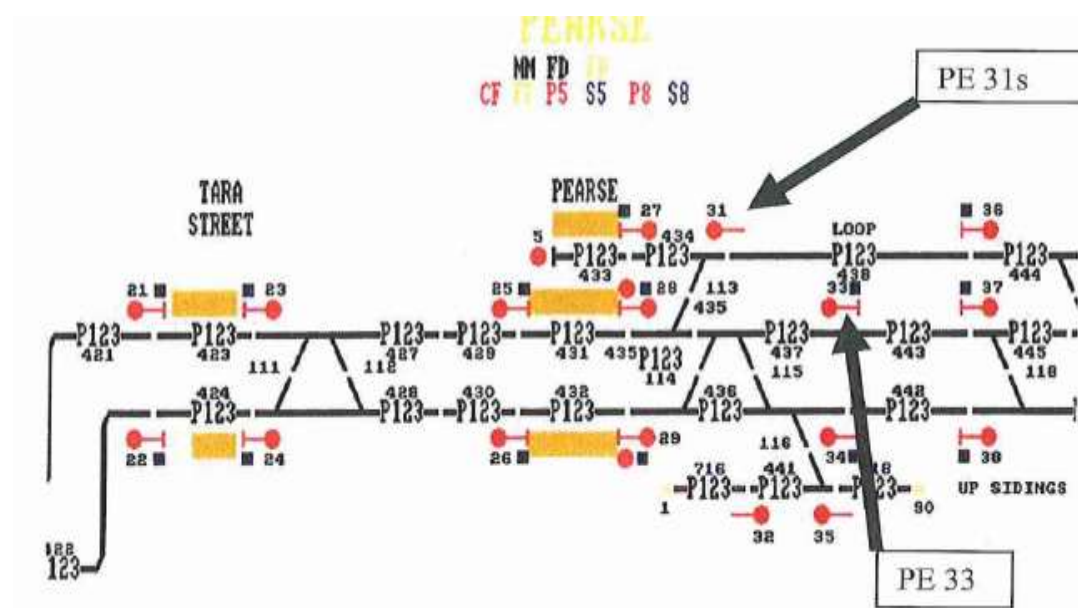
Figure 79 – Pearse Station layout (taken from IÉ report)

652 The driver (Driver P671) operated the 21:05 hrs passenger service from Maynooth to Pearse (Train P671) without incident. At Pearse, Driver P671 stabled the train in the down loop due to *reversible working* between Pearse and Tara (and vice versa). Driver P671 sees signal PE33 upgrade to yellow and assumes he is clear to return the platform; he does not see signal PE31s and passes it at danger, see Figure 79.

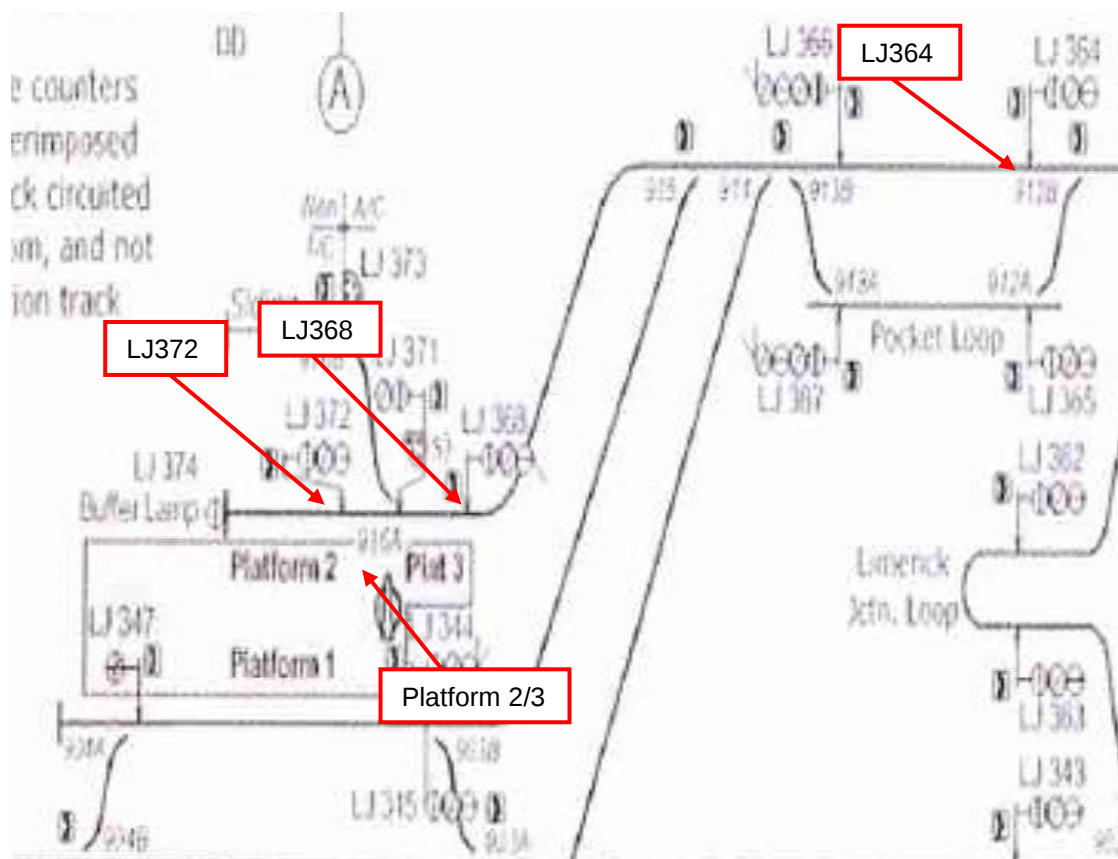
Figure 80 – Limerick Junction layout leaving Platform 2/3 (taken from IÉ report)

658 As the train was occupying Platforms 2/3 the CTC Signaller issued Driver A406 an authority number to pass Signal LJ372 at danger and proceed up to and obey LJ368 where the CTC Signaller would contact him again, see Figure 80 for location of signals. Although the CTC Signaller was aware that Signal LJ372 was behind Driver A406, as he was occupying both platforms, the CTC Signaller did not state that the authority number was being issued for Signal LJ372, behind him.

659 Driver A406 thought that Signal LJ372 was in fact the signal ahead of him, Signal LJ368 and passed the signal at danger. The CTC Signaller contacted Driver A406 and asked him if he had passed Signal LJ368 at danger, Driver A406 stated that he was approaching Signal LJ368. The CTC Signaller ended the call but called back requesting that Driver A406 stop the train. Driver A406 was now standing in rear of Signal LJ364, where he then realised he had passed Signal LJ368 at danger.

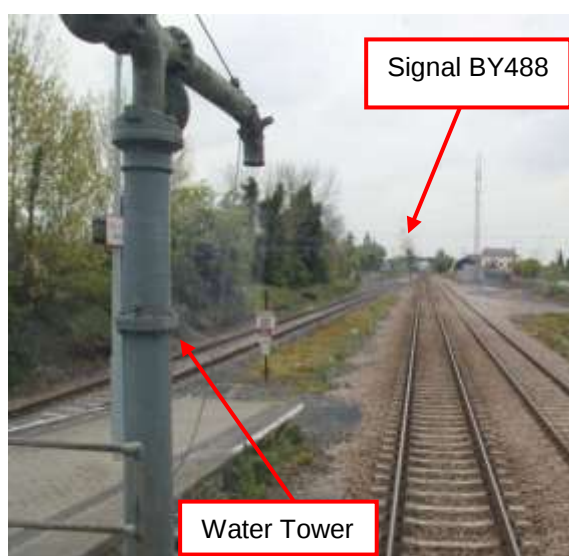
**Figure 81 – Drivers' view of Signal BY488**

663 On Tuesday 8<sup>th</sup> May Driver A312 was operating the 17:05 hrs passenger service from Heuston to Tralee (Train A312). After the passengers alighted and boarded Train A312, the PIC gave the 'Station Work Complete' signal and Driver A312 then closed the doors. Despite Signal BY488 displaying a red aspect (see Figure 81 for drivers' view of Signal BY488) the PIC gave the 'Ready to Start' signal without checking the signal as it was obscured by a water tower (see Figure 82 for PIC's obscured view of Signal BY488); however he was aware, due to experience, that it would be displaying a red aspect as a result of the previous train, travelling in the same direction, being delayed (as a result it had not cleared the section, resulting in Signal BY488 remaining at red). Signal BY488 is located 119 m from the platform end and the PIC assumed that Driver A312 would depart from the station and stop at Signal BY488.

664 Driver A312 did not look at Signal BY488 prior to departing, and while departing was looking at the PIC on the in-cab MMI screen in case the PIC wanted to stop the train. Driver A312 travelled past Signal BY488 at danger. On passing the signal, Driver A312 saw that the next signal, Signal CLXDD, was showing a yellow aspect while the CAWS indication in the cab was displaying red. Driver A312 then realised that he may have passed Signal BY488 at danger and started to bring his train to a stop, he stopped 815 m past Signal BY488. The signalman then contacted Driver A312 to inform him of the SPAD. As there were no other drivers available, Driver A312 was allowed to proceed with a second person, the Travelling Ticket Checker (TTC) to Thurles and then a DTE from Thurles to Limerick Junction, where he was relieved from his duties.

666 IÉ assigned an SRR of 19 to this SPAD. IÉ's internal investigation report (R006/2012) published on the 20<sup>th</sup> November 2012 found that the immediate cause of the accident was as a result of Driver A312 failing to observe signal BY488 at danger before starting or any time after starting his train from the down platform at Ballybrophy Station due to a lack of concentration; and he could not explain why he did not observe the signal and only noticed that the next signal was yellow after a distance of 235 m. Causal factors related to Driver A312 included: not obeying the Rule Book; not prioritising his tasks (looking at the MMI screen instead of the signal); not being aware of the risks on the route. Causal factors related to the PIC included the PIC giving the 'Ready to Start' while a red aspect was being displayed and the PIC's view of Signal BY488 by a water tower.

668 As a result of the incident, a development plan has been developed for Driver A312. IÉ made four recommendations related to route knowledge and assessment for drivers, including the review and updating of current documentation; and two recommendations in relation to the risks and assessment of PICs.

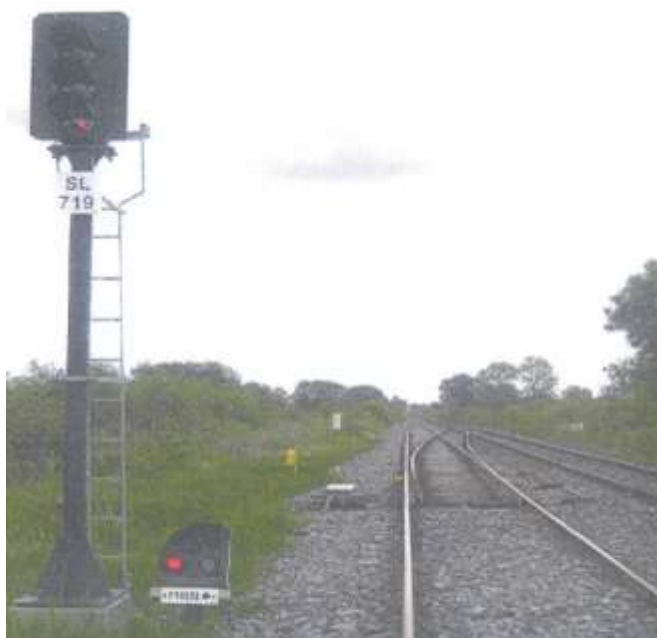
**Figure 83 – Signal SL719**

684 Driver A913 then entered his new train but did not look at Signal SL719 (which was located 77 m from the front of the train) before departing Killucan, see Figure 83 for the signal displaying a red aspect. Train A913 accelerated to a speed of 16 mph (25.6 km/h) before Driver A913 saw Signal SL719 at danger and applying the full service and emergency brakes. However, Train A913 passed Signal SL719 at danger, with the train stopping 10 m beyond the signal.

686 The SPAD was assigned an SRR of 12. IE's internal investigation report (Safety Office Ref 130621-1) published on the 8<sup>th</sup> October 2013 identified the immediate cause of the incident as Driver A913 failing to look at Signal SL719 before moving his train. Causal factors were identified as Driver A913 being distracted by the earlier incident of a passenger being taken ill. An underlying cause to the incident was Driver A913 having a lapse in concentration as a result of the earlier incident. As a result of this incident, Driver A913 was removed from driving duties.

687 The RAIU review of the incident found that Driver A913 had become distracted by the passenger taken ill on the train, in addition, he forgot to reset the passenger phone resulting in him becoming preoccupied in thinking about the phone. He also had an incorrect expectation of the signal, as he had looked at the green aspect for Train A913 and forgot (loss of situational awareness) that he was no longer on Train A913.

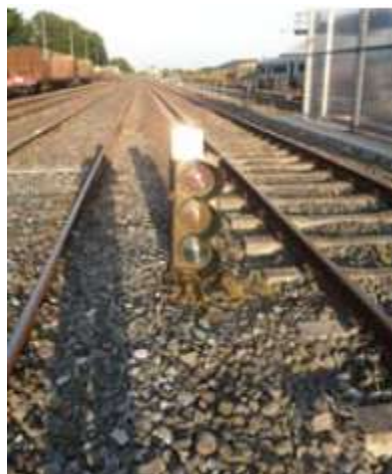
**Figure 84 – Signal LK5**

690 This SPAD was assigned an SRR of 14. Signal LK5 is now a multi-SPADed signal. IÉ's 5DIR (Report No. R0402-2014-19), published the 31<sup>st</sup> March 2013 determined that the immediate cause of the incident was Driver A478 misread Signal LK5 due to the visibility of the signal being affected by the sunlight, see Figure 84 for a photograph taken the day following the incident at approximately the same time. Underlying causes were identified as Driver A478's perception of Signal LK5 was affected by the sunlight and that as Signal LK5 is ground mounted on the right, these signals are harder to interpret during bright conditions.

692 The RAIU found that Driver A478 had become distracted by the bright sunlight, leading him to an incorrect expectation that Signal LK5 was displaying a yellow aspect.

691 Driver A478 was assigned a DD&SS. IÉ also undertook a number of other actions as a result of this incident, including a plan for the repositioning of LK5, as well as re-briefing to Signallers and drivers on issues involved in this incident. In relation to the sunlight, the District Manager Limerick issued a drivers notice in January 2014 highlighting the effect that sunlight can have on visibility of signals and the risks associated with starting on yellow when departing Limerick Station. As a result of these actions, and previous actions already taken in relation to signalling in the area, the

5DIR made one recommendation related to reviewing the risk assessment associated with trains departing Limerick Station on a yellow aspect.

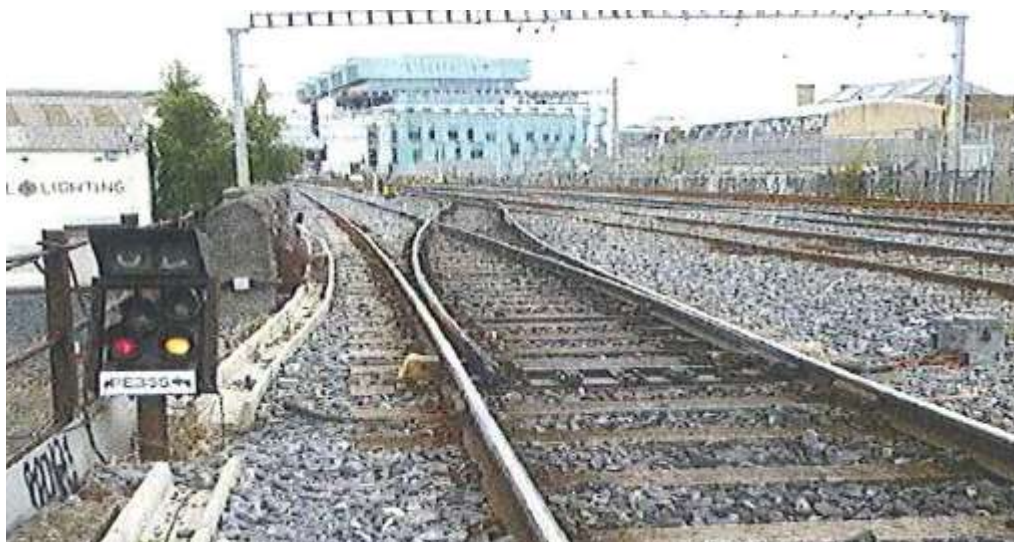
**Figure 86 – Position light signal, Signal PE35s**

714 Driver A905 checks that the points are set for his return onto the platform at Pearse Station and sees that they are. He then starts driving the train towards the platform without checking what aspect position light signal, Signal PE35s was displaying (which was displaying a danger aspect). Driver A905 then travels past Signal PE35s at danger (see PE35s in Figure 86).

715 At the time of the incident, Signal PE35s had been previously passed at danger on two occasions in the previous ten years.

717 This SPAD was assigned an SRR of 17. Signal PE35s is now a multi-SPADed signal. The IÉ internal investigation report (Safety Office Ref: 130810-IM01) published on the 8<sup>th</sup> October 2013 identified the immediate cause as Driver A905 failing to look at Signal PE35s before moving his train; the causal factor was that Driver A905 was distracted by another task (setting up the train radio); and the underlying cause was a lapse in concentration by Driver A905.

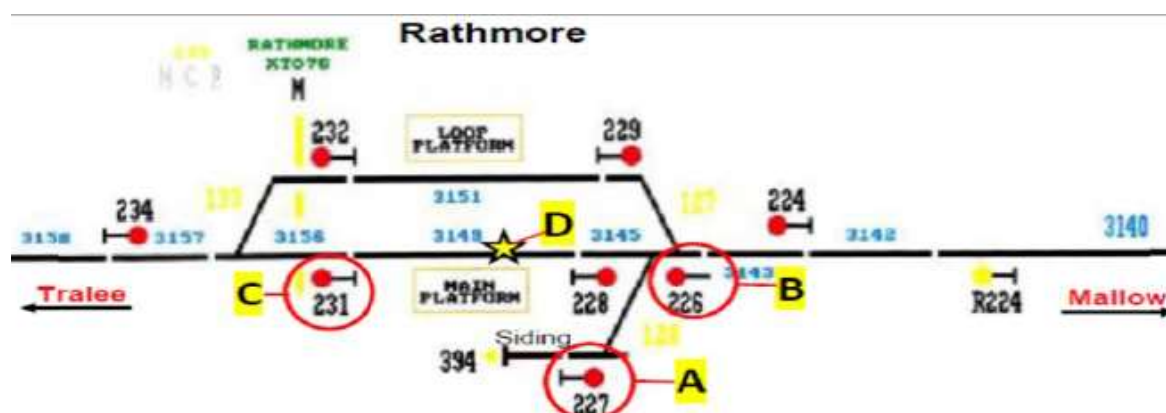
**Figure 87 – Layout at Rathmore**

720 On Friday 26<sup>th</sup> February 2014 the Inspection Car Driver (Driver Y370) was required to operate the Inspection Car (Train Y370) from Rathmore to Tralee, and then return to Limerick Junction. At Rathmore, as Train Y370 was stabled in the siding (see Figure 87), Driver Y370 contacted CTC to advise he was ready to shunt Train Y370 in readiness to travel to Tralee.

721 When CTC cleared Signal TL227 (See signal marked A in Figure 87) Driver Y370 drove Train Y370 onto the running line and stopped in rear of Signal TL226 (see signal marked B in Figure 87). He then switched the control of Train Y370 in order to travel towards Tralee. Driver Y370

then saw that the point were set towards Tralee and saw that Signal TL231 (see signal marked C in Figure 87) was displaying a green aspect. Train Y370 then proceeded towards Tralee, with Signal TL226 displaying a danger aspect, and passed Signal TL226 at danger without authority.

724 As a result of the SPAD, Driver Y370 was re-briefed and assessed. There were no recommendations as a result of this incident.

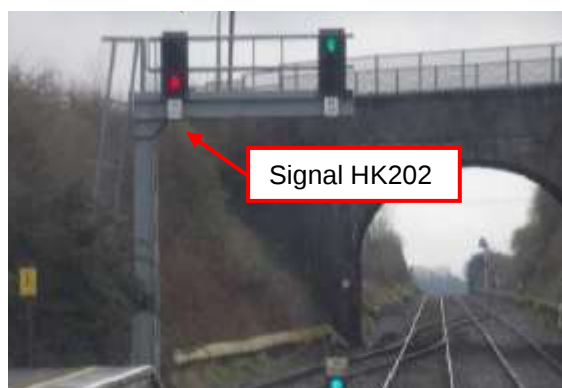
**Figure 88 – Signal HK202**

726 On Friday 14<sup>th</sup> March 2014 Driver A801 took up driving duties out the 05:15 hrs passenger service from Westport to Heuston at Athlone. As the train approached Kildare Station, Signal HK210R and Signal HK210 displayed double yellow and single yellow aspects, respectively. The starting signal, Signal HK202 (see Figure 88), was initially displaying a red aspect, which

727 There was no PIC present at the Kildare Station resulting in Driver A801 performing the train despatch procedures. Driver A801 departed Kildare Station at approximately 07:53 hrs, with the starting signal, Signal HK202 still displaying a yellow aspect. The weather was foggy at the time. Driver A801 increased speed to 60 mph (100 km/h) over a distance of 1.2 miles (1.96 km).

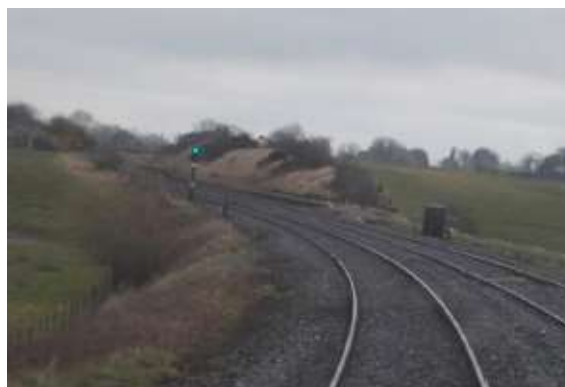
**Figure 89 – Signal HK196**

728 When Signal HK196 (see Figure 89) came into view, Driver A801 remembered that Signal HK202 was displaying a yellow aspect. He immediately applied the brakes to the full service position (07:55 hrs), but the train passed signal HK196 at danger by twenty metres.

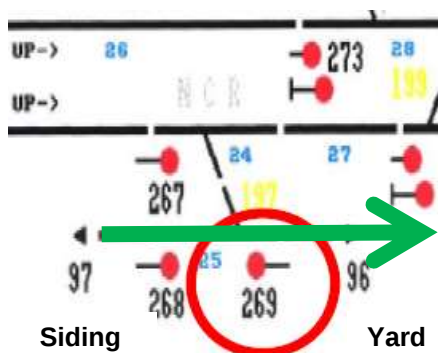
**Figure 90 – Shunt Driver movement into Yard**

734 The Shunt Driver contacted the signalman for permission to carry out the shunting moves, which was granted. The Shunt Driver then carried out the first shunt move from the front cab of the train, by taking the train from the siding up into the yard, see Figure 90. The Shunt Driver then keyed out of driving duties from the front cab.

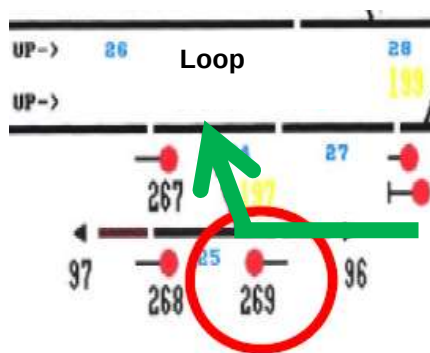
**Figure 91 – Train Driver movement onto Loop**

735 The Dundalk Driver, who was positioned in the rear cab, keyed into driving duties from the rear cab. The Dundalk Driver thought that Shunt Signal 269 was displaying as proceed aspect (two white lights), and began the shunting move from the yard onto the loop, see Figure 91. On approaching Shunt Signal 269 he saw that it was in fact displaying a restrictive aspects (one red

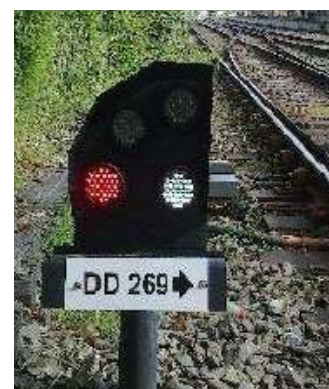
**Figure 92 – Shunt Signal DD269**

and one white light), as illustrated in Figure 92. He immediately applied the emergency brake, however he passed Shunt Signal DD269 at danger by three metres.

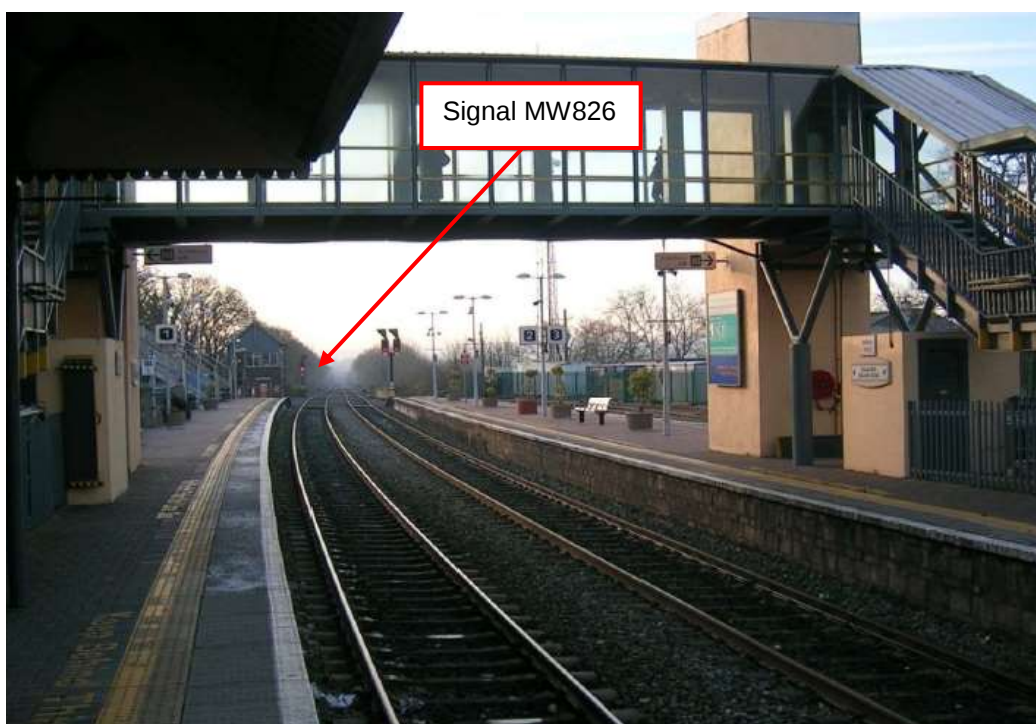
**Figure 93 – Mallow Station with Signal MW826**

744 Driver A302 then looked along the train and departed without checking the Signal MW826 (see Figure 93), assuming this was done by the PIC prior to giving the "ready to start" signal. Signal MW826 was displaying a red aspect as the CTC Signaller had not yet set the route. Driver A302 passed Signal MW826 at danger, and continued a distance of 966 m before the train was stopped on the request of the Waterford/Tralee Line Signaller.

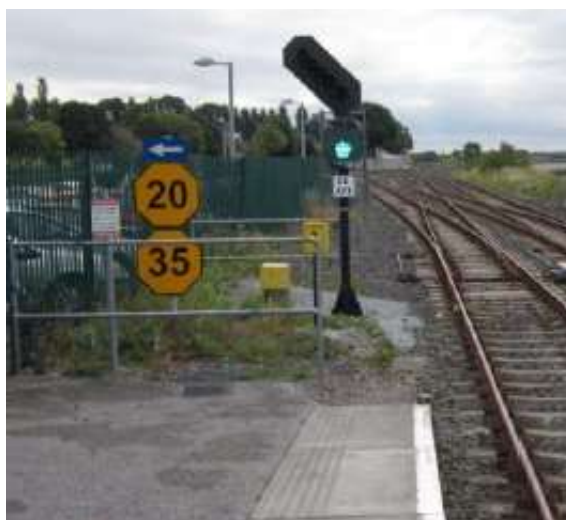
**Figure 94 – Signal CE473**

750 On arrival at the platform, the driver (Driver D273) carried out a number of station platform and despatch duties. Driver D273 departed Glounthaune Station, ahead of schedule, with the starting signal, Signal CE473 (Figure 94), displaying a yellow aspect and proceeded towards Signal CE842 (Figure 95) which was displaying a red aspect (this was as a result of the Cork East Signaller waiting for the train approaching Glounthaune Station in the opposite direction to clear the section).

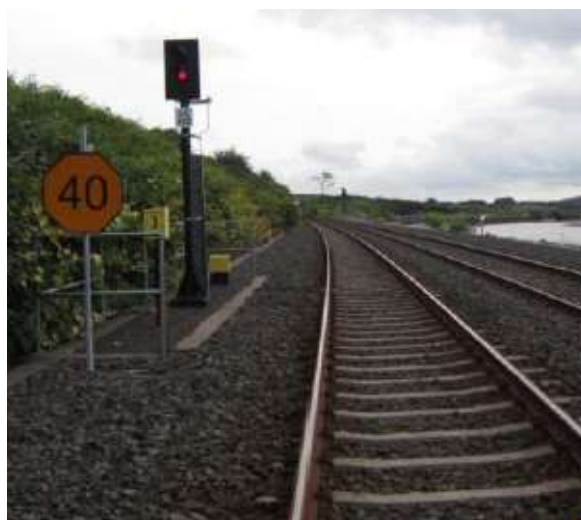
**Figure 95 – Signal CE482**

751 On approach to Signal CE482, Driver D273 saw that it was displaying a red aspect and applied the brakes. However, Train D273 passed Signal CE842 at danger, passing the signal by 82 m before coming to a stop.

that he had become distracted by the speed board<sup>18</sup> located in rear of Signal CE482 which was displaying an increased speed (see Figure 95). The RAIU found that Driver D273 was not adversely affected by any personal issues at the time of the incident as stated in the internal IÉ report.

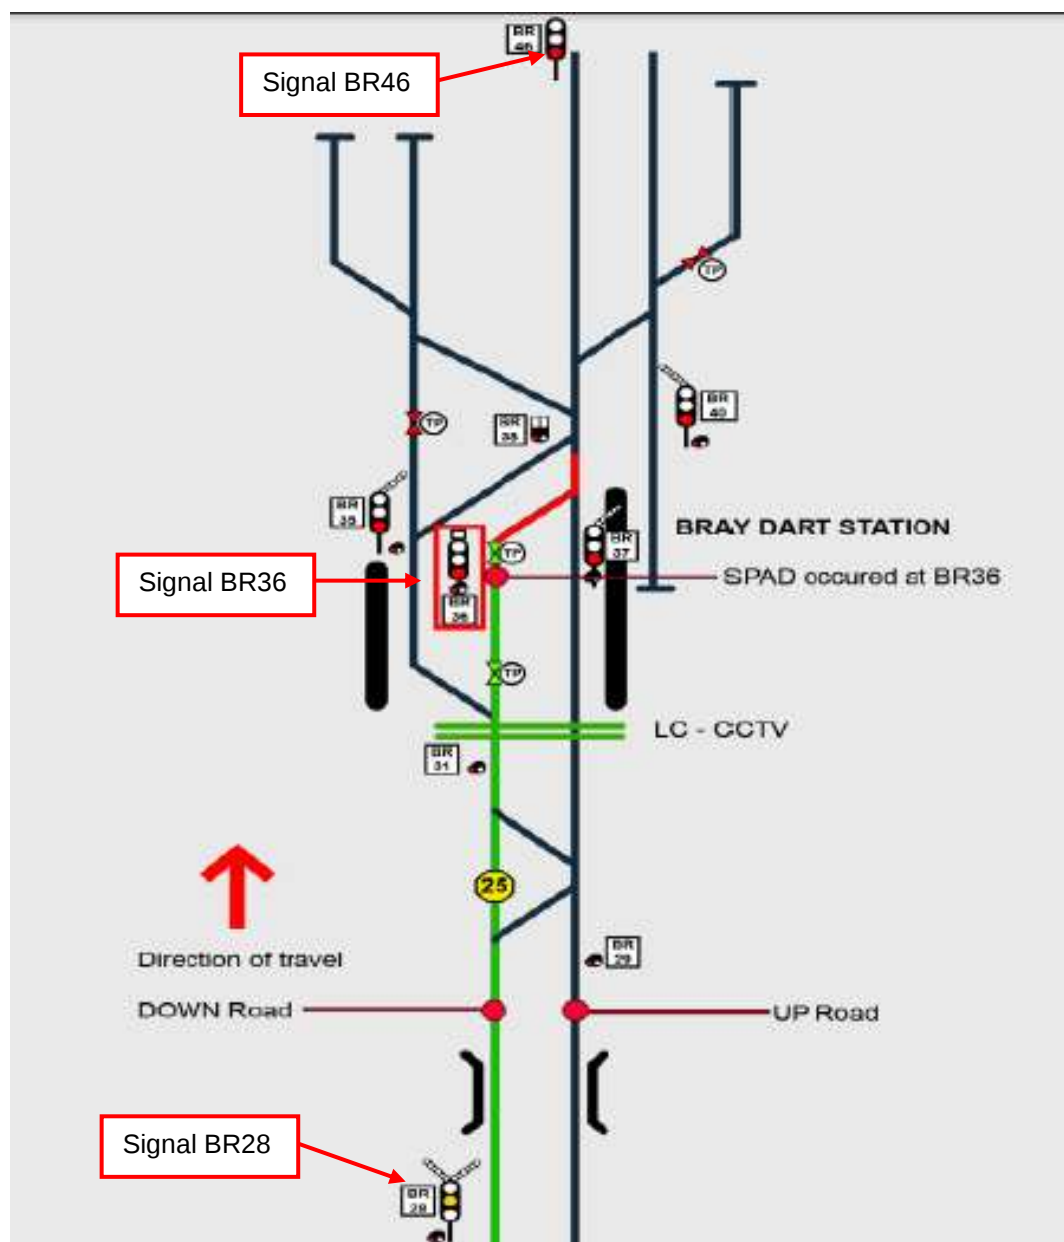
Figure 96 – Bray Station Layout & intended route (taken from IÉ internal report)

756 On the 20<sup>th</sup> August 2014, Train Y674 (an inspection car) was due to travel from Connolly to Greystones at 10:00 hrs, it was being operated by a BBRI staff member (Driver Y674). On the approach to Bray DART Station, Train Y674 stopped at the next red aspect, Signal BR28, see Figure 96. The signalman upgraded BR28 to a yellow aspect (meaning the next signal, Signal BR36 (see Figure 96) was displaying a red aspect) and Train Y674 travelled past Signal BR28 and continued towards the red Signal BR36. Driver Y674 saw that the route was made for his movement and looked at BR46 which was displaying a proceed aspect. Driver Y674 did not see Signal BR36 and continued past it at danger without authority. The signalman phoned Driver Y674 requesting that he immediately stop the train.

757 IÉ assigned an SRR of 16 to the SPAD. The BBRI/IÉ-IM investigation report found that the immediate cause of the SPAD was Driver Y674 “not locating and observing Signal BR36 at danger”. Causation factors were identified as Driver Y674 “focussing on Signal BR46” and not having “adequate route knowledge for the route concerned”. The underlying cause of the SPAD was “the lack of route packs for operators”.

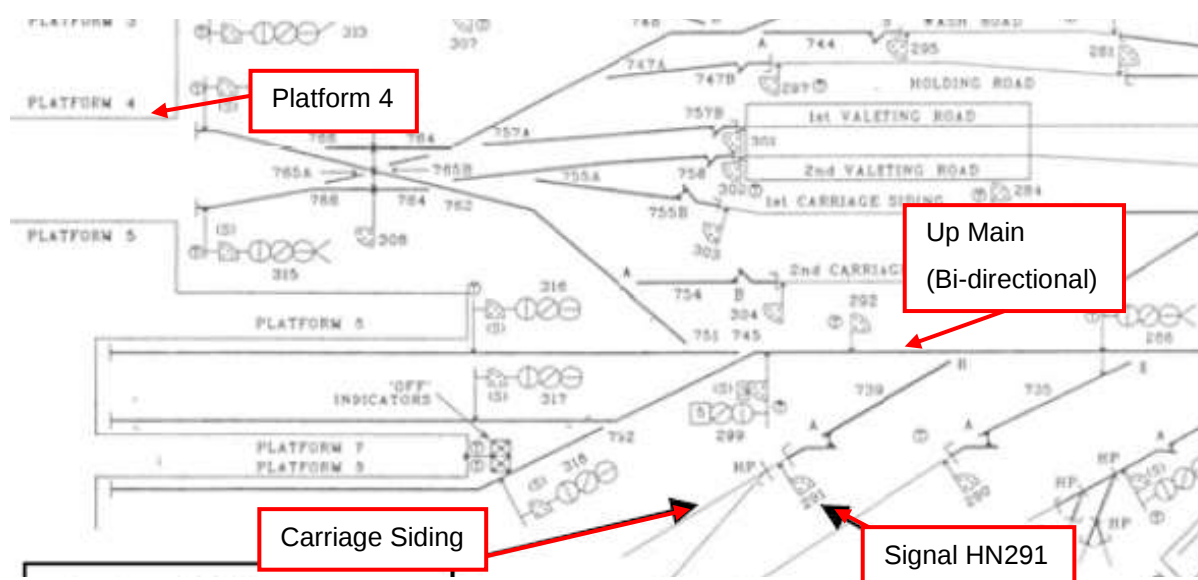
**Figure 97 – Layout at Heuston**

760 On Saturday 11<sup>th</sup> October 2014, Driver I215 was required to shunt an empty train (Train I215) from a Carriage Siding into Heuston Station. This was a regular movement which required a forward movement for the Carriage Siding onto the Up Main, driven from the locomotive, which would require the points to be set in the reverse position (the points are normally set in the trap position, as the Siding leads onto the Up Main). A reverse movement driven from the control car towards Platform 4 (see Figure 97) is then required.

761 After requesting the movements from Signal Equipment Room (SER) Driver I215 commenced the movement, believing that Signal HN291 (see Figure 97) was displaying a proceed aspect. As Driver I215 proceeded with the movement and on the approach to Signal HN291 Driver I215 noticed that the points were lying in the trapping position and immediately applied the emergency brakes. However, Train I215 continued past Signal HN291 at danger, and became derailed as it travelled over the points; he immediately called the signaller in SER to inform him of the SPAD.

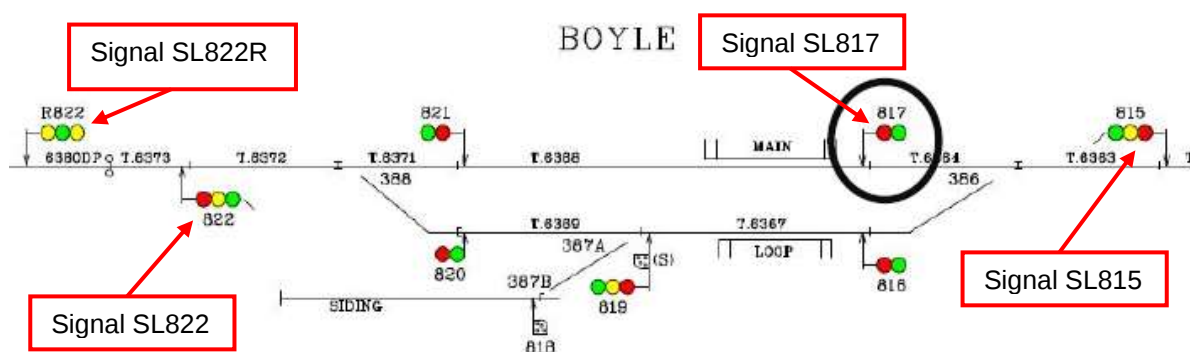
**Figure 98 – Signalling at Boyle Station**

768 Driver A911 travelled to the approach of Boyle Station, without incident. On the approach to the distant signal, Signal SL822R at Boyle, it was displaying a double yellow aspect; the home signal, Signal SL822, was displaying a single yellow aspect and the section signal, Signal SL817 was displaying a red aspect, see Figure 98.

769 At Boyle Station, the late running 15:05 hrs passenger service from Connolly Station to Sligo, (Train A904) was standing on the loop platform in Boyle Station, awaiting the arrival of Train A911. Additionally the 16:00 hrs passenger service from Connolly Station to Sligo (Train A906), was standing at Signal SL815 awaiting the departure of A904 from the loop platform, see Figure 98.

770 At Boyle Station, train despatch was performed by Driver A911 and after completing these duties he closed the doors and applied power to the train, departing Boyle Station with Signal SL817 displaying a red aspect (Signal SL817 is located 24 m from the top of the ramp on the main platform at Boyle Station). Train A911 was travelling at 7 mph (11.2 km/h) when Driver A911 saw that Signal SL817 was displaying a red aspect; he immediately applied the brakes, but the train travelled past the signal by approximately 5 m.

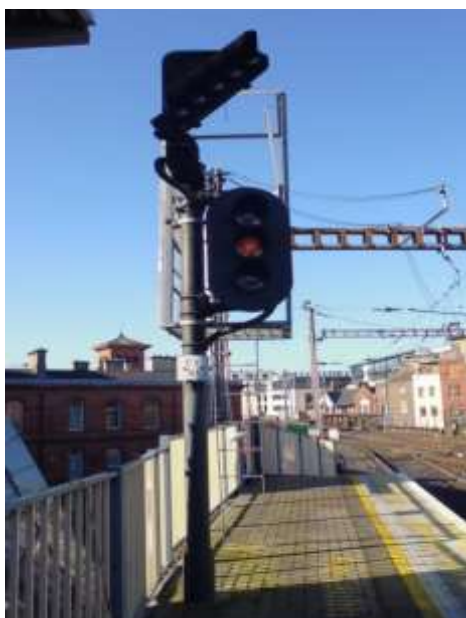
**Figure 99 – Signal CY91 (Platform 5)**

778 Train P618 continued, without further incident, until it arrived on Platform 5, Connolly Station. The signal departing Platform 5, Signal CY91, was displaying a red aspect on arrival of Train P618 (see Figure 99). The signal upgraded to a single yellow while passengers were boarding and alighting from the train on Platform 5. When station working was complete Driver P618 closed the doors on the train, rechecked the monitor on Platform 5 and departed Connolly Station at approximately 18:01:39 hrs.

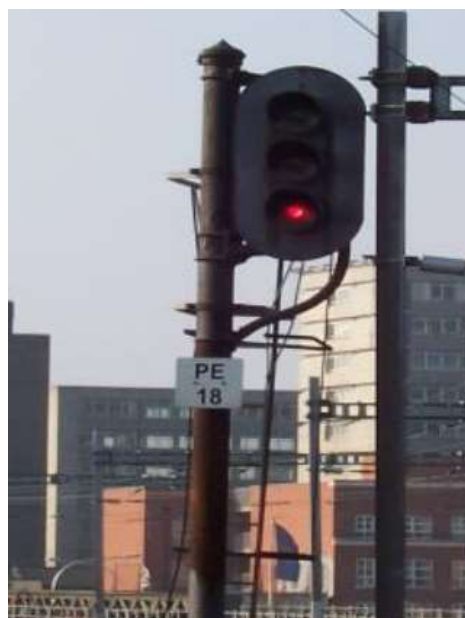
**Figure 100 – Signal PE18**

779 Driver P618 started to accelerate the train, and 147 m in rear of Signal PE18 (see Figure 100), Driver P618 acknowledged the downgrade to red in the CAWS whilst travelling at 18.16 km/h. At 18:02:27 hrs, 14 m in rear of Signal PE18, Driver P618 applied the brake to the braking position; he applied the emergency brake 5 m in rear of Signal PE18; however, Train P618 passed Signal PE18 at danger by approximately 3 m.

782 IÉ assigned an SRR of 16 to the SPAD. The OOR, published in May 2015, identified the immediate cause of the SPAD as Driver P618 not focusing on the primary task of controlling the train sufficiently on approach to Signal PE18 resulting in the signal being passed at danger. Contributory factors were identified as:

783 IÉ identified the underlying cause to the SPAD as the train not being fitted with the ATP function.

787 The RAIU found that Driver P618 had become distracted and preoccupied by thinking of future movements on the approach to Pearse, leading to him losing situational awareness.

785 The OOR notes that the train protection upgrade programme, IÉHS, is underway. In addition, Signal PE18 is to be removed from its current position and replaced with two new signals, installed between Connolly and Tara Street Stations.

786 As a result, this OOR resulted in one new recommendation, whereby, the RU Safety Manager is to prepare and issue a specific briefing/notice to remind train drivers of the risks of running on restricted signals, the management of the resultant CAWS interventions and the necessity to remain focused on the driving activity in such circumstances.

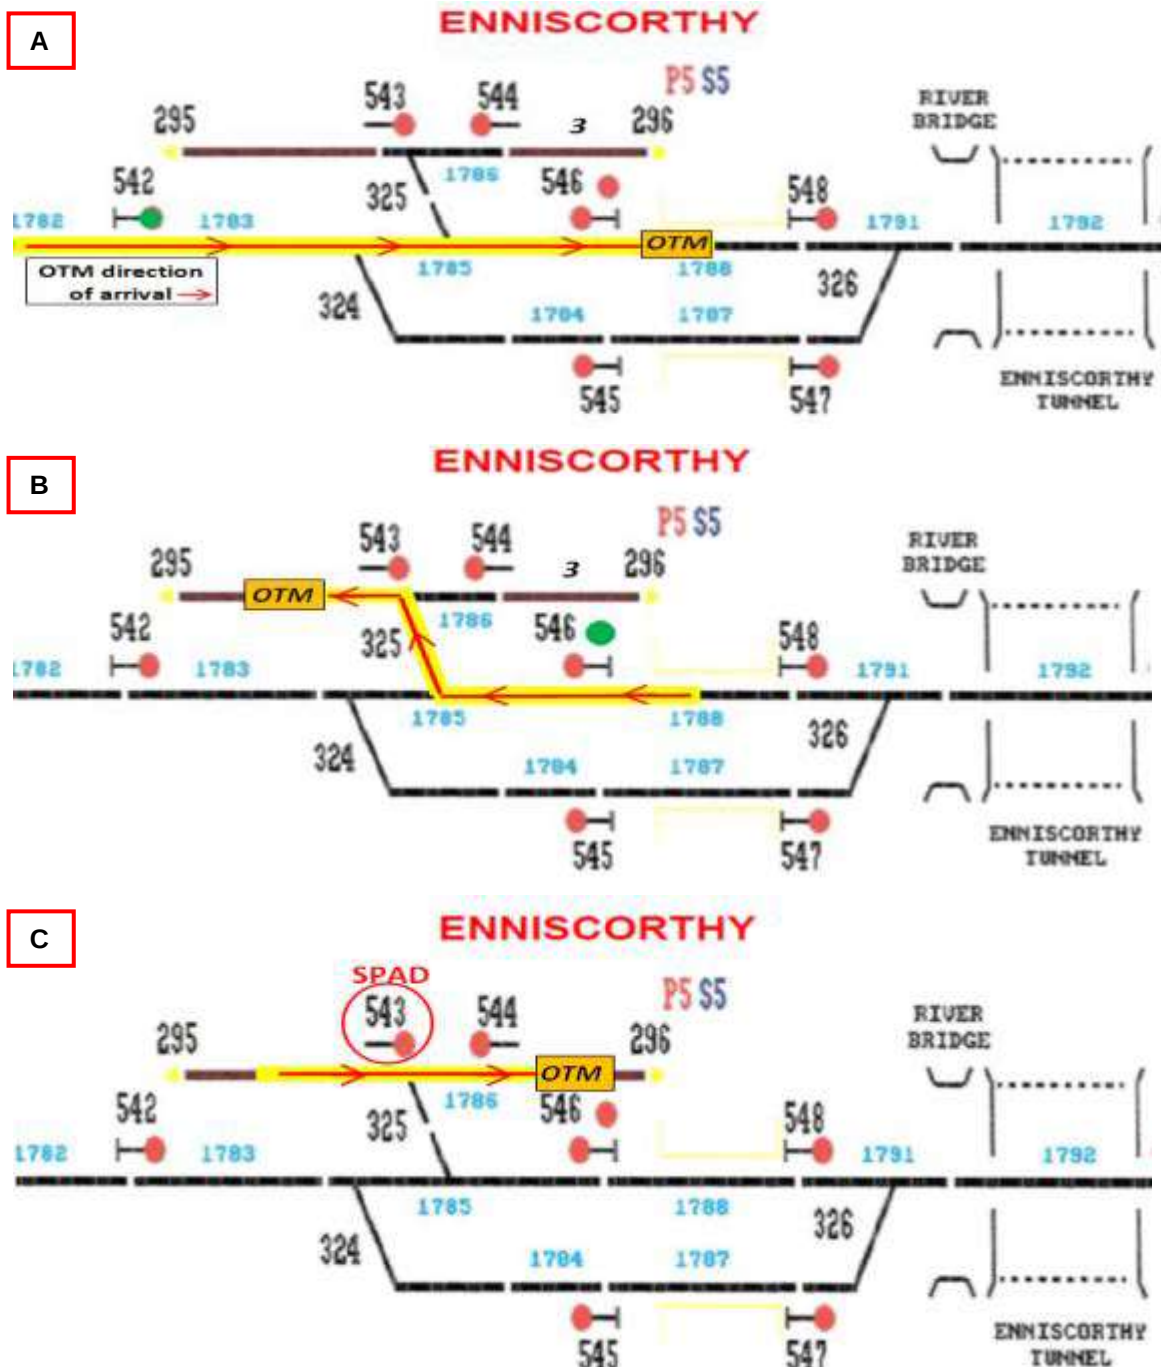
Figure 101 – Sequence of movements for the OTM (taken from IÉ/BBRI Report)

804 The Signaller then signalled the OTM into the siding and Driver Y632 stopped the OTM approximately 18 m in rear of Signal RL543 and advised the Signaller he was in clear and safe (Figure 101 B). He changed from Cab B to Cab A (facing Signal RL 543) with the intention of stabling the OTM in rear of Signal RL544 which was at the opposite end of the siding and also the last movement of the day; however, he did not relay this intended movement to the Signaller.

805 From Cab A Driver Y632 observed the points ahead moving to the normal position and assumed this was for his intended route. Driver Y632 checked Signal RL543, thought he saw a proceed aspect, and moved the OTM to the opposite end of the siding and passed Signal RL543 at danger in the process (Figure 101 C). The Signaller then contacted Driver Y632 to query his movement and it was confirmed that the OTM had passed Signal RL543 at danger without authority.

807 The SPAD was assigned an SRR of 0. The IÉ-IM / BBRI report of investigation 'SPAD involving On-track Machine (703 Ballast Regulator) at Signal RL543 in the siding at Enniscorthy 9<sup>th</sup> of June 2015', published on the 14<sup>th</sup> September 2015, found that the immediate cause of the SPAD was "Train Y632 passed Signal RL543 at Danger after the Driver failed to check the signal". Causal factors were identified as "The Driver observed the points returning to normal and then drove the OTM to the opposite end of the siding passing Signal RL543 at Danger without authority"; and "The Driver did not request Signal RL543 from the Signaller during the communication. Although the Signaller repeated back the message to confirm the OTMs position in the siding, the Driver continued the call in a form of words which did not clearly indicate his intentions and the Signaller did not realise or query what he meant by this. As a result a clear understanding was not reached". No underlying causes were identified.

809 The RAIU found that Driver Y632 had an incorrect expectation Signal RL543 was displaying a proceed aspect. This incorrect expectation was as a result of strong sunlight shining onto the signal at the time (and into the face of the Driver Y632); this meant that Driver Y632 did not request the signal from the Signaller. Driver Y632 was also distracted at the time of the incident as a result of changing pay conditions being enforced at the time<sup>19</sup>. Poor communications also contributed to not gaining a clear understanding of the movement to be undertaken.

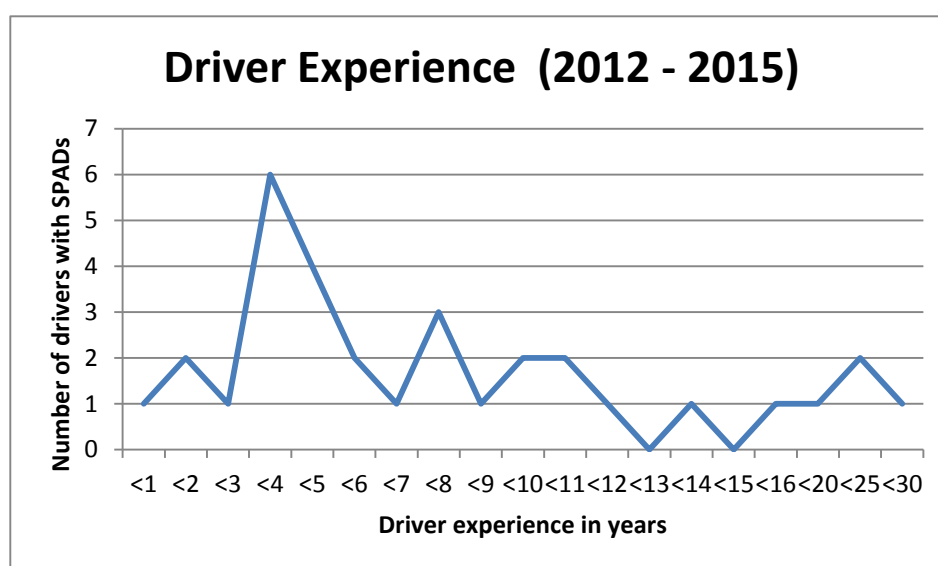
**Figure 102 – Driving experience & the occurrence of Category A SPADs (2012 – 2015 (June))**

826 In relation to years driving experience and the occurrence of Category A SPADs from January 2012 to June 2015, the graph shows that SPADs are most likely to occur with drivers with between three and five years of driving experience, see Figure 102.

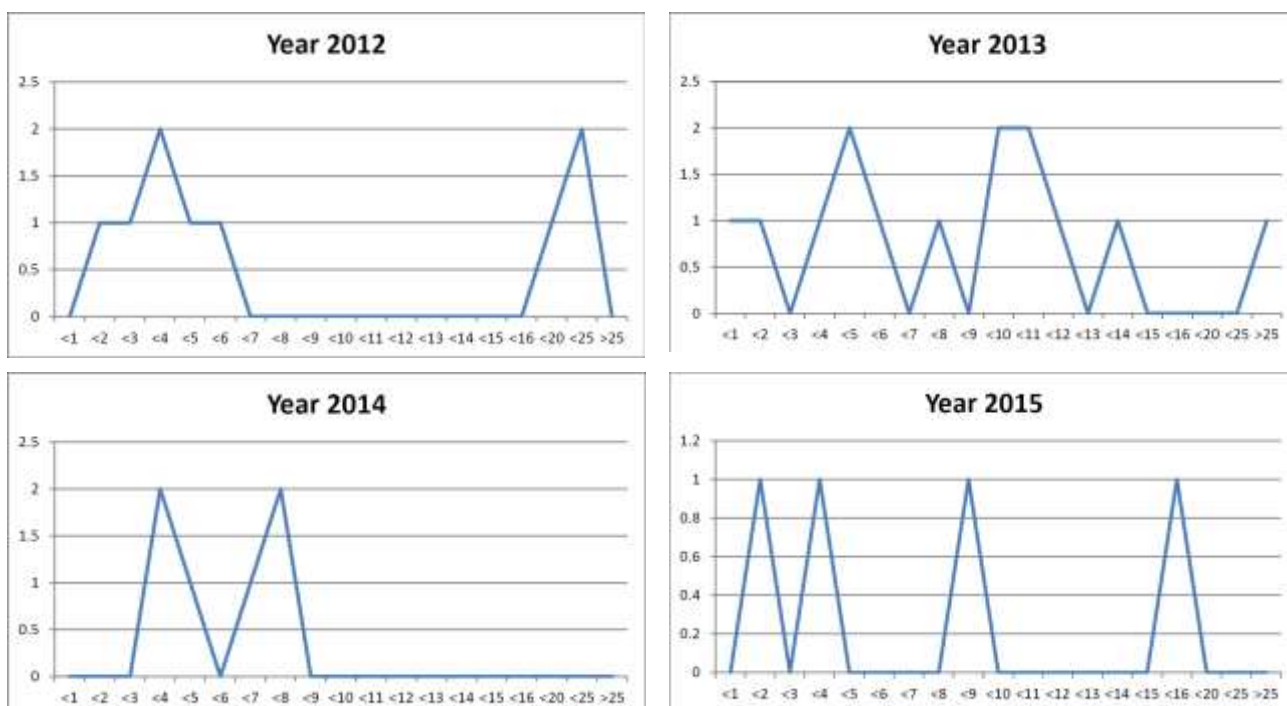
**Figure 103 – Annual figures for the occurrence of SPADs and driving experience**

827 However, if the years are plotted individually i.e. for 2012, 2013, 2014 and 2015 (to June), see Figure 103, the graphs show that in:

- 2012 – The occurrence of SPADs occur with drivers with less than seven years driving experience and greater than twenty years driving experience;
- 2013 – There is no clear trend in the occurrence of SPADs with driving experience;
- 2014 – There is a number of SPADs occurring with drivers with three to eight years driving experience;
- 2015 – To date, there are a number of SPADs with drivers with less than five years driving experience, eight to ten years driving experience and sixteen to twenty years driving experience.

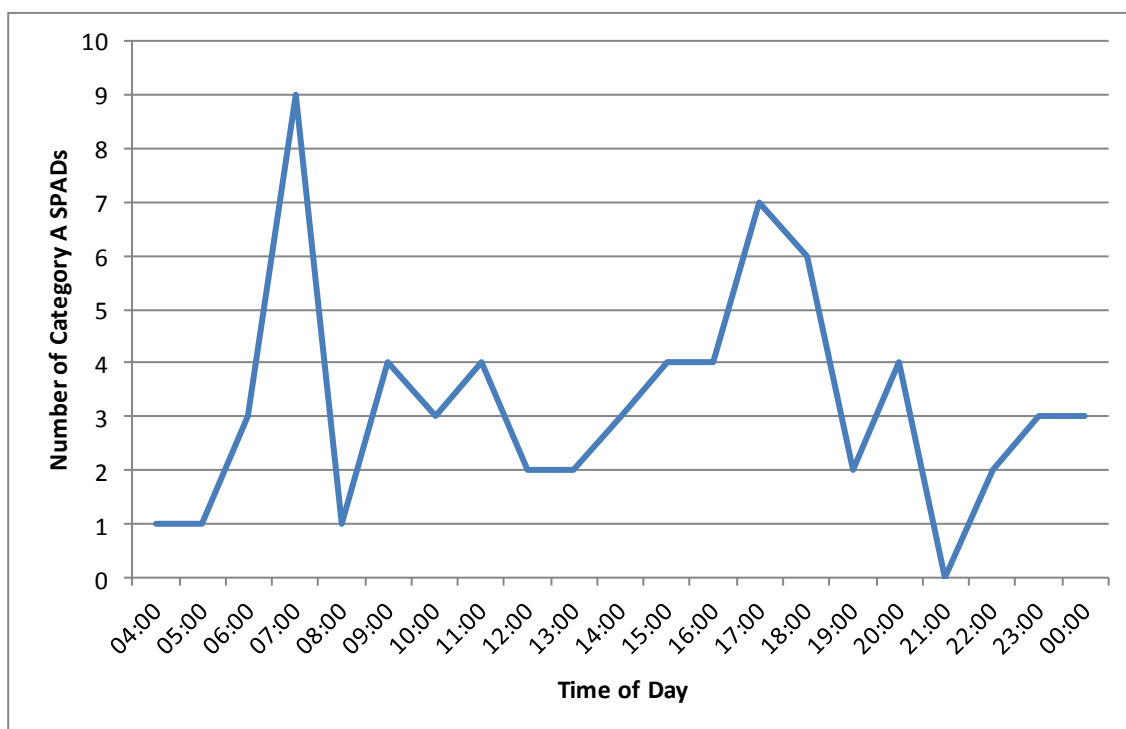
Figure 107 – Time of day for Category A SPADs 2012 – 2015 (to June)

834 In relation to the time of day in which Category A SPADs occur, this investigation plotted the available time of the SPADs from 2012 – 2015 (end of June 2015); this plotting shows that there are a number of peak times when SPADs are more prevalent, i.e. between 06:00 hrs and 08:00 hrs, and between 17:00 hrs and 20:00 hrs.
