# RAILWAY ACCIDENT INVESTIGATION UNIT IRELAND

## INVESTIGATION REPORT

**Investigation into SPADs on IÉ Network,  
from January 2012 to June 2015**

**RAIU Report No: R2016 – R001**

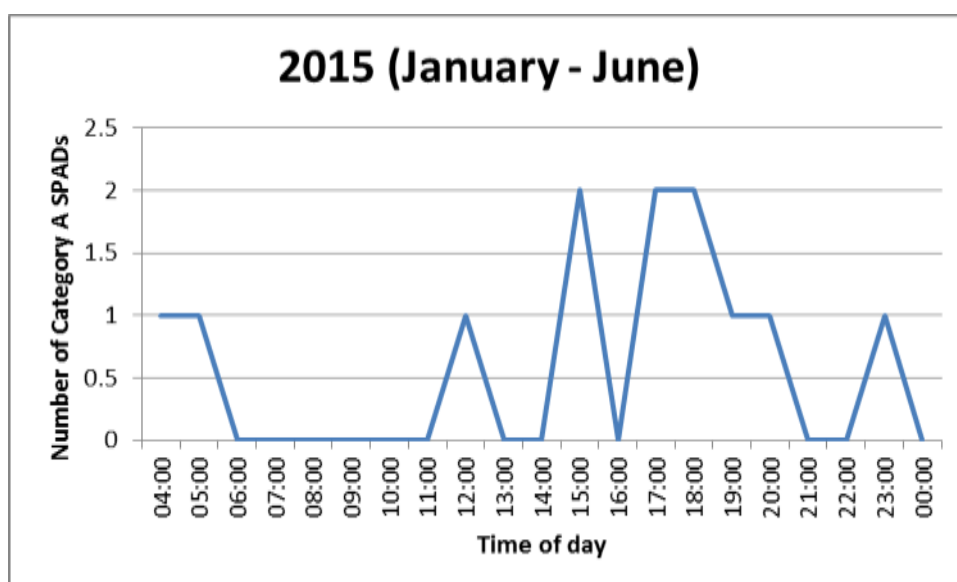
Figure 108 – Time of day for Category A SPADs showing annual changes

835 More recently, in 2015, the occurrence of a SPAD was more prevalent at the later peak time (17:00 hrs to 21:00 hrs), although it should be noted that there has been no significant change in timetabling of trains or rostering of drivers, see Figure 108.

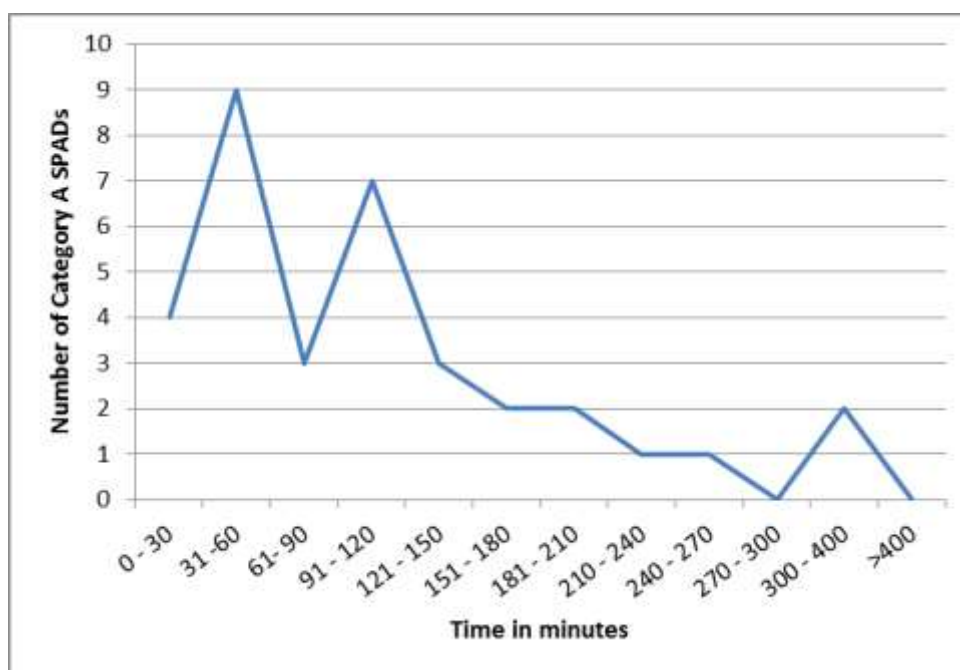
**Figure 109 – Driving time and Category A SPADs (2012 – 2015 collectively)**

836 Plotting the time spent driving, in thirty minute intervals, prior to the Category A SPAD event, for SPAD events between 2012 – 2015 (end of June 2015) the graph indicates that the most SPADs occur within the first thirty minutes driving, and are most prevalent within the first hour of driving, reducing slightly for the second hour of driving, and then decreasing significantly after two hours driving, see Figure 109.

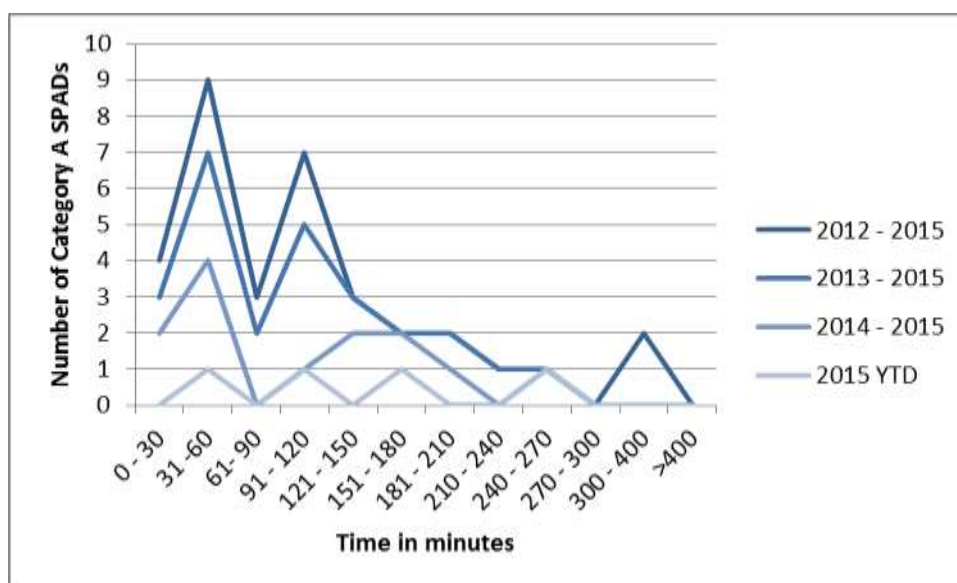
**Figure 110 – Driving time prior to the occurrence of Category A SPADs (showing annual changes 2012 – 2015)**

837 However, the number of SPADs occurring within the first two hours has decreased over the years, and more recently, there is no apparent trend in terms of the occurrence of a Category A SPAD and driving time, see Figure 110.

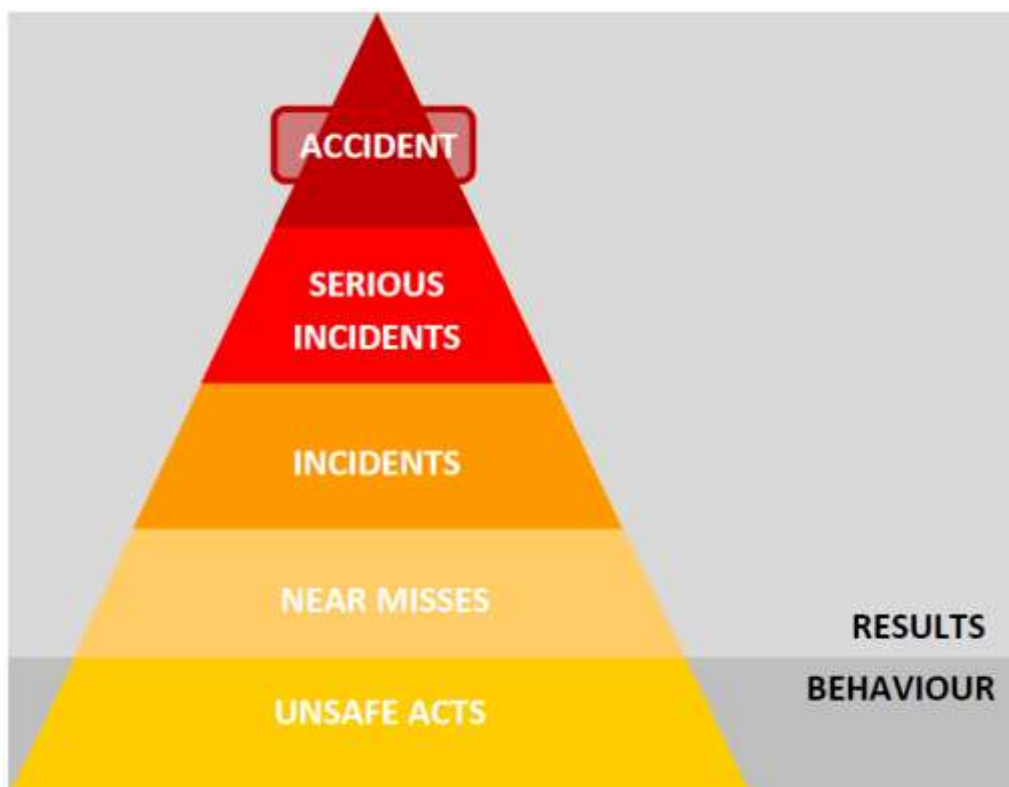
**Figure 111 – Safety Triangle**

956 As a general rule in incidents there are generally a number of unsafe acts, near-misses and incidents and serious incidents prior to an accident occurring, see Figure 111.

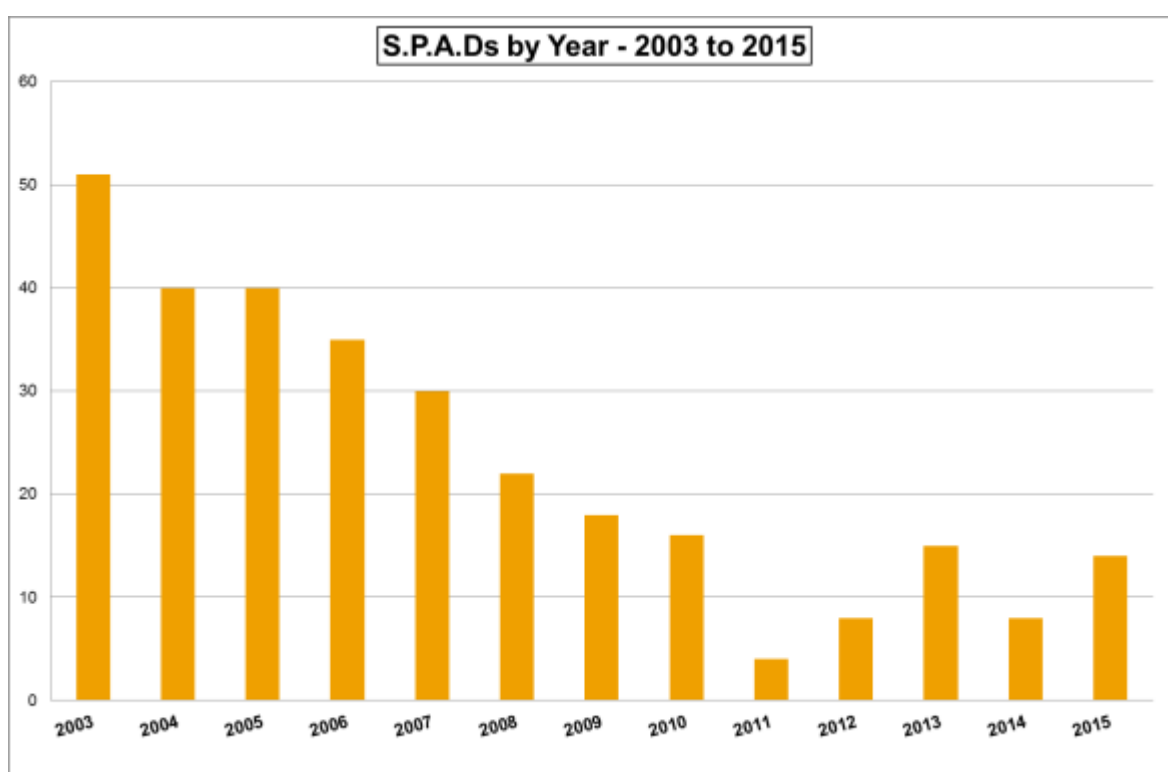
**Figure 112 – SPADs by Year - 2003 to YTD 2015**

1002 IÉ state that they are “seeking to continuously improve its management of SPAD risk”. The following figure (Figure112) shows the significant reduction in the number of SPADs which has been achieved from 2003 to 2015 (however it is noted that there are two peaks in the numbers of SPADs in 2013 and 2015).
