**Railway Accident
Investigation Unit
Ireland**

INVESTIGATION REPORT

**Collision with track equipment between Newbridge
and Kildare,**

RAIU Report No: 2023 – R002

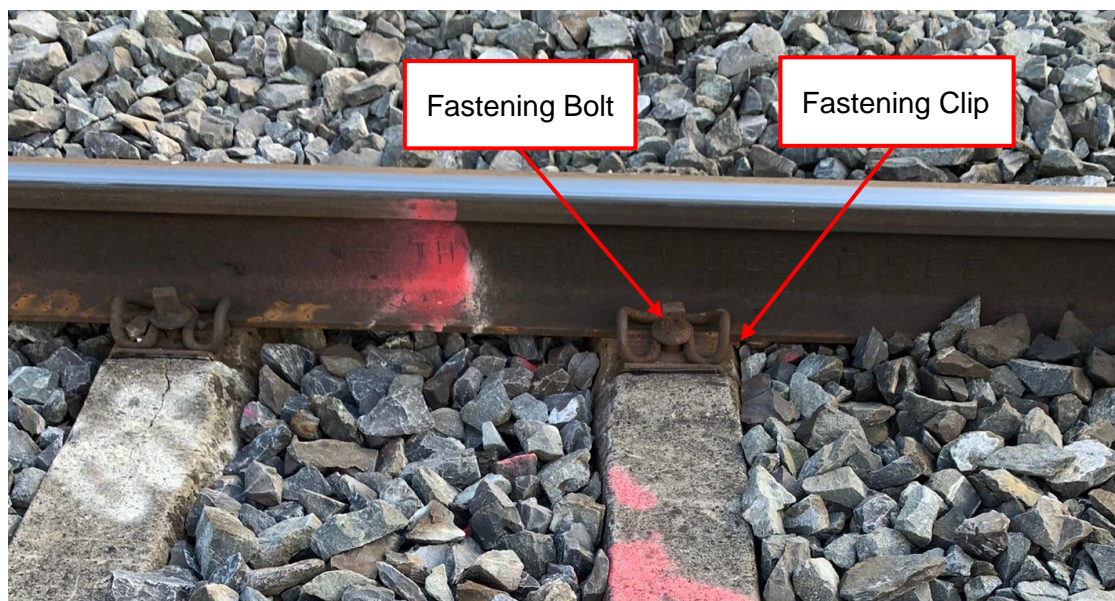
Figure 1 – Fastening bolts

- 25 At the site of the defective rail, the GO started to loosen the fastening bolts, which fasten the rail to the concrete sleeper by means of fastening clip (see Figure 1).

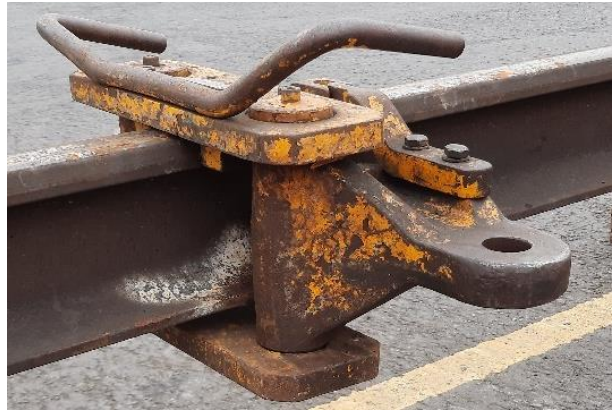
Figure 2 – Clamp fixed to rail

26 At the same time, one of the contracted welders started digging the ballast out from around where the clamp⁶ was to be placed, whilst the two other contracted welders started to attach the clamp to the Down Leg of the Up Line. Figure 2 illustrates how the clamp would be fixed to the rail during the works.

- 27 The contractor that was digging the *ballast*, turned to put down his shovel, when he saw the lights of an approaching train and shouted “train on” and all staff quickly moved to a *position of safety*.
- 28 Train J283 struck the clamp, which at the time of collision, was clamped onto the rail, see Figure 2.
- 29 Driver J283 brought Train J283 to a stop and contacted the Mainline Signaller to report that Train J283 had struck something on the line as the train approached the Curragh; and, that he saw members of staff on the Up Line who had moved off the line as Train J283 approached.
- 30 There were issues with the reporting of the accident by the ES and other members of staff, which initially “downplayed” the accident, with inference given that a small bolt had struck Train J283 and not that a piece of equipment that had been clamped to the rail.

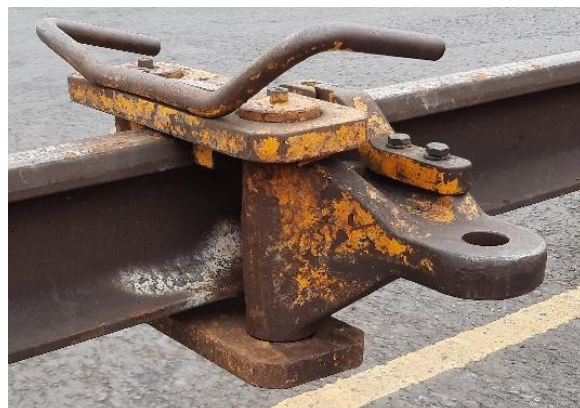
Figure 8 – Clamp on the rail

- 47 The clamp was also damaged, see Figure 7. Figure 8 shows how the clamp would have attached onto the rail.

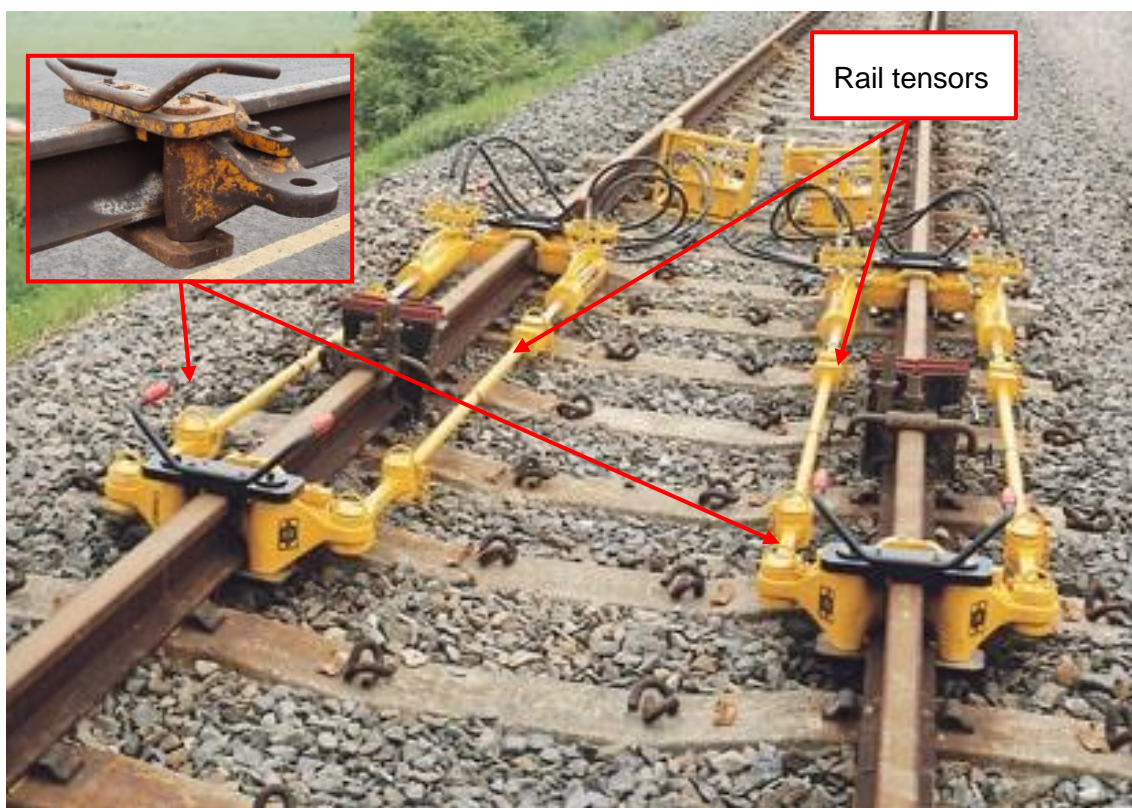
Figure 16 – Rail tensioning device

118 The rail stressing involves attaching two clamps around the rail (inset and arrowed in Figure 16) and applying the hydraulic rail tensors (Figure 16) which use hydraulic cylinders to pull rail sections together to allow for new rail to be welded into place.
