ROMANIAN RAILWAY INVESTIGATING BODY

INVESTIGATING REPORT

of the railway accident happened in the railway station Aiud,
on the 18th of July 2010

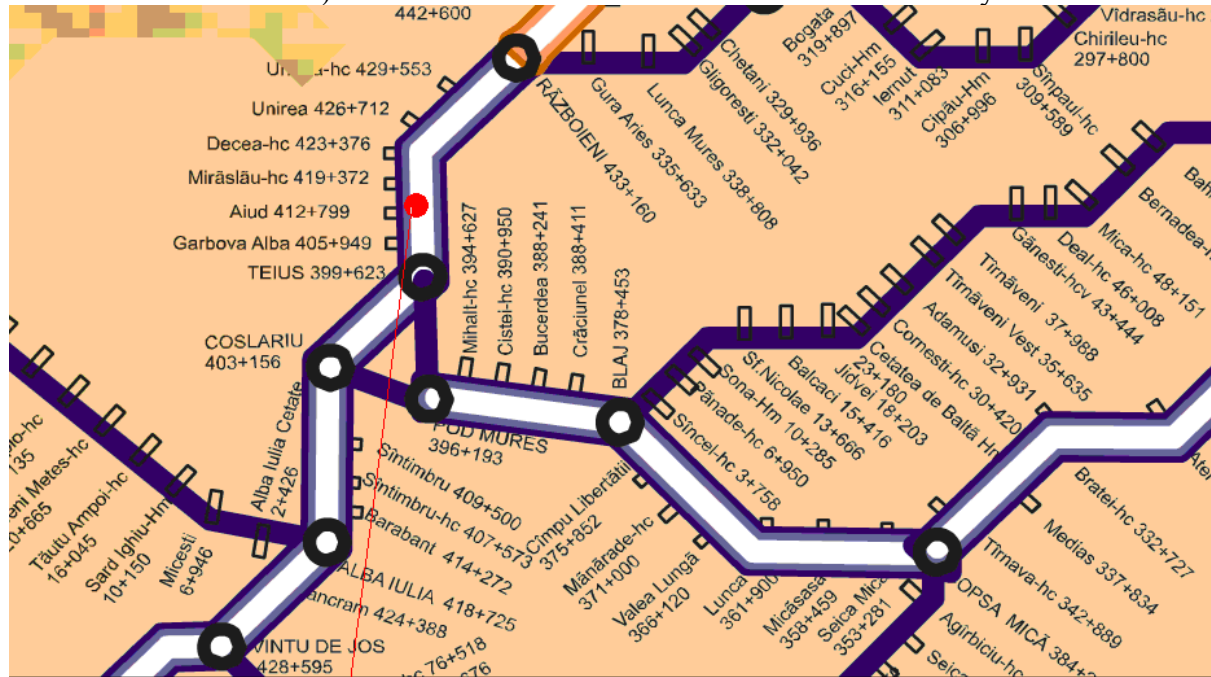
Geographical position of the accident

On the 18th of July 2010, at 17,15 hour, in the **Branch of the Railway County Brasov**, in the railway station Aiud, in the running of the freight train no 60133-2 (operated by SC GRUP TRANSPORT FERROVIAR SA), at its entry on the direct line III happened the derailment of the second bogie in the running direction of the wagon no. 84535451255-8 (the 19th after the locomotive) over the switch no. 6 from the end Y of the railway station.

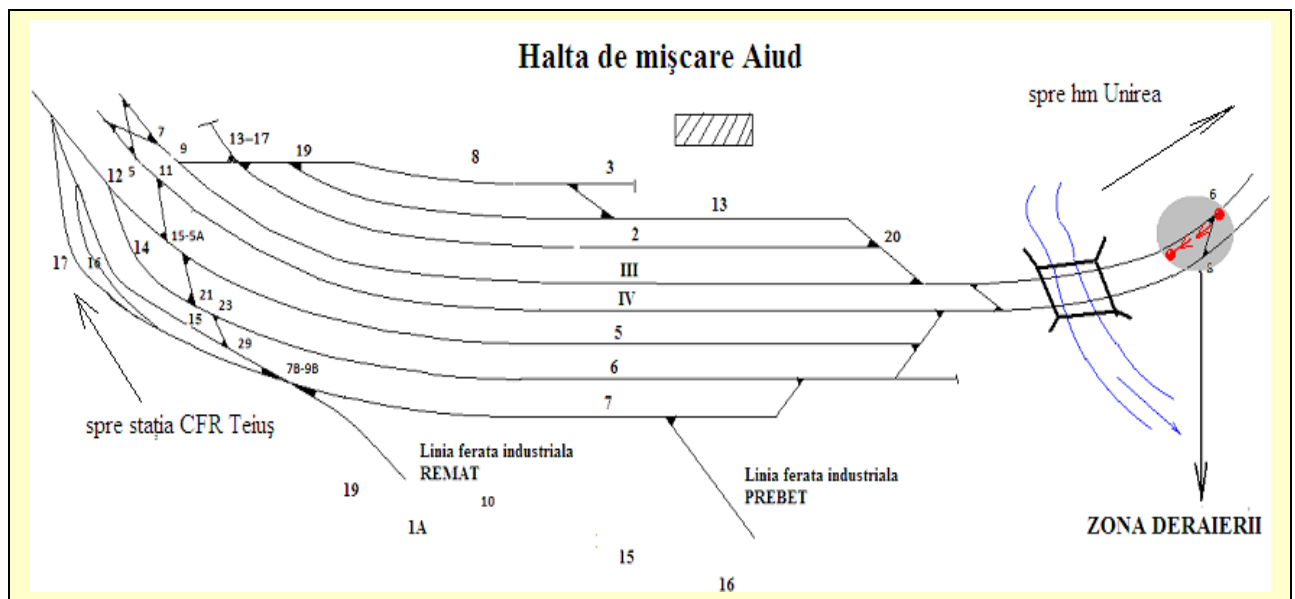
THE SKETCH OF RAILWAY STATION AIUD

The train was dispatched from the line 7 of the railway station Campia Turzii and run without stop up to the railway station Aiud, where it had to entry on the direct line III. Over the switch no. 6 from the end Y of the railway station happened the derailment of the second bogie of the wagon no. 84535451255-8 (the 19th after the locomotive), in the running direction. The first derailment trace was found out on the built-up common crossing of the switch no. 6, where the first axle of the derailed bogie (the axle corresponding to the wheels 5-6) run in the wrong direction (on the deflecting section), then over-climbed the right rail in the running direction at about 80 cm. from the joint of the switch end of a turnout. The wagon run derailed about 61 m, stopping at the km. 413+505, because of the emergency braking, generated by the crack of the air general pipe from the derailed wagon
