MINISTRY OF TRANSPORTS AND INFRASTRUCTURE  
ROMANIAN RAILWAY AUTHORITY - AFER

## INVESTIGATING REPORT

On the fire occurred on the 2<sup>nd</sup> of November 2010 at the locomotive DA 60-0965-8, hauling the passenger train no. 1555-2, in the Branch of the Railway County Iasi, between the railway stations Bucecea – Veresti, at the km 13+500

Final edition  
The 20<sup>th</sup> of January 2011

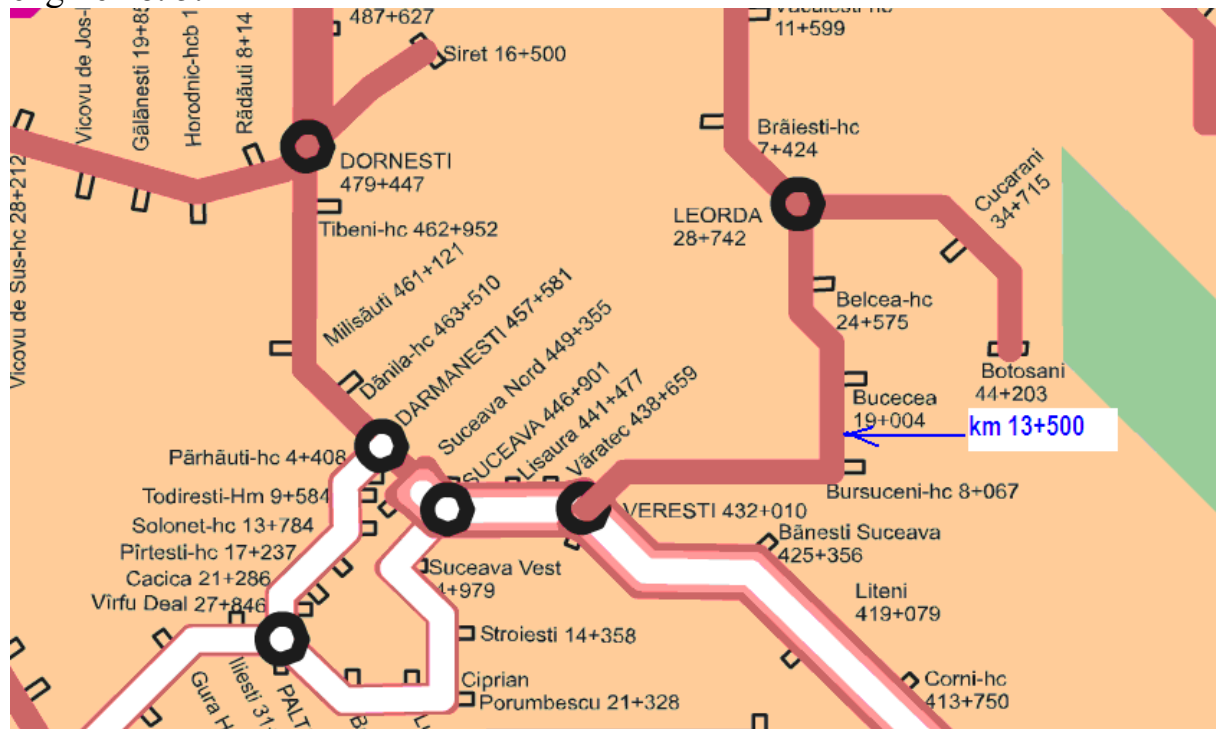
RAILWAY ACCIDENT PLACE

On the 2<sup>nd</sup> of November **2010**, the passenger train no. 1555-2 run between Botosani and Veresti, consisting in the locomotive DA 60-0965-8 and 3 compartment coaches. After the departure of the train 1552-2 from the railway station Bucecea, on the running line to the railway station Veresti, at the km 13+500, a fire occurred in the engine box of the locomotive, at the traction engine no. 5.

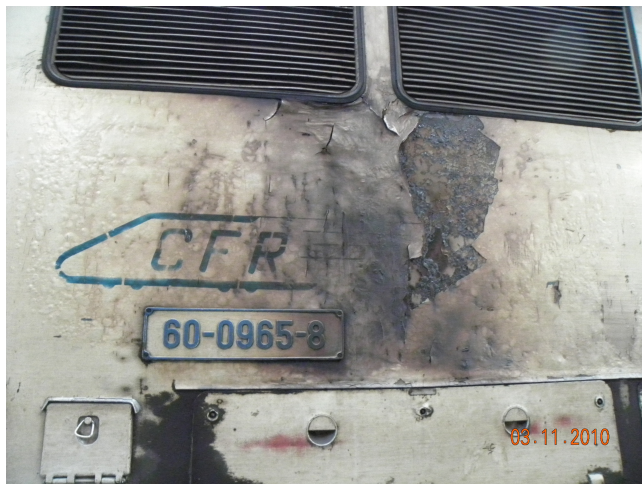
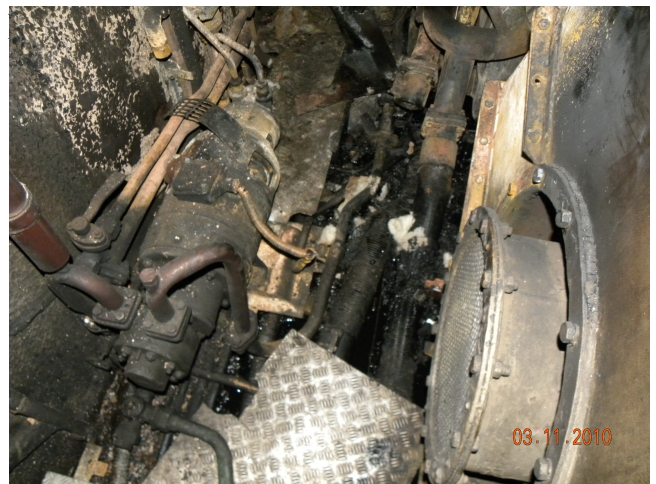
- the locomotive DA 60-0965, hauling the train no. 1555-2 from Botosani to Veresti, was stabled on the line 6 of the railway station Veresti;
- the locomotive box, on the left side to the driving cab 2, had the paint overheated on 1 square meter;
- in the engines box, the Argus pipes were carbonized;
- no damages at the lines and equipments in the accident area.

At 17,30 hour, the running line Veresti-Bucecea was closed and at 17,45 hour the locomotive DHC was routed from the railway station Veresti in order to haul the fired locomotive DA 60-0965-8 and hauled it to the level crossing from the km 13+100 in order to facilitate the firemen intervention. Starting with 18,20 hour, the military firemen from the Firemen Department Suceava started the procedures for the fire extinguishing, up to 19,00 hour.
