MINISTERUL TRANSPORTURILOR SI INFRASTRUCTURII  
AUTORITATEA FERROVIARA ROMANA - AFER

ORGANISMUL DE INVESTIGARE FERROVIAR ROMAN

## INVESTIGATING REPORT

of the railway accident occurred on  
02.08.2010 on the non-interoperable running section Timișoara Vest - Crucești

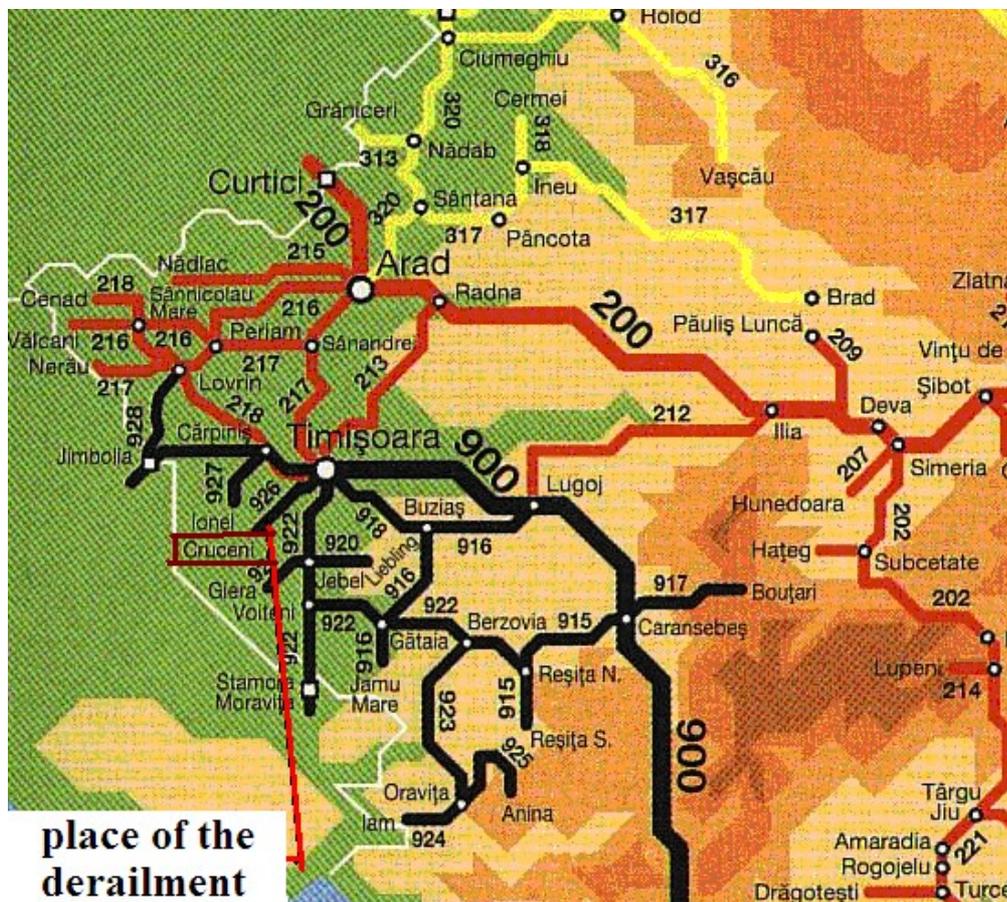
**The direct cause** of the accident occurrence consists of decreasing the distance between inside faces and the parallelism modification of the wheel rims of the two wheels of axle no.4, causing the fall of the right wheel, in the running direction, between the stretch of rails.

There were no injured, damages were recorded at the tracks and at the passenger motor driven AMX 97-0566-6.
