## INVESTIGATING REPORT

of the railway accident occurred in the railway station Halmeu,  
on the 28<sup>th</sup> of May 2010

Final edition  
The 5<sup>th</sup> of August 2010

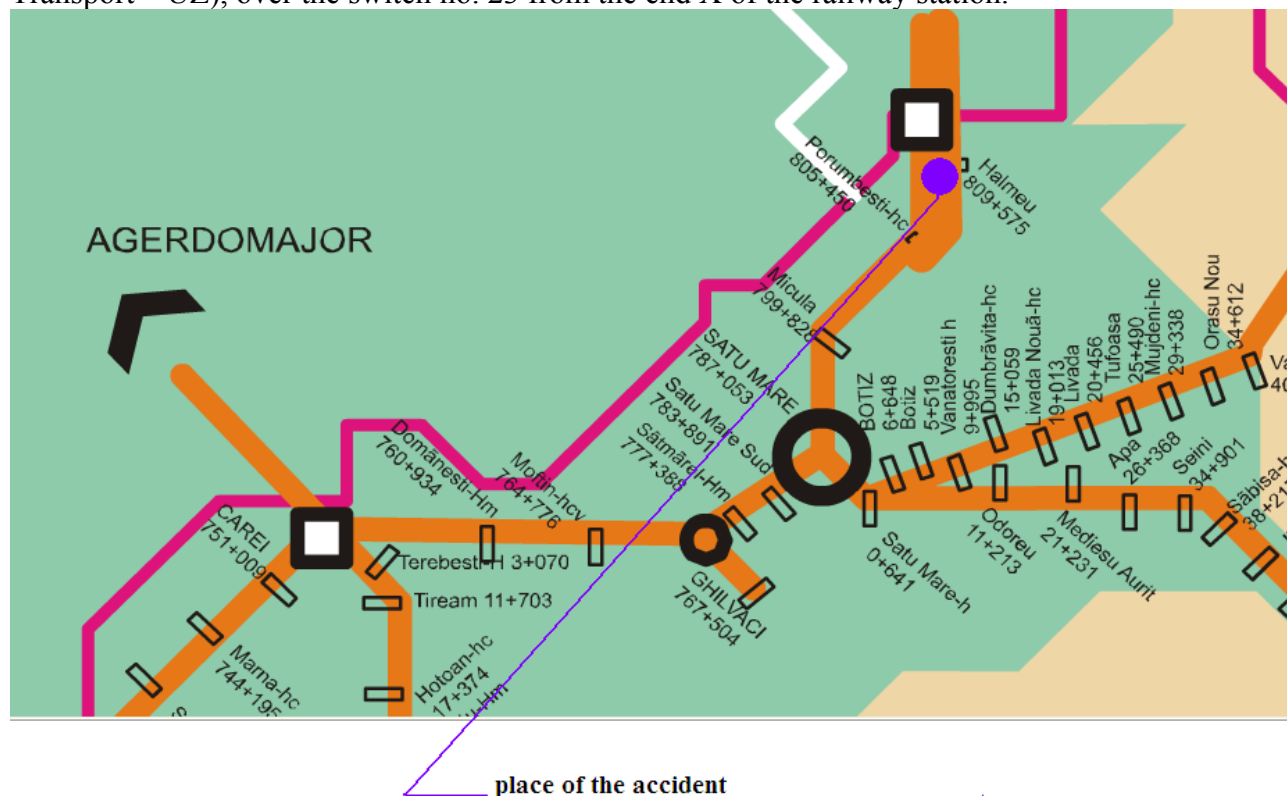
At the accident place, one found out that the first bogie of the wagon no. 67573287 (the 5<sup>th</sup> of the train) was derailed in the running direction and situated at about 1.5 m left most against the rail head from the right side of the running direction.

The traces of the derailment indicated that the derailment happened on the switch no. 23, the derailed wagon running in this condition up to the switch no. 19, where it stopped.
