INVESTIGATING REPORT

on the derailment, of two wagons from the passenger train composition no. 4485
owned by SNTFC “CFR Călători” SA, manufactured in the railway station Mogoșeni
on 07th of April 2010

Final Edition

August 17, 2010

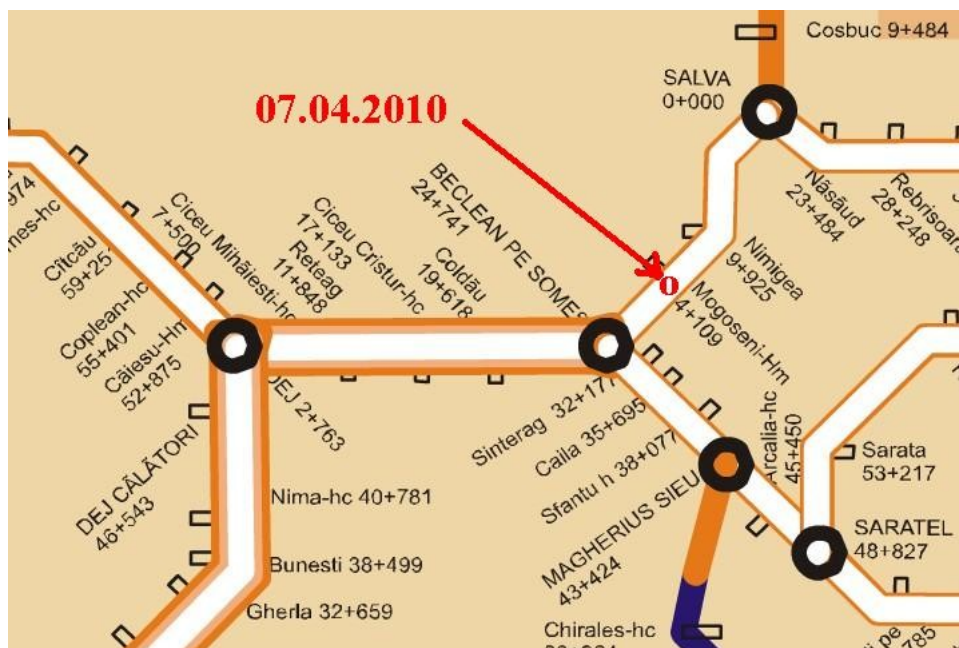
Foto 1: The geographical position of the accident

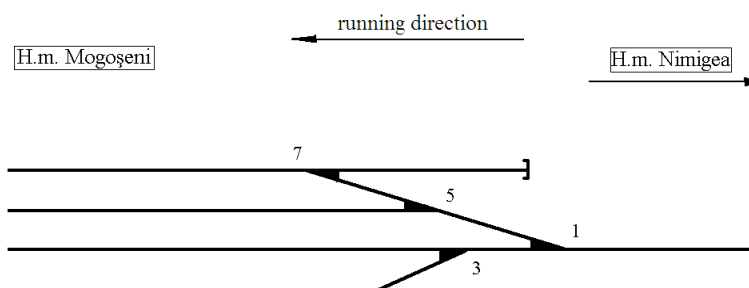
The derailment started from a distance of 80 cm from the right point switch heel (the 14th sleeper), the left wheel of the first axle, in the running direction, of wagon no. 505320476896, the 2nd from the locomotive, get into the space between the lateral surface of the curved stock rail head and the lateral surface of the connecting band from the left side of the direct line of switch no.5 due to the sleeper suddenly yielding on which the metal plate was situated from which the curved stock rail is fixing and the connecting band from the left side of the direct line of switch no.5, followed by the breaking and deformation of the coach screws.

the railway station Mogoșeni scheme, in the area where the accident occurred photo no.2
