MINISTRY OF TRANSPORTS AND INFRASTRUCTURE
ROMANIAN RAILWAY AUTHORITY - AFER

ROMANIAN RAILWAY INVESTIGATING BODY

INVESTIGATING REPORT

on the railway accident
occurred on the 8th of February 2011, in the railway station Capu Midia

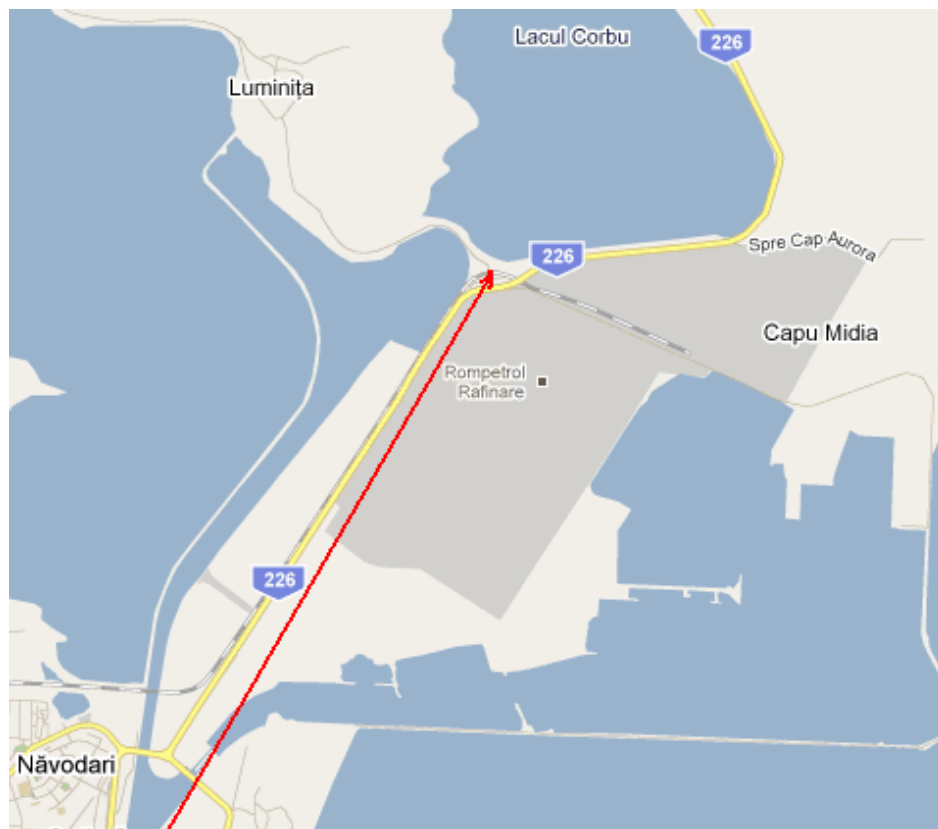
Place of the accident

Around 5:15 p.m., at the entry in the railway station Capu Midia, at the km 32+337, there occurred the derailment of three wagons in the composition of the train, as follows:

- wagon no. 33877919348-5, the 19th by the train locomotive, derailed by a bogie;
- wagon no. 37807923043-9, the 20th by the train locomotive, derailed by both bogies and inclined;
- wagon no. 33807920395-0, the 21st by the train locomotive, derailed by both bogies.
