ROMANIAN RAILWAY INVESTIGATING BODY

INVESTIGATING REPORT

on the railway accident
occurred on the 1st of April 2011, in the railway station CFR Chisineu Cris

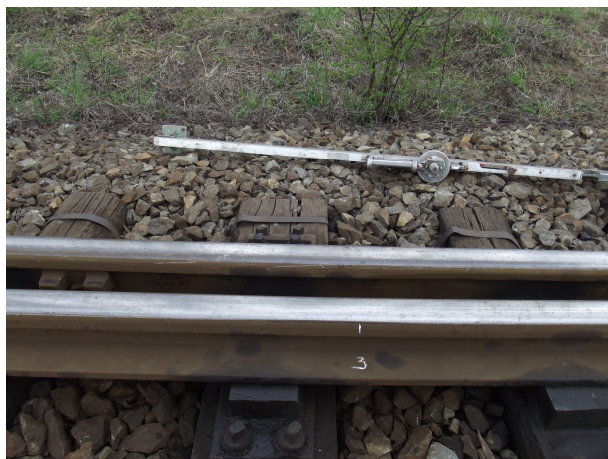
- the first signs of abnormal rolling of the wagons wheels in the composition of the train were found at a distance of 6 m from the needle top of the switch no. 3, where on the curved counter-needle (wire on the right) were found 4 signs of falling inside the path (between the sleepers no. 11 and no. 13 numbered from the top of the switch);
- at a distance of 11 m from the top of the needle, on the right counter-needle (the wire on the left) were found 4 signs of falling inside the path (between the sleepers no. 39 and no. 21);
- from the place of the first signs of abnormal rolling of the wagons wheels in the composition of the train (km 47+182) and to the stopping

point of the first derailed and overturned wagon (the 5th in the composition) – km 47+260, the train ran a distance of about 76 m. The first part of the train, (the towing locomotive and the first 4 wagons in the composition) stopped with the last wagon at the km 47+457.
