INVESTIGATING REPORT

**to establish the conditions and determine the causes that led to breaking a large number of rails, during 2010-2011,
on the range of activity of C.F. Iasi Regional Branch – Section L4 Bacau, on the main line no. 500, on the lines I and II between the railway stations Adjud and Bacau**

*Final report
The 23rd of January 2012*

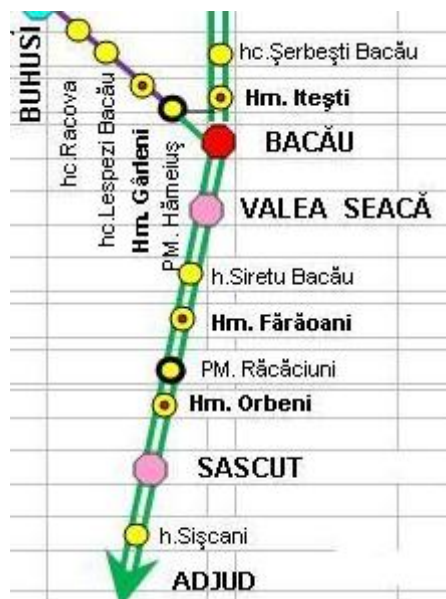
figure 1. area of the defects occurrence

Location of the area of the defects occurrence is presented - figure 1

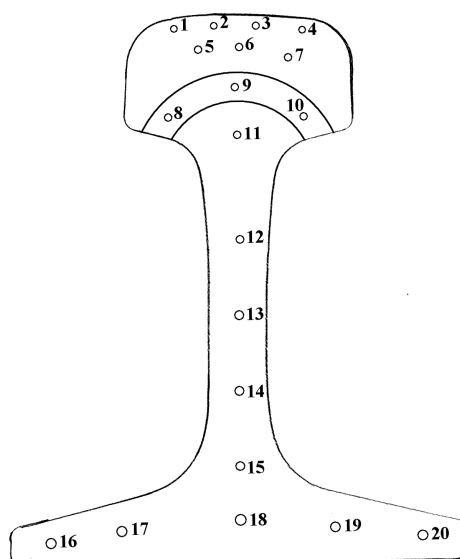
photo no. 13 – placement of the measurement points

The placement of hardness prints on the 7 cross slices used in the test is shown in figure no. 13.

As a general characteristic, common to the 7 measured sections, is that the hardness measured value decreases vertically, from values of 370-390 HBW at the running surface to values of 270-290 HBW in the points at the bottom level of the rail sole.

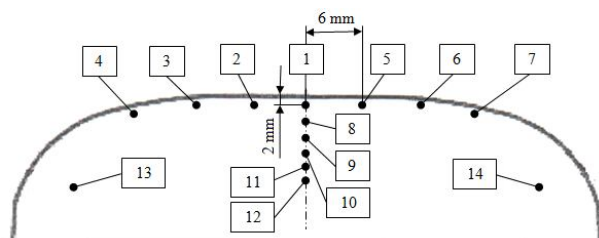
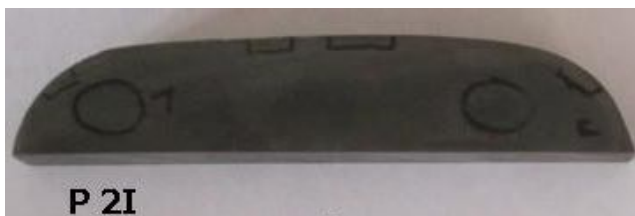
photo no. 15 – the 14 points in which the hardness was determined

In points 1-7 were placed at a distance of 2 mm from the running surface and the distance between two points, in cross plan is of 6 mm. Points 8-12 are placed at a distance of 2 mm from each other and are placed on the axis of symmetry of the rail. Points 13 and 14 are placed in the area from which samples were taken for the test at traction.

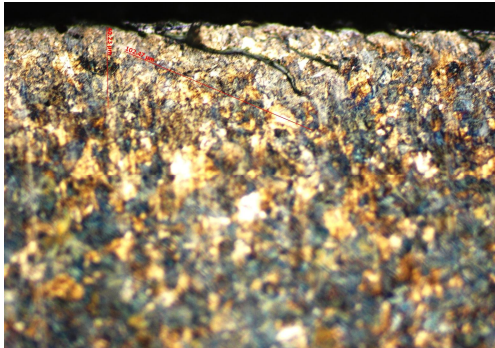
photo no. 26 – (200:1)

For the rail A were found micro-cracks on the depth of 0,040 mm and lengths of 0,102 mm on a harden structural fund, oriented obliquely and parallel to the running surface (photo no. 26), a white layer of thermal hardening with the average thickness of the white layer of 0,021 mm (photo no. 27)

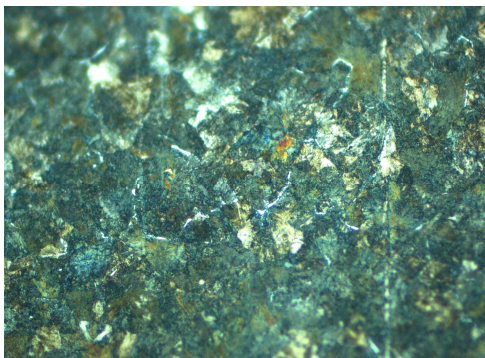
photo no. 28 - 500:1

The structure in the area of thermal treatment is built of signs of interrupted network of ferrite on pearlite fund, which proves an incomplete hardening (photo no. 28) and in the middle of the rail-head the structure is built of lamellar pearlite, placed in rosettes, specific to a material subjected to a normalizing thermal treatment (photo no. 29)

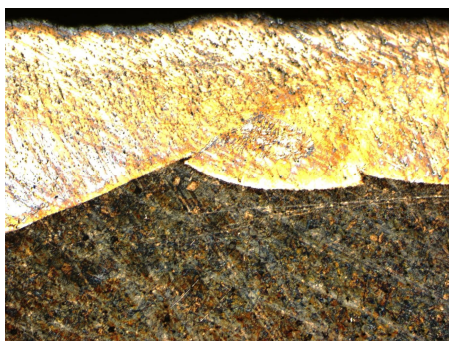
photo no. 30 - 50:1

For the rail B was found at the running surface deposited material successively by welding, with structure made of columnar grains of austenite + interrupted networks of carbides, specific to a manganese austenitic steel (photo no. 30) and immediately under the layer of deposited material, it can be observed a crack approximately perpendicular with the length of 1.065 mm (photo no. 31). The decarbonized edges of the crack prove that:

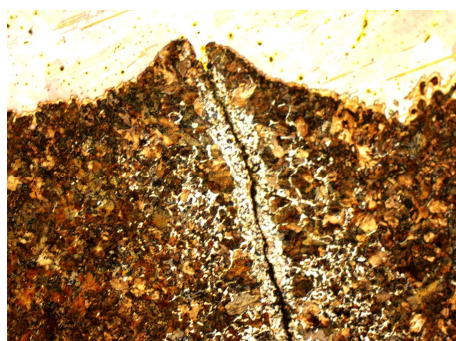
photo no. 31 -100:1

- the crack could occur before the appliance of the superficial thermal treatment;
- the crack could occur before the process of loading with welding.

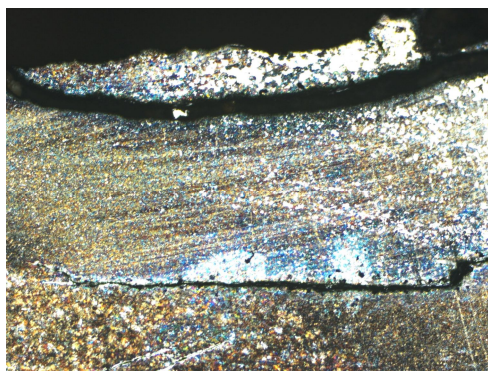
Fig. 34 - 50:1

For the rail C was found at the running surface deposited material successively by welding, with structure made of columnar grains and numerous cracks that cross the deposited material and the areas thermally influenced by welding (photo no. 34). On the rail-head flanks, the decarburization had the average thick of 0.329 mm (photo no. 35).

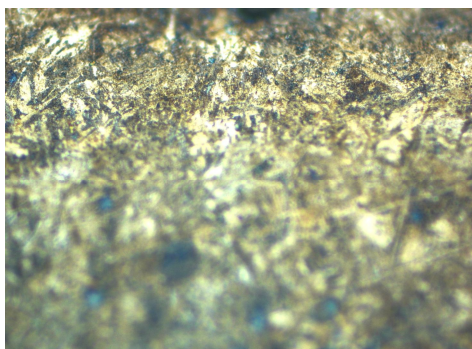
photo no. 38 - 500:1

For the rail D was found at the running surface a slightly hardened structure of sorbitized pearlite, obtained after the thermal treatment of superficial hardening (photo no. 38) and on the rail-head flanks is a slight decarburation with the average thick of 0.300 mm (photo no. 39)

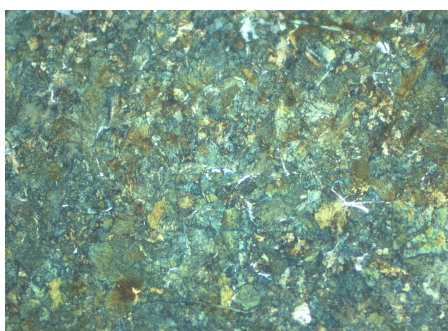
photo no. 40 - 500:1

Towards the center of the rail-head section, the structure consists of signs of interrupted network of ferrite in pearlitic substance, which proves a thermal treatment of incomplete hardening (photo no. 40) and in the middle of the rail-head the structure is built of lamellar pearlite, placed in rosettes, specific to a material subjected to a normalizing thermal treatment (photo no. 41)

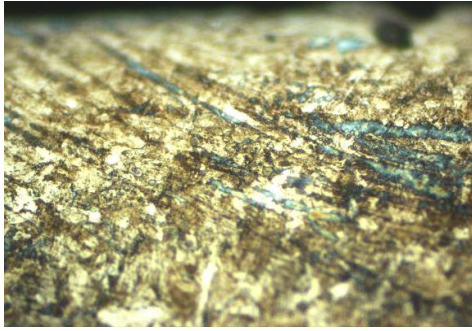
photo no. 42 - 500:1

For the rail E was found on the running surface a pearlite structure strongly hardened (photo no. 42) and thermal cracks, opened obliquely to the rolling surface and in the superficial layer, as consequence of the seizure phenomena and thermal hardening (photo no. 43).

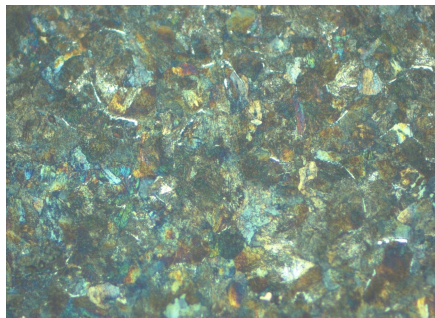
photo no. 44 - 500:1

In the area of superficial thermal treatment the structure consists of signs of interrupted network of ferrite on pearlite and troostite fund, which proves a thermal treatment of incomplete hardening (photo no. 44) and in the middle of the rail-head the structure is built of lamellar pearlite, placed in rosettes, specific to a material subjected to a normalizing thermal treatment (photo no. 45).

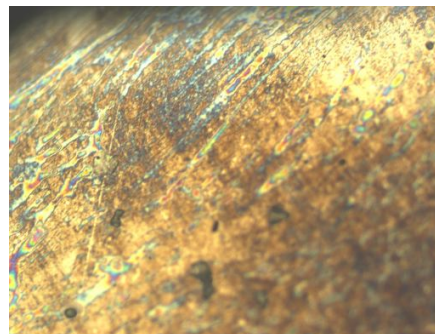
photo no. 46 - 200:1

For the rail F was found on the running surface a pearlite structure strongly hardened, composed of fine martensite, sorbitized pearlite and troostite, specific to thermal treatment of superficial hardening (fig. 46) and in the area of superficial thermal treatment micro-cracks developed at 2 and 4 mm from the rolling surface (fig. 47).

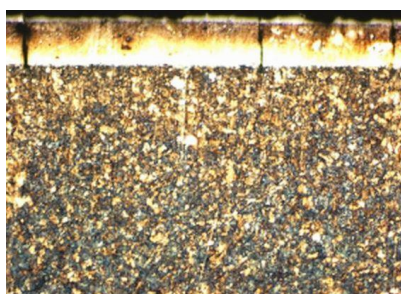
photo no. 48 - 100:1

For the rail G was found at the running surface a double white layer of thermal hardening with the average thick of 0.175 mm (photo no. 48) and immediately under the running surface are thermal micro-cracks with the length of 0.758 mm (photo no. 49)

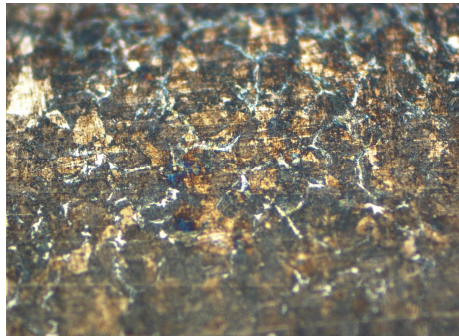
photo no. 50 - 500:1

In the area of superficial thermal treatment the structure consists of signs of interrupted network of ferrite on pearlite fund and rare rosettes of troostite, which proves a thermal treatment of incomplete hardening (photo no. 50), in the middle of the rail-head the structure is made of lamellar pearlite, ordered in rosettes, specific to a material subjected to a normalizing thermal treatment (photo no. 51).

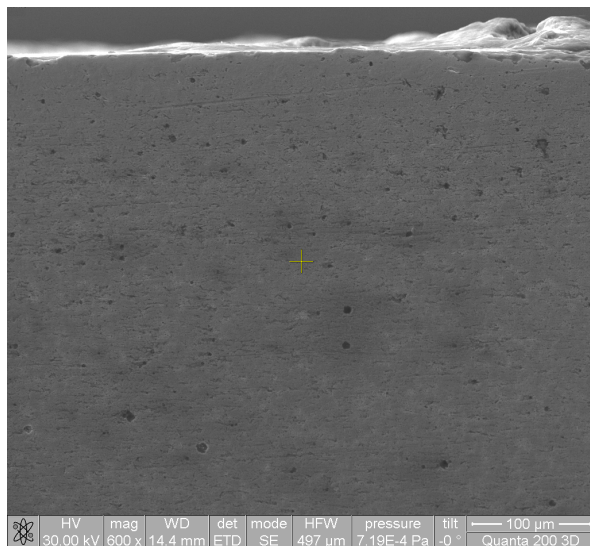
a) Area A – the rolling surface of the rail, being prepared microstructures for zooming powers of 600x, 5000x and 10000x, resulting photo no. 55, 56 and 57. It is noticed that along the rolling surface of the rail was observed a combination of black portions, with oxidized areas and small cavities in the material

photo no. 55. Area A. Microstructure of the rolling surface (600x)

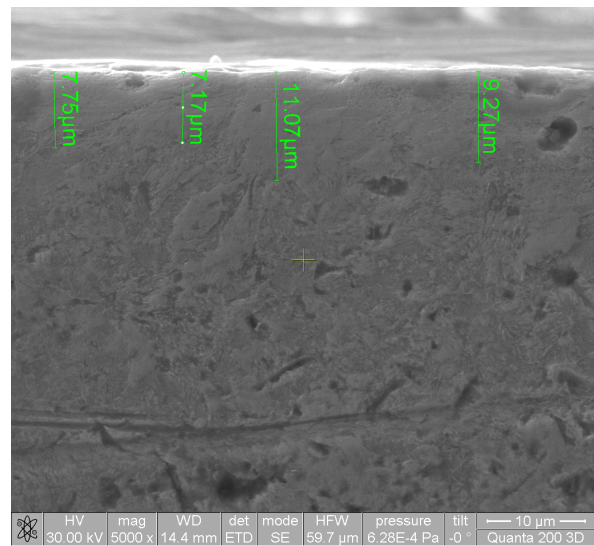
photo no. 56. Area A. Microstructure of the rolling surface (5000x). Thickness of the hardened layer

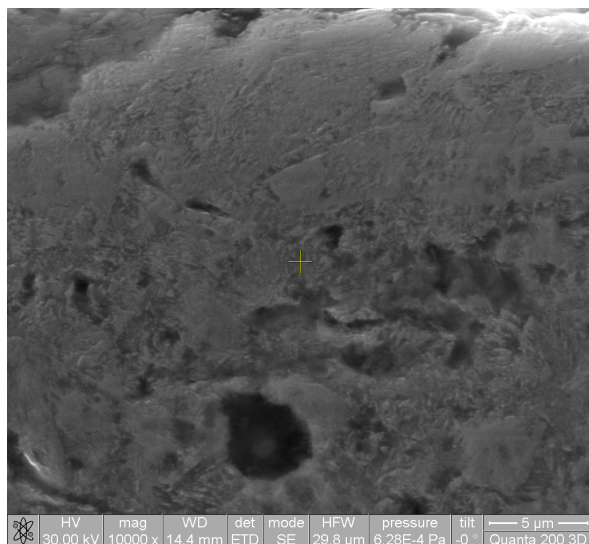
photo no. 57. Area A. Microstructure of the rolling surface (10000x)

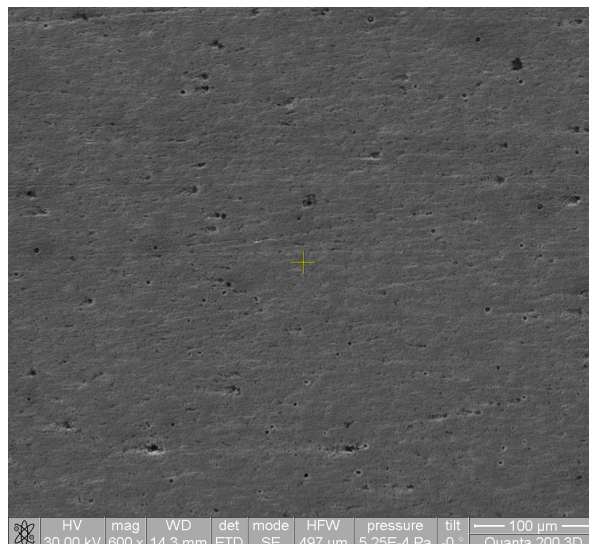
b) Area B – the core (the rail depth), being prepared microstructures for zooming powers of 600x, 5000x and 10000x, resulting photo no. 58, 59 and 60. It is observed a pearlite structure.

photo no. 58. Area B. Microstructure of the core (600x)

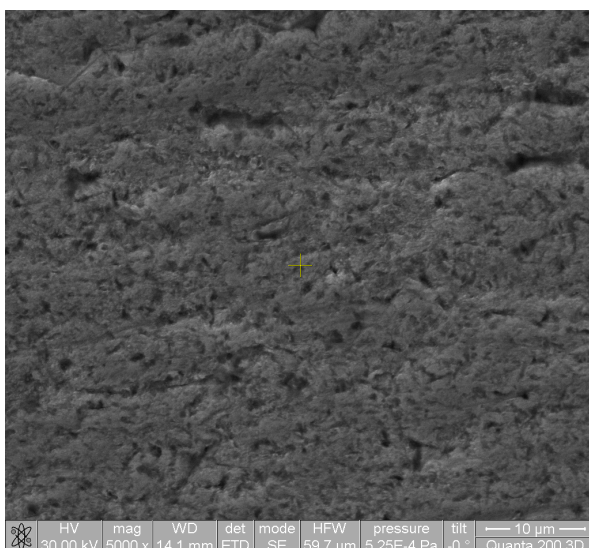
photo no. 59. Area B. Pearlite microstructure of the core (5000x)

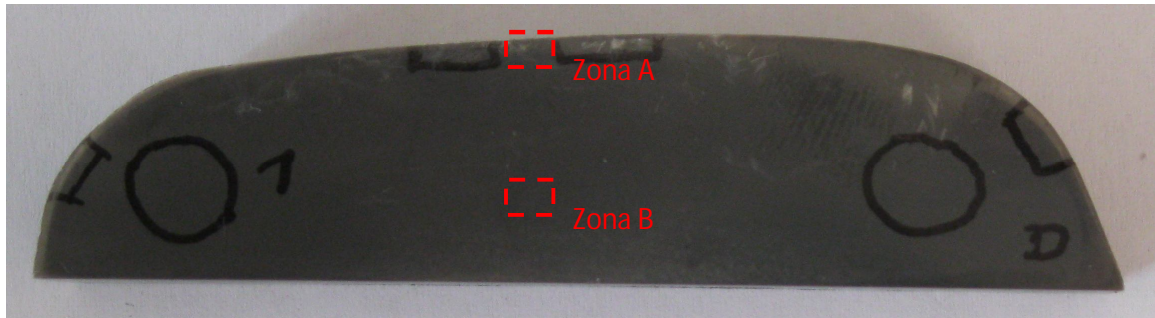
photo no. 63. Sample taken from the coupon 2 II 1989

There were analyzed 2 areas of the vertical section through the rail-head – photo no. 63.

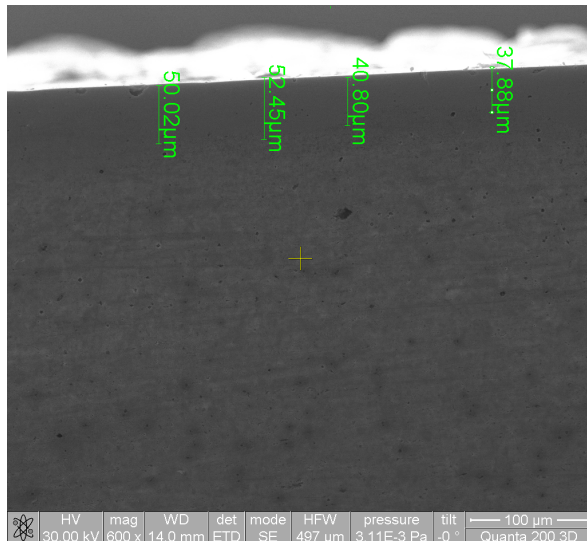
a) Area A – the rolling surface of the rail, being prepared microstructures for zooming powers of 600x, 2400x, 5000x and 10000x, resulting photo no. 64 and no. 65. It is noticed that the thickness of the hardened layer (with martensite structure) varies between 44 and 51 μm .

photo no. 64. Area A. Microstructure of the rolling surface (600x). Thickness of the hardened layer

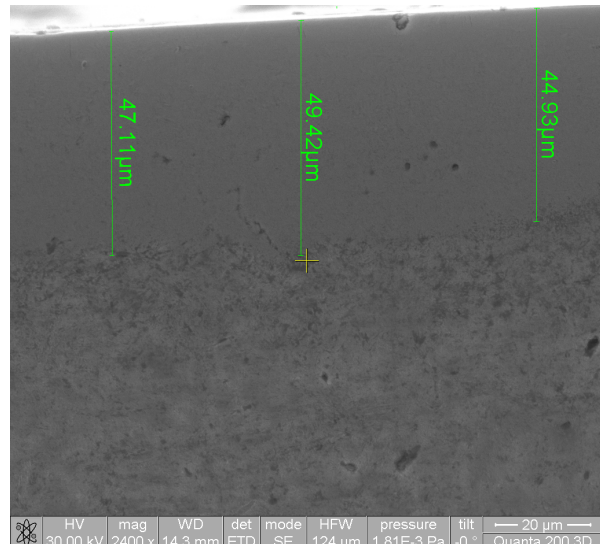
photo no. 65. Area A. Microstructure of the rolling surface (2400x). Thickness of the hardened layer

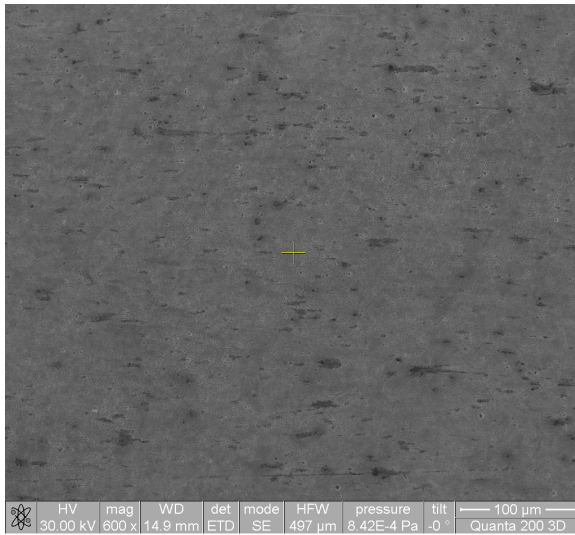
b) Area B – the core (the rail depth), being prepared microstructures for zooming powers of 600x, 5000x and 10000x, resulting photo no. 66 and no. 67. It is observed a pearlite structure.

photo no. 66. Area B. Microstructure of the core (600x)

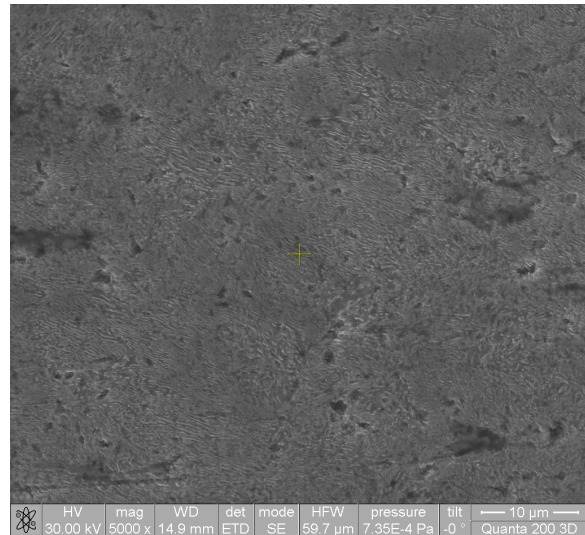
photo no. 67. Area B. Pearlite microstructure of the core (5000x)

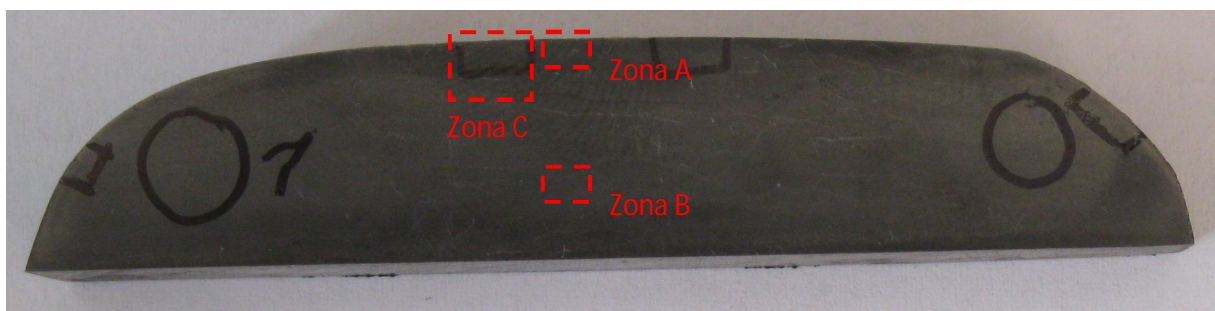
Fig. 68. Sample taken from the coupon 2 III 1990

There were analyzed 3 areas of the vertical section through the rail-head – photo no. 68.

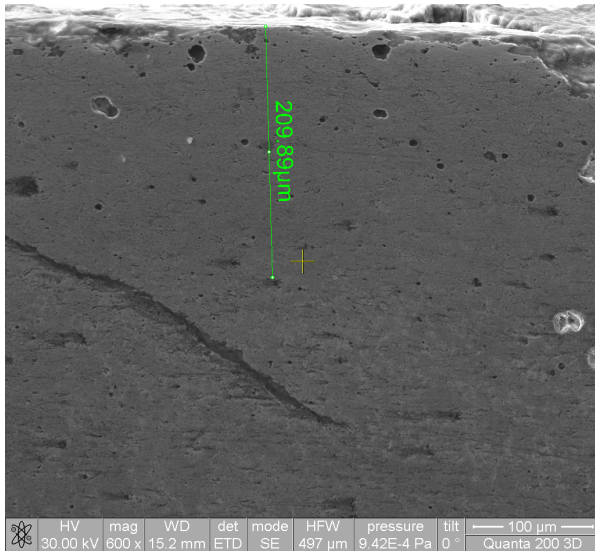
- a) Area A – the rolling surface of the rail, being performed microstructures for zooming powers of 600x, 5000x and 10000x, resulting photo no. 69 and no. 70. It is noticed that the thickness of the hardened layer (with martensitic structure) varies between 200 and 210 μm . It is also noticed the presence in the hardened layer of a superior layer having the thickness of 12.21 μm .
- b) Area B – the core (the rail depth), being performed microstructures for zooming powers of 600x, 5000x and 10000x, resulting photo no. 71 and no. 72. It is observed a pearlite structure.
- c) Area C – the crack, being performed microstructures for zooming powers of 38x, 600x and 5000x, resulting photo no. 73 and no. 74. In photo no. 73 is observed the distance from the rail surface to the maximum depth of the crack (3.39 mm).

photo no. 69. Area A. Microstructure of the rolling surface (600x). Thickness of the hardened layer

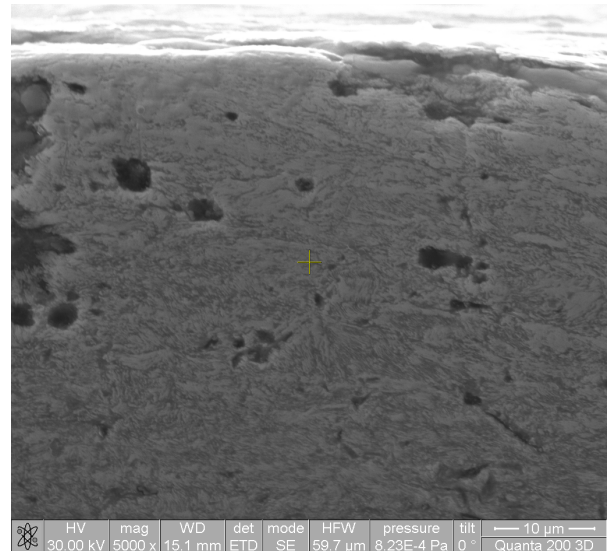
photo no. 70. Area A. Microstructure of the rolling surface (5000x).

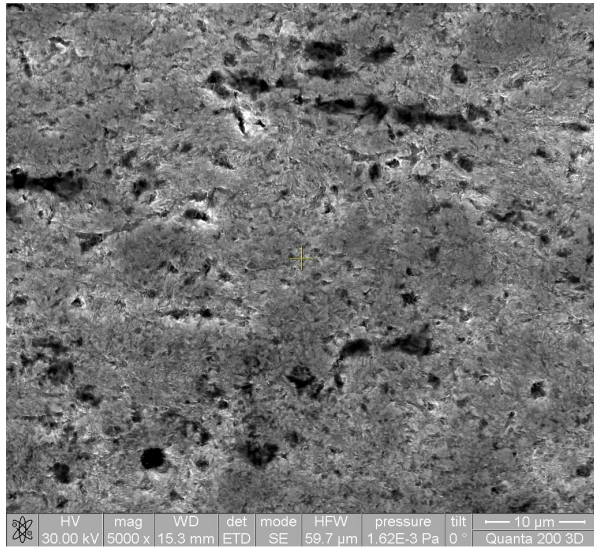
photo no. 71. Area B. Pearlite microstructure of the core (5000x)

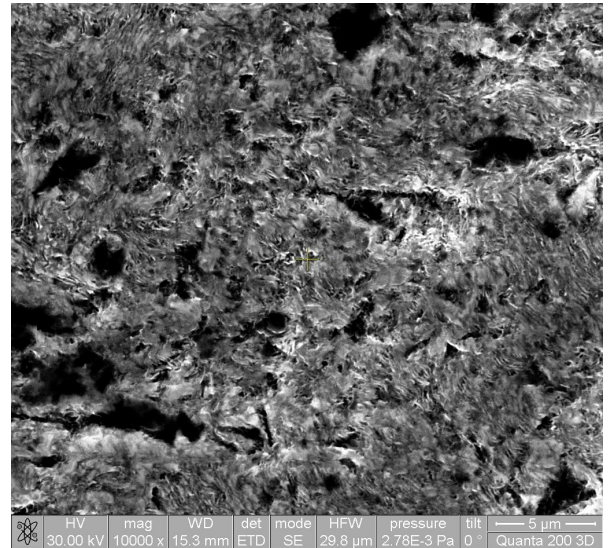
photo no. 72. Area B. Pearlite microstructure of the core (10000x)

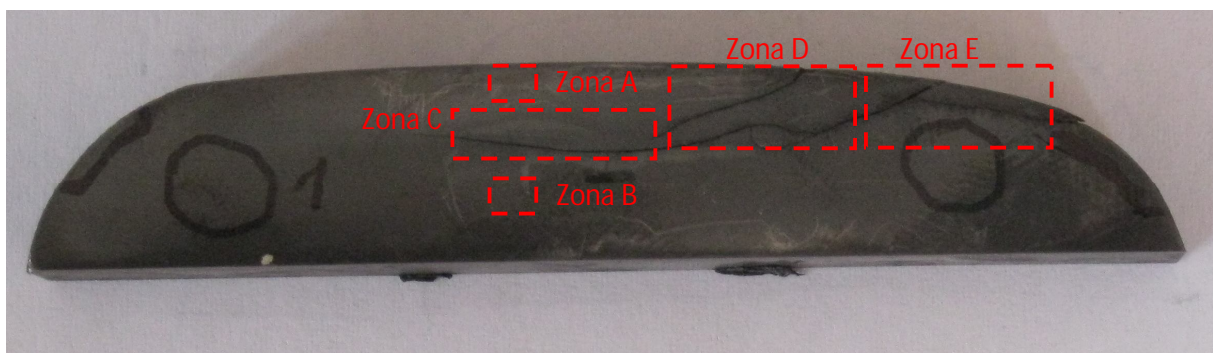
photo no.75. Sample taken from the coupon 1 IV 1989

There were analyzed 3 areas of the vertical section through the rail-head – photo no.75.

The cracks on the samples 2 I 1990, 2 III 1990 and especially those on the sample 1 IV 1989 may lead in time, due to operation, to flaking or breaking of the rails.

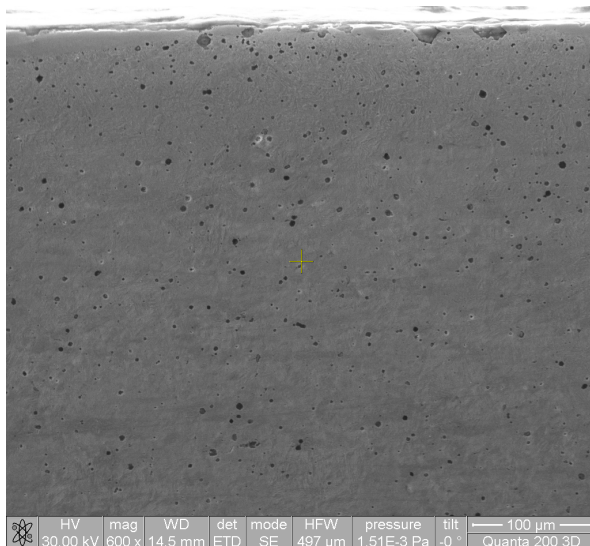
a) Area A – the rolling surface of the rail, being performed microstructures for zooming powers of 600x (two images), 5000x and 10000x, resulting photo no. 76 and no. 77. It is notices that the thickness of the hardened layer (with martensitic structure) varies between 20 and 35 μm .

photo no. 76. Area A. Microstructure of the rolling surface (600x)

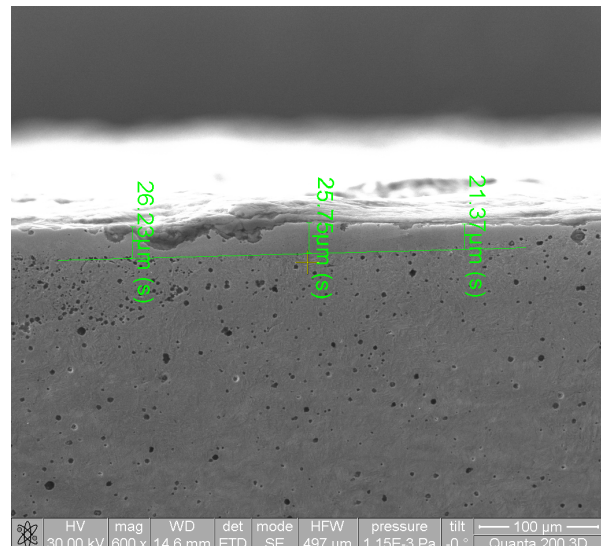
photo no. 77. Area A. Microstructure of the rolling surface (600x). Thickness of the hardened layer

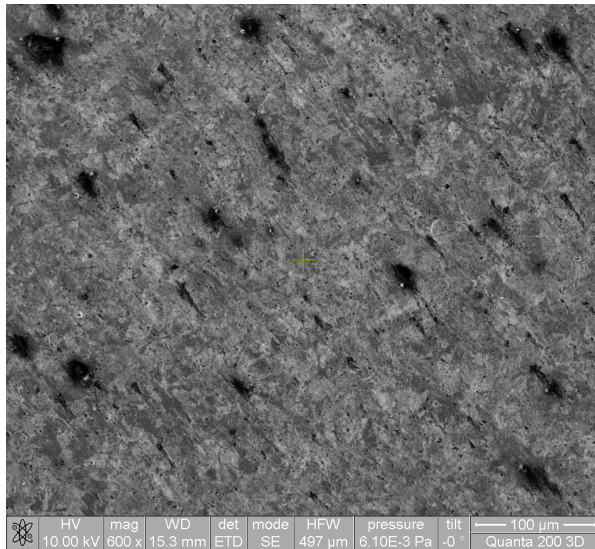
b) Area B – the core (the rail depth), being performed microstructures for zooming powers of 600x, 5000x and 10000x, resulting photo no. 78 and no. 79. It is observed a classic fine pearlite-ferrite stricture, characteristic to eutectic steel.

photo no. 78. Area B. Microstructure of the core (600x)

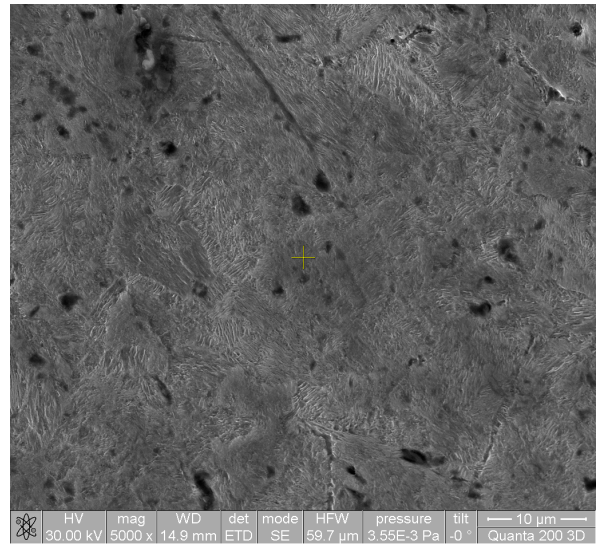
photo no. 79. Area B. Pearlite microstructure of the core (5000x)
