INVESTIGATING REPORT

on the railway accident occurred on the 27th of September 2010 on the range of activity of CF
Brasov Regional Branch between the railway station CFR Miercurea Ciuc – Hm CFR Sanraieni

FINAL EDITION
Date: the 4th of February 2011

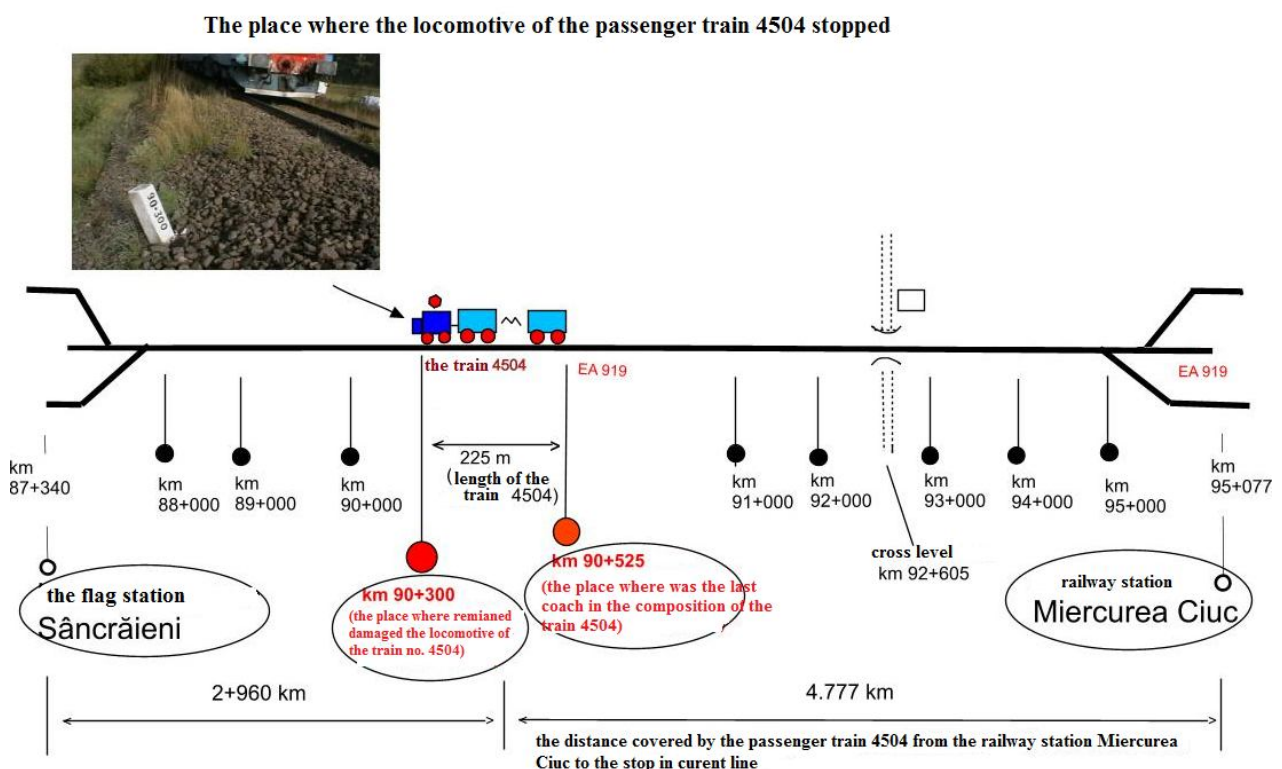
From the railway station CFR Miercurea Ciuc the passenger train no. 4504 ran on the distance Miercurea Ciuc – Sanraieni, and at km 90 + 300 (km. position next to the locomotive), after running 4 + 777 km., at 7:04a.m., it stopped due to a failure of the graduator of the locomotive EA 40-0198-8.

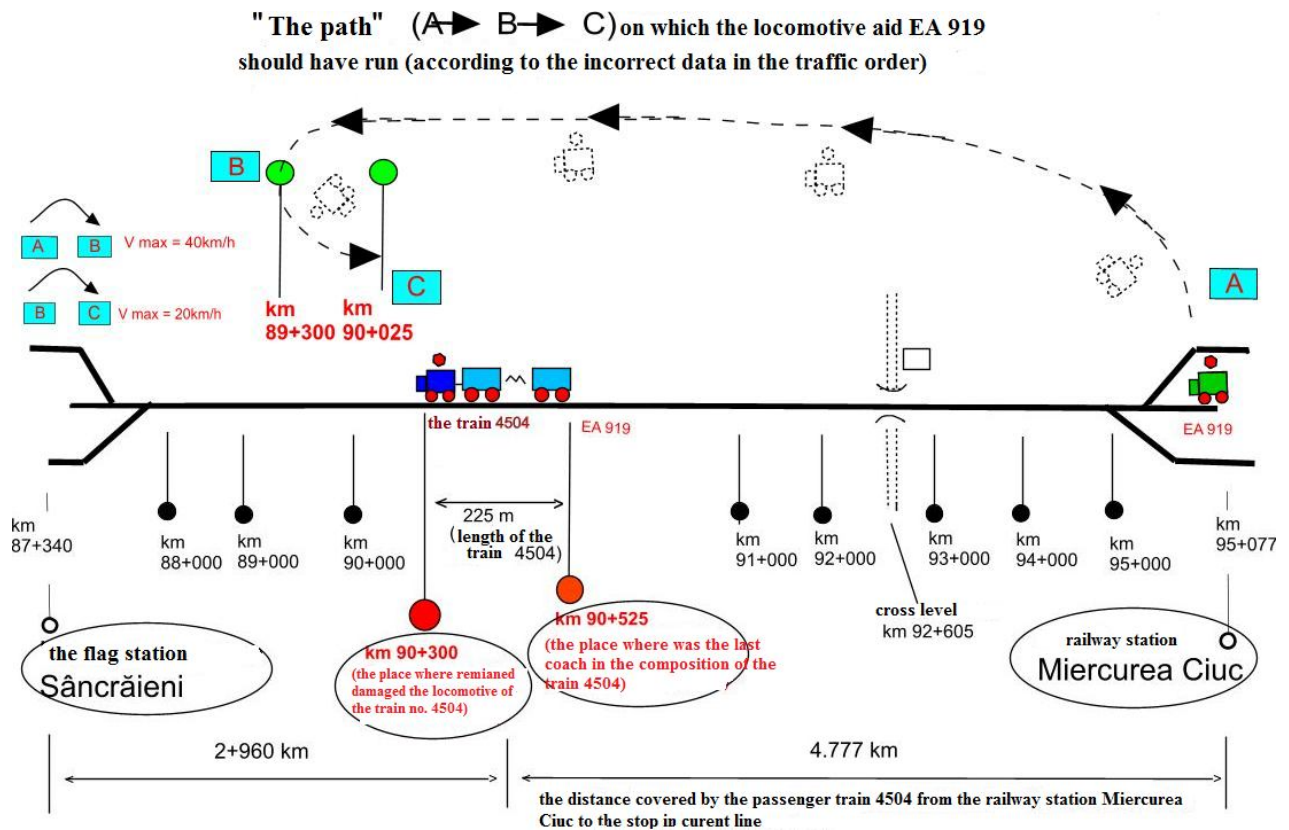
The locomotive aid EA 40-0919-7 ran between the railway station CFR Miercurea Ciuc and the place where was stopped in current line the passenger train no. 4504, with speeds within 17 and 40 km/h, and around 7:44'02" a.m., at a speed of 23 km/h collided the last coach in the composition of the train no. 4504.
