MINISTRY OF TRANSPORTS AND INFRASTRUCTURE
ROMANIAN RAILWAY AUTHORITY - AFER

ROMANIAN RAILWAY INVESTIGATING BODY

INVESTIGATING REPORT

on the fire occurred on the 25th of May 2011, on the range of CF Constanta Regional Branch, between the railway stations CFR Navodari – Constanta Marfuri, at the locomotive DA 60 – 1528 (belonging to SC Grup Feroviar Roman SA Bucharest) in the composition of the train no. 79156

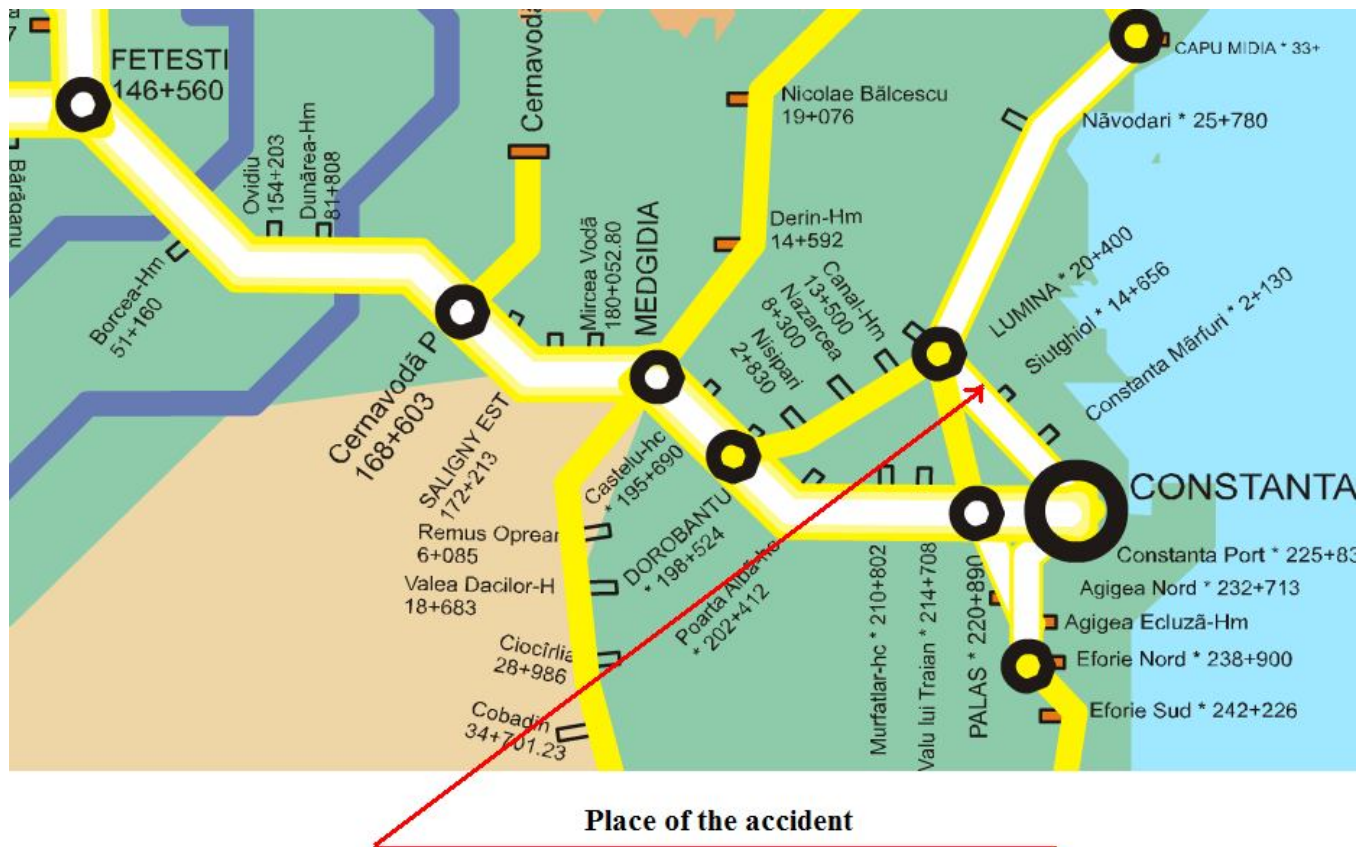
On the 25th of May 2011, the train no. 79156, composed of the locomotive DA 1528 in head (driven/served in complete team belonging to SC Grup Feroviar Roman SA Bucharest) and DA 1562 towed (served by locomotive driver belonging to SC Grup Feroviar Roman SA Bucharest) was running on the running section Capu Midia – Palas, between the railway stations CFR Navodari - Constanta Marfuri (km. 16+500).
