## INVESTIGATING REPORT

on the fire occurred at the locomotive DHC 80-0172-9  
belonging to SNTFC “CFR Calatori” SA,  
in the running of the train no. 17360 on the 8<sup>th</sup> of September 2010,  
on the non-interoperable running section Oravita – Berzovia (km. 45+700)

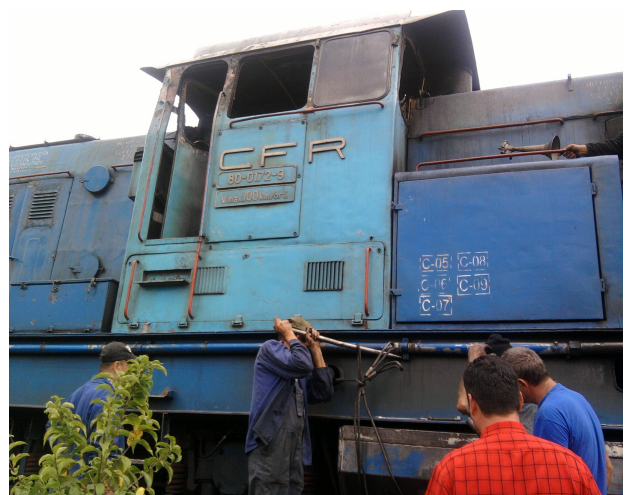
From the thermal effect of the fire in the area on the main tank on the left in the running direction, there was an overpressure in the tank followed by the upper surface deformation and breaking its two tank mounting bolts on the main strut and the crack in the tank sides joining areas (two cracks in the upper side of the tank and one at its bottom), which led to entire quantity of oil leaking from the tank, to axle no. 3, on the left side of the locomotive.

To fit to the dimensional quotas set for the locomotive CFR gauge, it was necessary to insure the main tank through the intervention of a team belonging to Timisoara Locomotives Repairs Department from Locomotives Repairs Company “CFR SCRL” Brasov.
