## **INVESTIGATING REPORT**

on the railway accident occurred on the 9<sup>th</sup> of July 2011,  
on the range of activity of CF Iasi Regional Branch  
between the railway station Podu Iloaie and the flag station Sarca

Final EDITION  
*The 5<sup>th</sup> of September 2011*

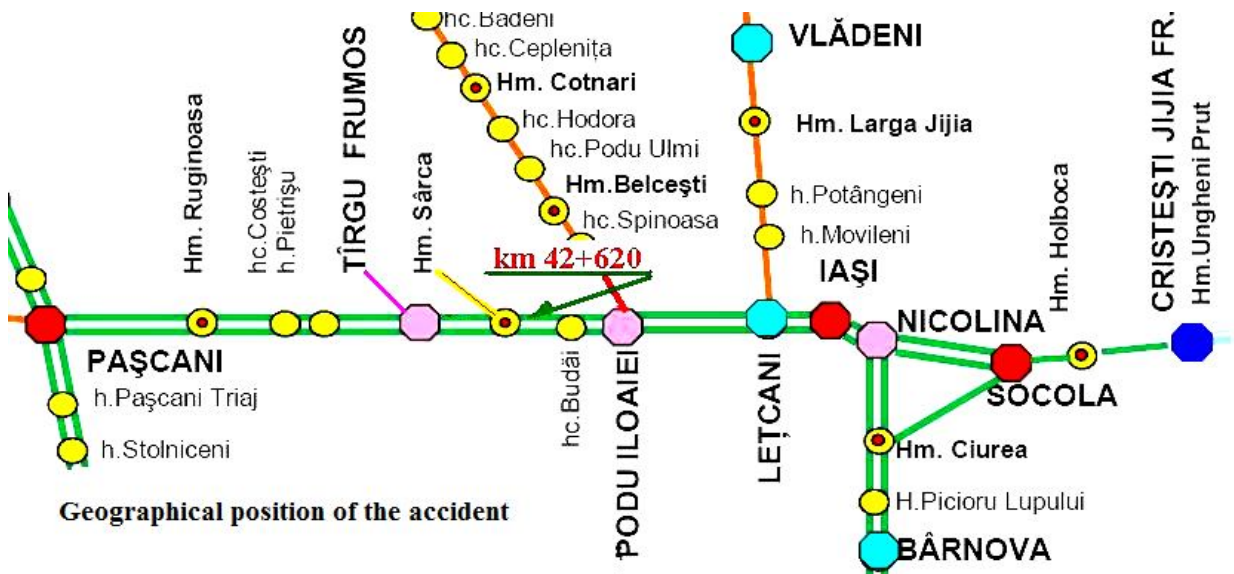
Running on the current line I, towards the flag station Sarca, at the km 42+620 occurred the derailment, by both axles, of the last bogie, of the last but one wagon (in the running direction), this running derailed till it stopped at the km 42+210.

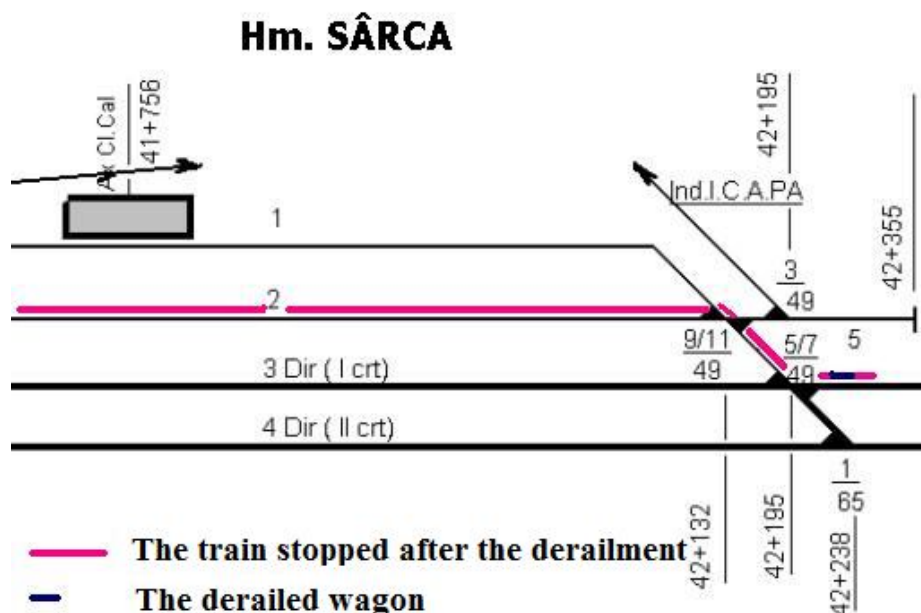
**Drawing hm Sarca, X end**

The derailed bogie was stopped at the km 42+210, at 2 m from the shunting signal M 3 of hm Sarca and at 10 m from the first joint of the double-junction crossing 5/7 from the X end of the flag station.

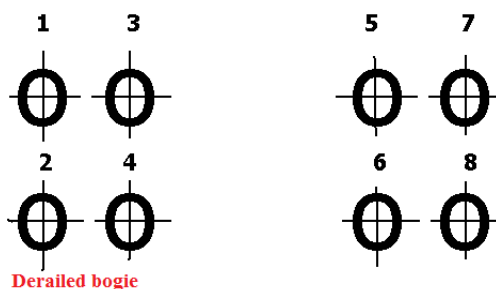
- at the involved wagon were performed measurements in 3 steps that aimed to establish in a first stage the running conditions from the hm Sarca to the railway station CF Pascani and in a second to observe the deformation degree of the derailed bogie, of the chassis and of the wagon box.

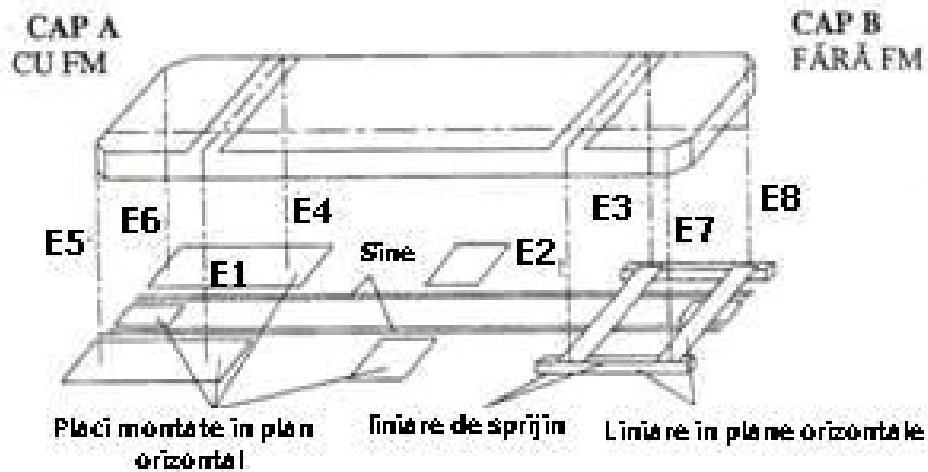
- *measurements of the chassis twisting*

- $q_l$  - chassis twisting at the side struts level  
 $q_l = (E1 - E4) - (E2 - E3)$
- $q_c$  - chassis twisting at the consoles level  
 Head A:  $q_{c1} = (E5 - E6) - (E1 - E4)$   
 Head B:  $q_{c2} = (E2 - E3) - (E7 - E8)$
- $q_t$  - chassis twisting at the front sleepers ends level  
 $q_t = (E5 - E6) - (E7 - E8)$
