INVESTIGATING REPORT

on the fire occurred at the locomotive **DA 60-0945-0**
owned by SNTFM “CFR Marfa” SA, in the running of the train no. 83972,
on the current line Targusor Dobrogea-Nicolae Balcescu (km 31+000),
on the 23th of August 2010

Final EDITION

The 19th of January 2011

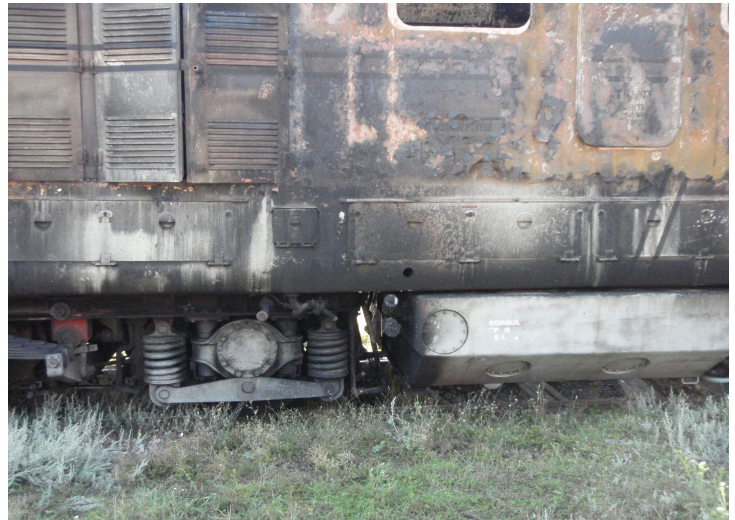
Photo. 10

Fuel tanks condition

- the afferent fuel lines were intact, thermal affected, without traces of recent intervention;
- the main fuel tank wasn't deformed by the overpressure created by the oil heating, with only slight traces thermal influence (photo. 10);
- the hydrostatic installation tank empty with the flexible connections type Argus burned;
