Accident Investigation Report

Collision between trains

at Hordorf crossover

Bonn, 14 September 2011

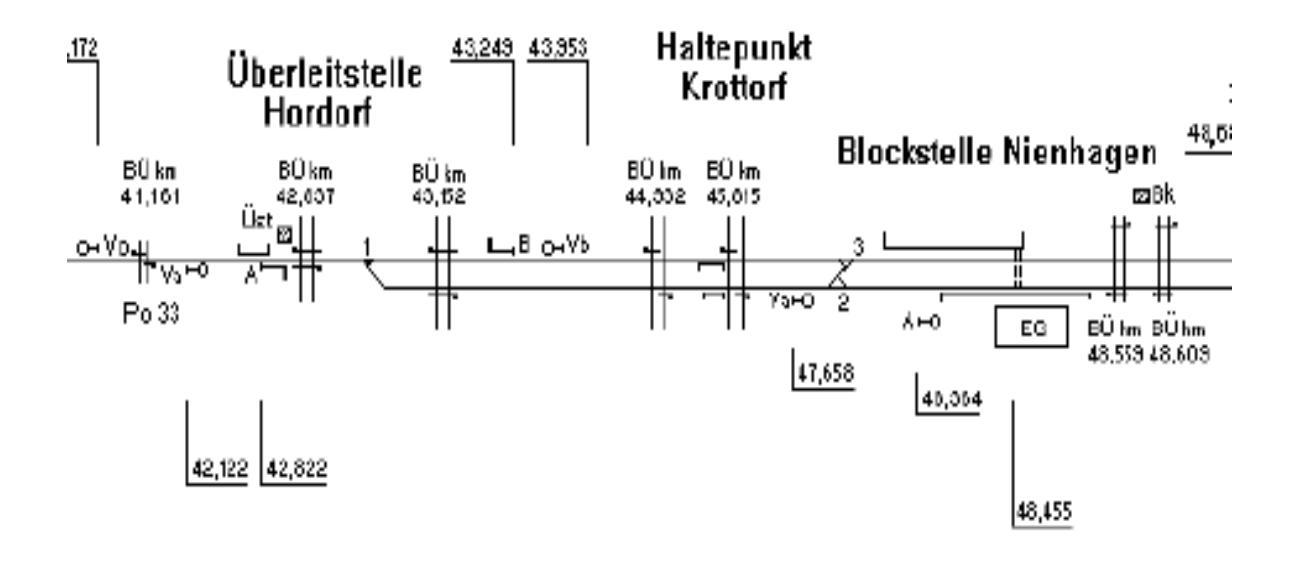
Figure 1: Outline situation plan

At approximately 22:28 on 29 January 2011, a frontal collision between freight train DGS 69192 proceeding towards Oschersleben and passenger train DPN 80876 proceeding towards Halberstadt occurred at the Hordorf crossover at kilometre 42.702. At that point, the Magdeburg – Halberstadt line (line No 6404) is single.
