Investigation Report No. R2010 – 004

**Malahide Viaduct Collapse on the Dublin to Belfast Line,
on the 21st August 2009**

Title	Malahide Viaduct Collapse on the Dublin to Belfast Line on the 21 st August 2009
Document type	Investigation Report
Document number	R2010 – 004
Document issue date	16/08/2010

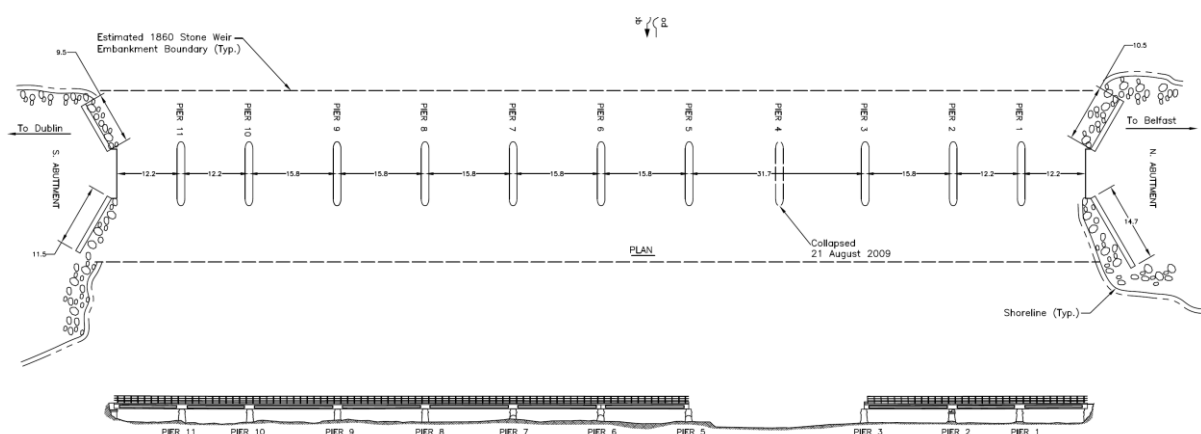
Figure 6 – Plan and elevation illustrating pier numbering

For the purposes of this report, the numbering of the piers begins at Pier 1 at the Belfast end (north end) and increased numerically to the Dublin end (south end), (see Figure 6). It should however be noted that historically the IÉ numbering system is the reverse, with Pier 1 at the Dublin end and increasing numerically to the Belfast end. Other historical documents may also use this convention.

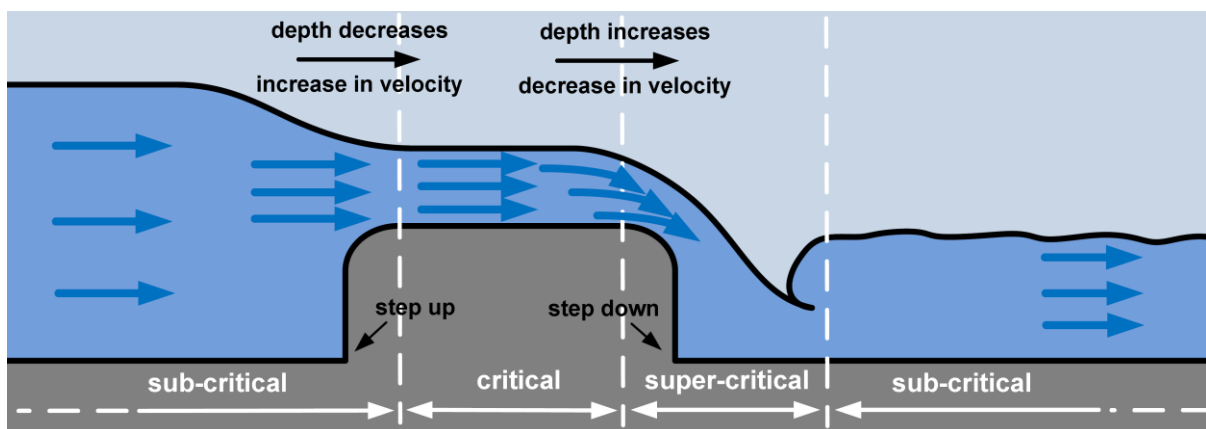
Figure 8 – Increase in velocity as a result of the water flowing over the weir

For sub-critical flow, the weir acts as a step up from the bed of the estuary. This water level drop (depth decrease) resulting from the step up reduces the flow area through the viaduct, causing a drop in pressure, which in turn increases the velocity of the flow of water as the *kinetic energy* increases (see Figure 8), thus increasing scour potential.

For super-critical flow, the weir acts as a step down. This water level increase (depth increase) from the step down increases the flow area, causing an increase in pressure which in turn decreases the velocity of the water flow (see Figure 8).

For sub-critical flow to convert to super-critical flow, the flow must go through critical flow (see Figure 8).

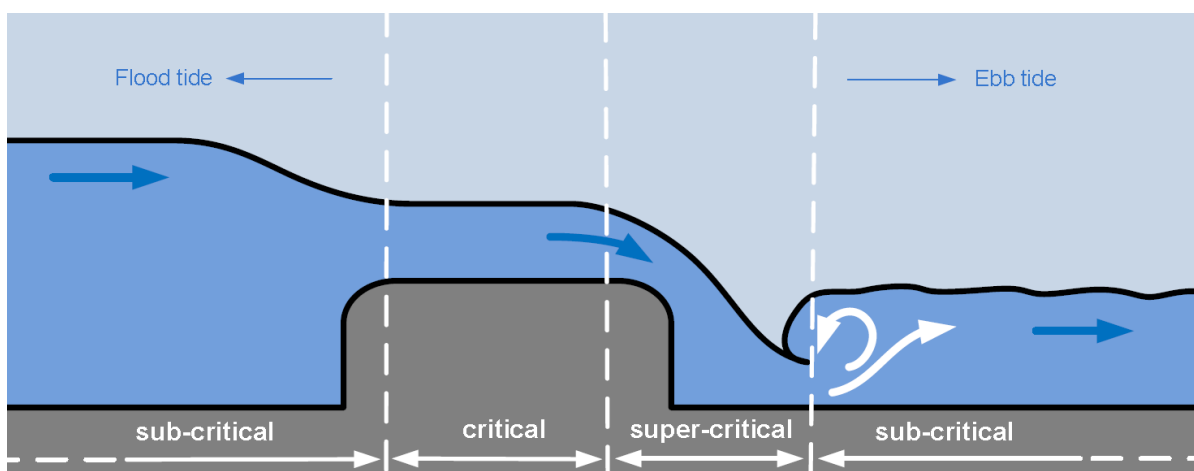
Figure 9 – Water flow over a weir

When the initial flow goes from sub-critical to super-critical, it does so smoothly as the water surface curves rapidly but smoothly through the critical flow. The change from sub-critical to super-critical is not so smooth. Hydraulic jump occurs as the depth of water increases abruptly due to downstream boundary condition, which causes a vigorous turbulent mixing action (see Figure 9).

As illustrated above, when the water level drops the flow of water (over the weir, through the viaduct) increases in velocity. There is an additional drop as the viaduct structure itself causes the water level to drop further as a result of the reduced width of the estuary exit, further increasing the velocity through the viaduct.

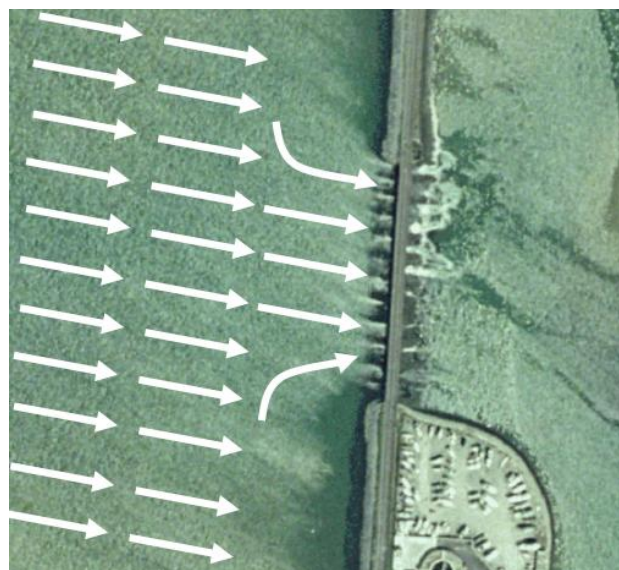
Photograph 7 – Even flows through all twelve spans (during ebb flow)

The viaduct construction allowed for even flows through all twelve spans of the viaduct (see Photograph 7).

Lift forces on the piers are most likely to have been negligible at the time of the collapse due to the good alignment of flow under the structure (see Photograph 7). Drag and lift forces though are likely to have been contributory to the gradual collapse of the weir.

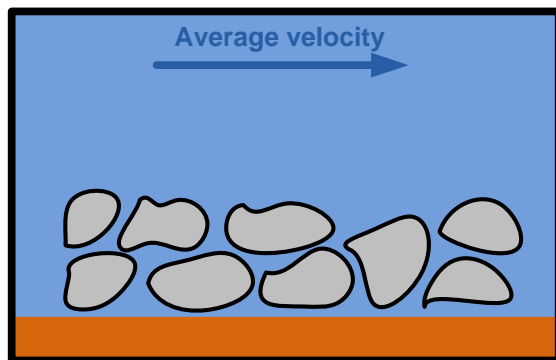
Figure 10 – Stable cobbles during average velocities

The 2-D 1:40 laboratory moveable model was created to simulate the sediment transport between the piers for the Broadmeadow estuary level (west), at 2.7m, 2.0m and 1.5m OD. Simulated 300 – 400mm stones were placed along the full length of the simulated pier. The model showed that these stones were unstable and moved even when slightly dislodged, suggesting that the stones were close to the *threshold of movement* when velocities are high, as occur during high ebb tides, Figures 10 and 11 illustrate this movement. The velocity measurements were taken from the model and scaled up to give prototype velocities ranging from 3.48m/s to 4.9m/s.

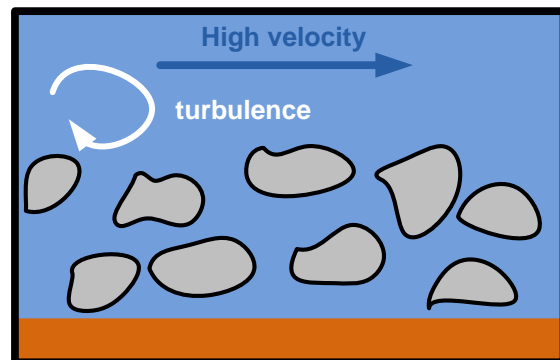
Figure 11 – Unstable and moving cobbles during turbulence caused by high velocities

This movement of stones, simulated over a period of many years, resulted in the material being eroded from the crest of the weir; this process is generally referred to as *winnowing*. This erosion resulted in the weir's profile changing over the years from the original weir profile, illustrated in Figure 7, to a more elongated weir on the eastern side, illustrated in Figure 12.

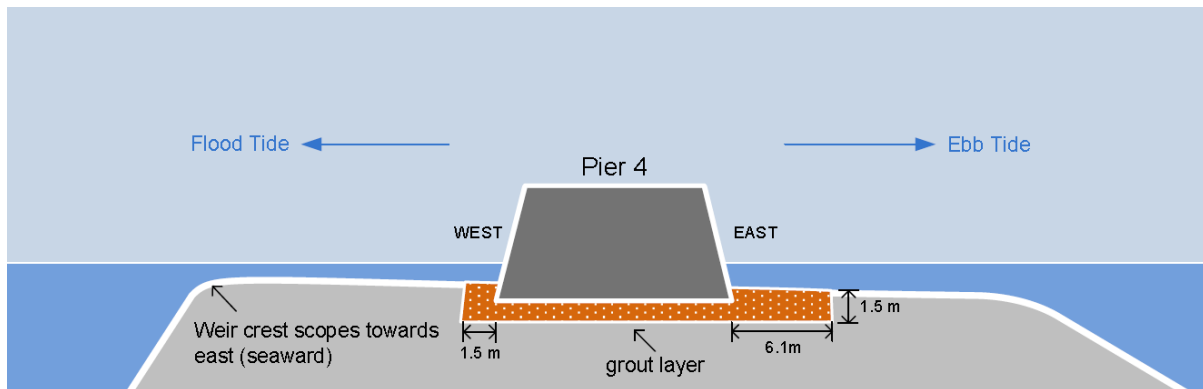
Figure 13 – Grout layer (grouted rock armour) inserted in 1967 – 1968

ICE Session 68-9 records that the weir crest was *grouted* in 1967 and 1968, in an attempt to stabilise for a period the weir; this formed a grouted rock armour extending approximately two metres in depth (see Figure 13). The Malahide Viaduct article in ICE Session 68-9 Volume 95, noted that “the surface of the stone ‘weir’ varied from crest level to the west side sloping steeply to about 100 feet (30m) out from the pier on the seaward side.”, (see Figure 13).

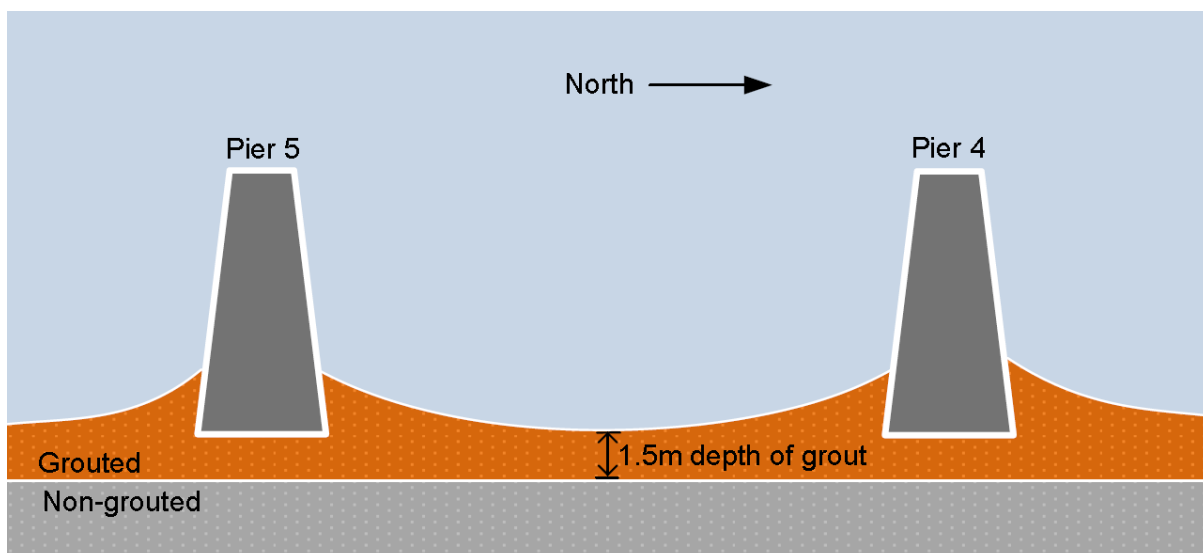
Figure 14 – Elevation illustrating the dipped profile between the piers

The Malahide Viaduct article in ICE Session 68-9 Volume 95, also noted, in relation to the grouting scheme, that “the general longitudinal profile dipped between piers to concentrate the main flow away from the piers while providing optimum protection to the piers foundations”. These features were retained for the grouting (see Figure 14).

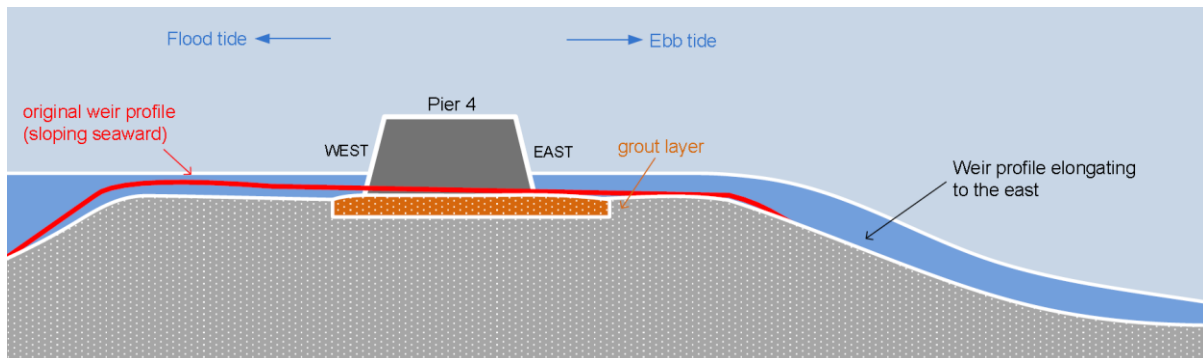
Figure 15 – Weir profile remains elongated to the east, with the grout layer (rock armour) stabilising the scouring

The stabilisation by the grouted rock armour was proved successful by the absence of observed scouring or potholing after the storms in February 1969, and the elongated profile on the east remained, (see Figure 15).

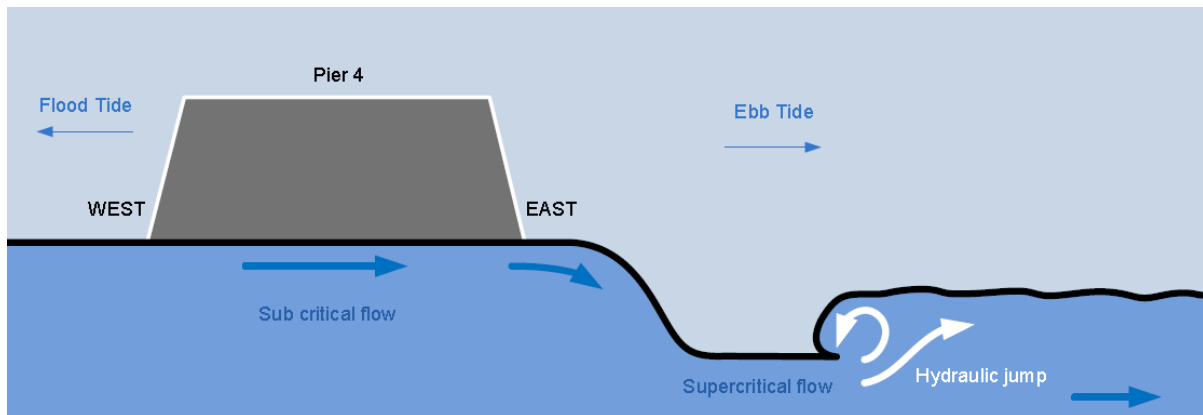
Figure 17 – Malahide viaduct original hydraulic jump

Referring back to Figure 8, the hydraulic jump should be downstream of the weir, a safe distance from the bridge pier foundations. This is also illustrated in Figure 17 for what should happen at Malahide Viaduct.

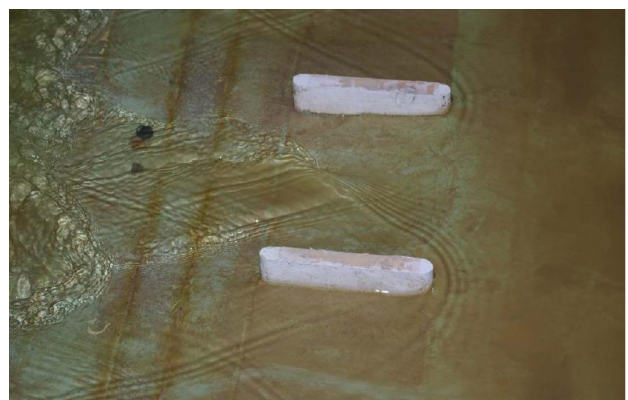
Photograph 8 – 3-D model of movement of hydraulic jump

However, the 3-D 1:80, simulating the high spring *ebb tide* flowrate, showed that when the tide reached certain critical levels on the eastern side, a hydraulic jump formed between Pier 4 and Pier 5, the location of the collapsed pier (see Figure 18 and Photograph 8). Velocity measurements were taken from the model at the mid-point of the pier to the downstream side of the weir. These measurements were recorded in the model and scaled to the prototype giving values in the range of 4m/s to 5.5m/s.

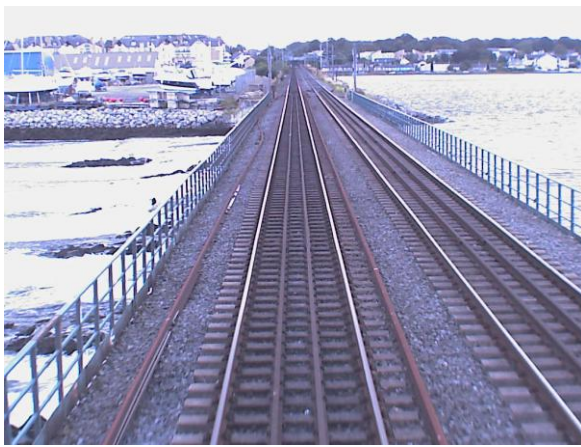
Photograph 13 – TRV still towards Dublin

IE's track and structures inspection requirements standard, Track and Structures Inspection Requirements, I-PWY-1107, states that the *Track Recording Vehicle (TRV)* has a six monthly track inspection rate. The TRV has travelled over the Malahide viaduct eight times, in each direction, since its first run in May 2007. The last run on the viaduct (both directions) was the 20th August 2009, the day before the collapse, at which time it recorded the track to be in a good condition (i.e. no defects were found and no significant changes in the vertical and horizontal *alignment*, *cross level* or *twist* which would have indicated that the viaduct was close to failure were recorded for the run or in any of the previous eight runs). Still photographs from the TRV video taken on the day before the collapse are illustrated below in Photographs 13 and 14.

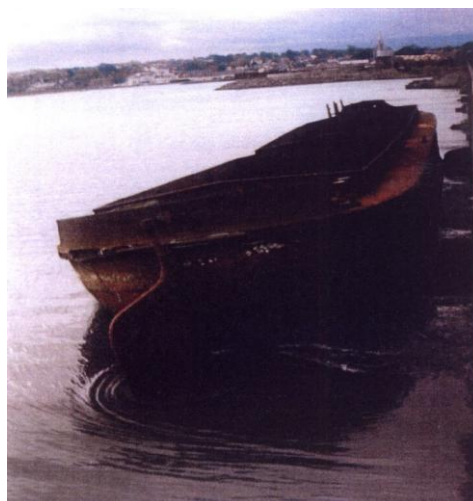
Photograph 17 – Derelict barge

In 1982 a derelict barge, approximately 27m long, was abandoned against the seaward side of the Malahide Viaduct, (see Photograph 17). The barge was lodged against Piers 5, 6, 7, and at certain tides, the barge rubbed against these piers.

- The pointing was generally in “okay condition”;
- Scouring and undercutting can be “found on a few piers where rock armour and concrete have been washed away”;
- “Underwash and undermining of concrete pour due to hole and tidal flow” at Pier 7;
- The inspection diver concludes that the rock armour is “too light for the job it is to do”;
- The rock armour grout has diminished by approximately 80% on the west side of the Malahide Viaduct and 70% on the east side;
- Evidence of cracking and *spalling* of the concrete deck;
- “Scouring starting at the base” of Pier 4 (the Pier which collapsed);
- Debris (twisted metal and old railway sleepers) recorded between Piers 4 and 5.

In 1997, IÉ were granted permission to remove the barge, and in the same year hired North East Diving Services to remove the barge.
