## **INVESTIGATION REPORT**

**Fog signal activation in DART driving cab,  
Bray, 6<sup>th</sup> March 2012**

**RAIU Report No: R2013 – 003**

**Published: 19/09/2013**

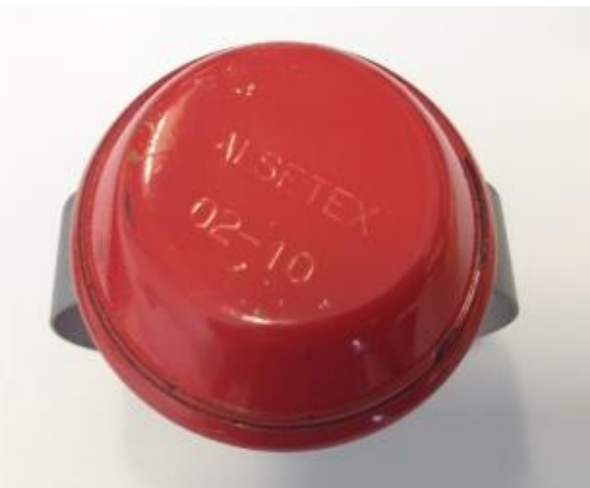
Figure 5 – Alsetex branded fog signal

During the investigation it was found that the fog signal supplier had changed the fog signals supplied to Iarnród Éireann to a less robust fog signal. Iarnród Éireann had not been notified of this change and had not noticed the difference in fog signals until after the accident.

- 40 Eleven of the twelve fog signals exploded. The eleven exploded fog signals were marked as 'Irish Rail Alsetex' while the remaining unexploded fog signal was marked 'Irish Rail Lacroix'. The Lacroix fog signal was out of date at the time of the explosion; the date on the case was 01-06 (indicating this was the first batch of 2006), meaning that it should have been replaced five years later, in January 2011.
- 41 An examination of the carrying tube revealed that the majority of its down facing edge had been burnt in the explosion; also the fog signals at the bottom of the tube had rubber burnt onto its surface, see Figure 20; and the rim of the tube was burnt, Figure 21.

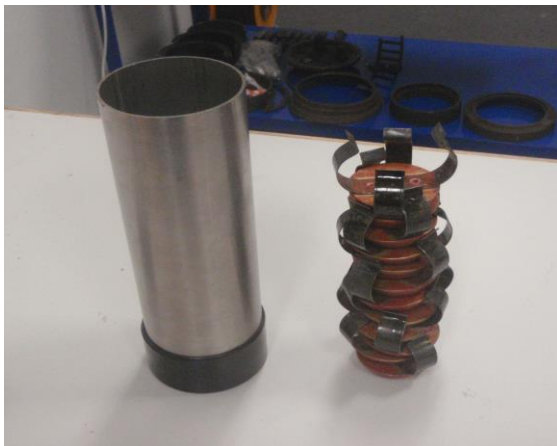
**Figure 14 – Twelve stacked fog signals**

- 34 The fog signals are issued to drivers directly from these boxes. When inspections identify out of date signals, they are exchanged on a one for one basis. There is no formalised procedure for the issuing of the fog signals.
- 35 The fog signals are issued to drivers in a batch of twelve. They are stored by stacking them (Figure 14) inside a purpose made stainless steel tube with removable plastic covers at either end, see Figure 15. The stainless steel tube weighs 1,478g; the twelve fog signals clipped together weigh 793g.

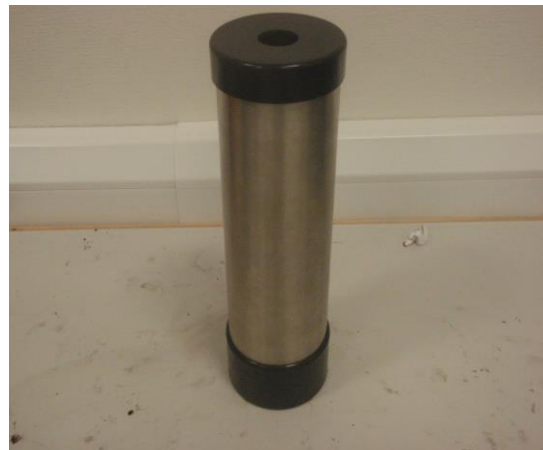
**Figure 15 – Stainless steel tube with cap**

- The fog signals storage tube, designed by Iarnród Éireann, allowed the fog signals to impact on one another which may have caused them to degrade over time;

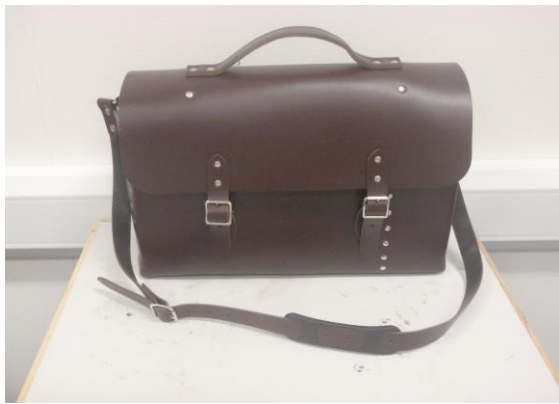
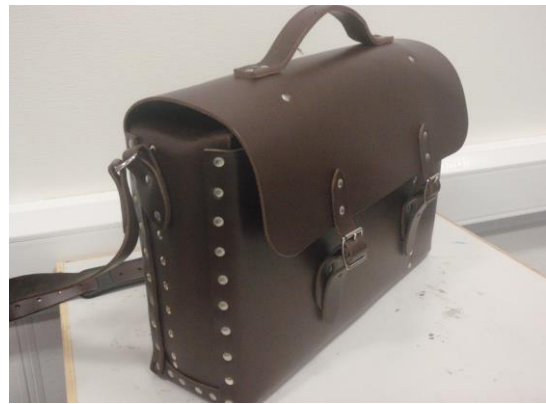
**Figure 17 – Photographs of the driver's bag**

- 38 The stainless steel tube is carried inside the driver's leather bag. The driver's bags are issued to all drivers and are robustly constructed in 3mm leather with riveted seams and a double buckle fastening, a shoulder strap is attached to the bag. Drivers use the bags to carry signal flags and a signalling lamp, rule books and twelve railway fog signals for use in emergency, see Figure 17 for photographs of a driver's bag similar to the bag used on the day of the occurrence.

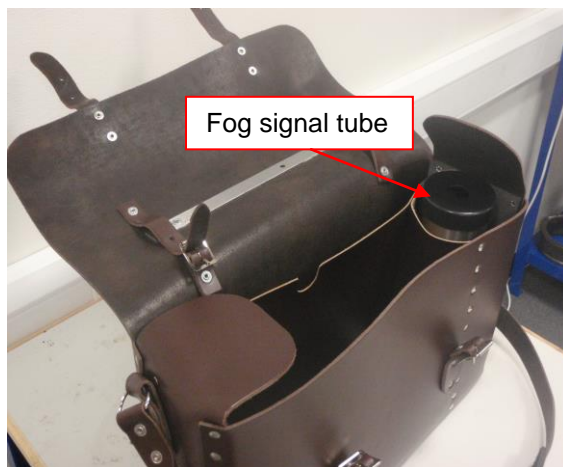
**Figure 18 – Tube in driver's bag**

- 39 The driver's bag has a section designed to allow it to remain upright and separated from any other contents of the bag, see Figure 18. A protective flap covers the top of the container before the bag is fastened, see Figure 19.

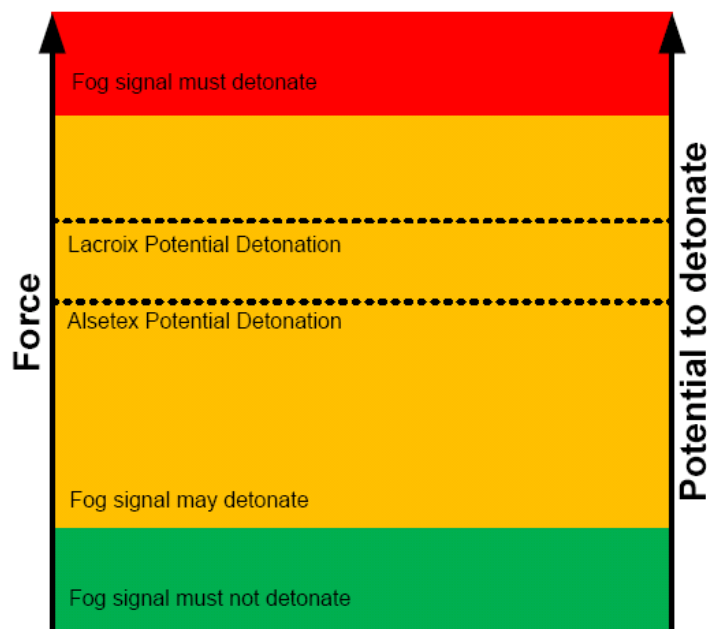
**Figure 27– Alsetex and Lacroix potential to detonate**

- 60 Of the eighty fog signals sent for testing, all of the fog signals tested passed the specifications set out in CT444 and the PSDS Sheets (from Lacroix and Alsetex) in relation to the dropping of 1kg from 1m. None were found to be damaged internally or leaking any explosive compound. All of the fog signals were activated and again they performed within the manufacturer's specification.
- 61 Reviewing the CT444 specifications (paragraph 25) for fog signals there is a large spectrum between when a fog signal must detonate and must not detonate (orange area in Figure 27). For example, a fog signal could detonate when a weight of 1 kg is dropped from a height of 4 m or when a weight of 4kg is dropped from a height of 1 m.
