# Railway Accident Investigation Unit

## **INVESTIGATION REPORT**

**Fog signal activation in DART driving cab,  
Bray, 6<sup>th</sup> March 2012**

**RAIU Report No: R2013 – 003**

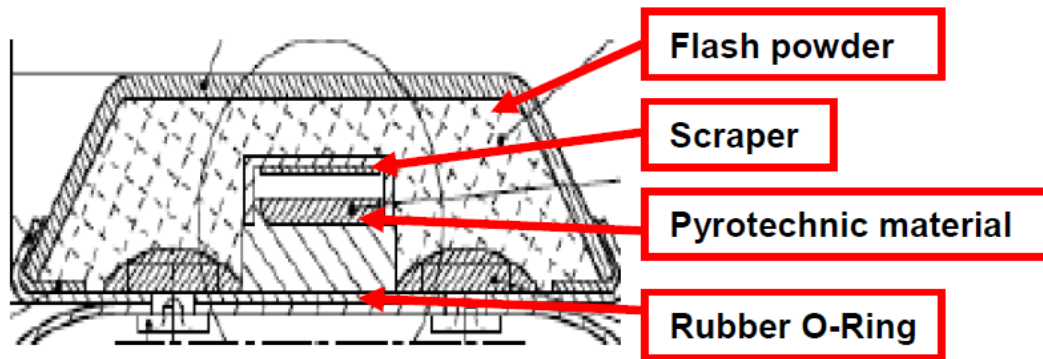
Figure 9 – Design of the Alsetex fog signal

- 28 The Alsetex fog signal has a metal exterior and contains two small plastic cylinders capped at both ends in the centre of the device. The top cap has a small scraper attached and the bottom cylinder contains pyrotechnic materials. These plastic cylinders are surrounded with flash powder, see Figure 9. The Alsetex has a rubber O-Ring around the edge of the device between the cap and the base of the fog signal.

covered the base of the plastic cylinders (paragraph 28), potentially allowing for the flash powder to leak. However, this could not be confirmed to have contributed to the explosion.

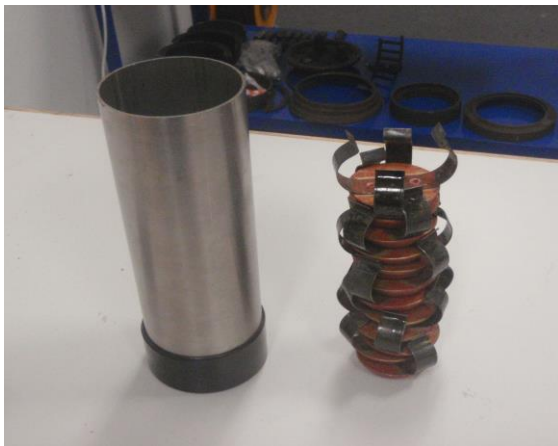
**Figure 14 – Twelve stacked fog signals**

- 34 The fog signals are issued to drivers directly from these boxes. When inspections identify out of date signals, they are exchanged on a one for one basis. There is no formalised procedure for the issuing of the fog signals.
- 35 The fog signals are issued to drivers in a batch of twelve. They are stored by stacking them (Figure 14) inside a purpose made stainless steel tube with removable plastic covers at either end, see Figure 15. The stainless steel tube weighs 1,478g; the twelve fog signals clipped together weigh 793g.

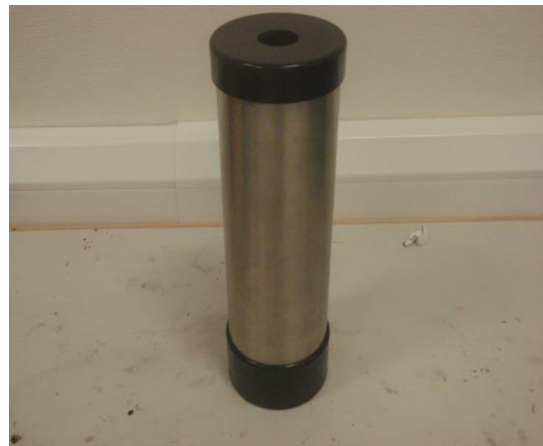
**Figure 15 – Stainless steel tube with cap**

- The fog signals storage tube, designed by Iarnród Éireann, allowed the fog signals to impact on one another which may have caused them to degrade over time;

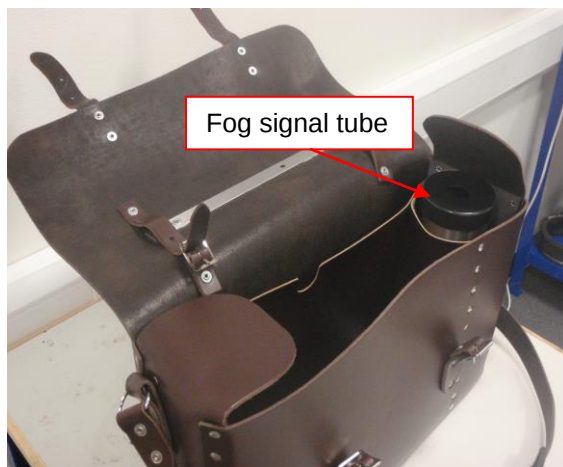
**Figure 18 – Tube in driver's bag**

- 39 The driver's bag has a section designed to allow it to remain upright and separated from any other contents of the bag, see Figure 18. A protective flap covers the top of the container before the bag is fastened, see Figure 19.
