AGENȚIA DE INVESTIGARE FERROVIARĂ ROMÂNĂ - AGIFER

INVESTIGATION REPORT

of the railway accident happened on the 8th April 2017,
in the railway county Timișoara, track section Livezeni – Simeria (electrified double-track line),
between the railway stations Bănița and Merișor

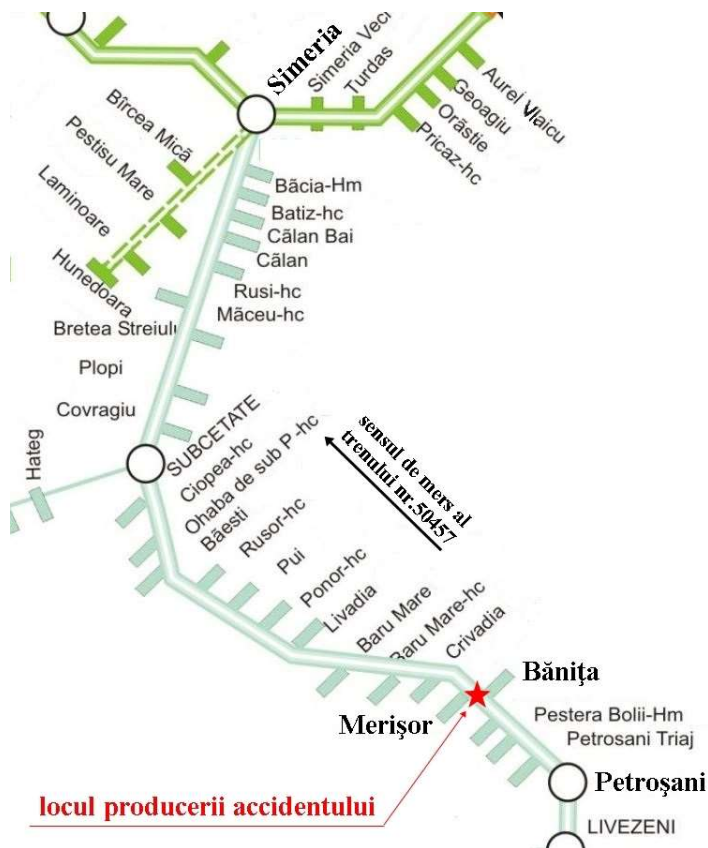
Sketch no. 1

On the 8th April 2017, at 14:30 o'clock, in the railway county Timișoara, track section Petroșani - Simeria (electrified double-track line), between the railway stations Bănița and Merișor, on the track I, km 62+940, the first 14 of the freight train no. 50457 and its hauling locomotive, EA 759, derailed.

The accident site is presented in the picture no. 1.

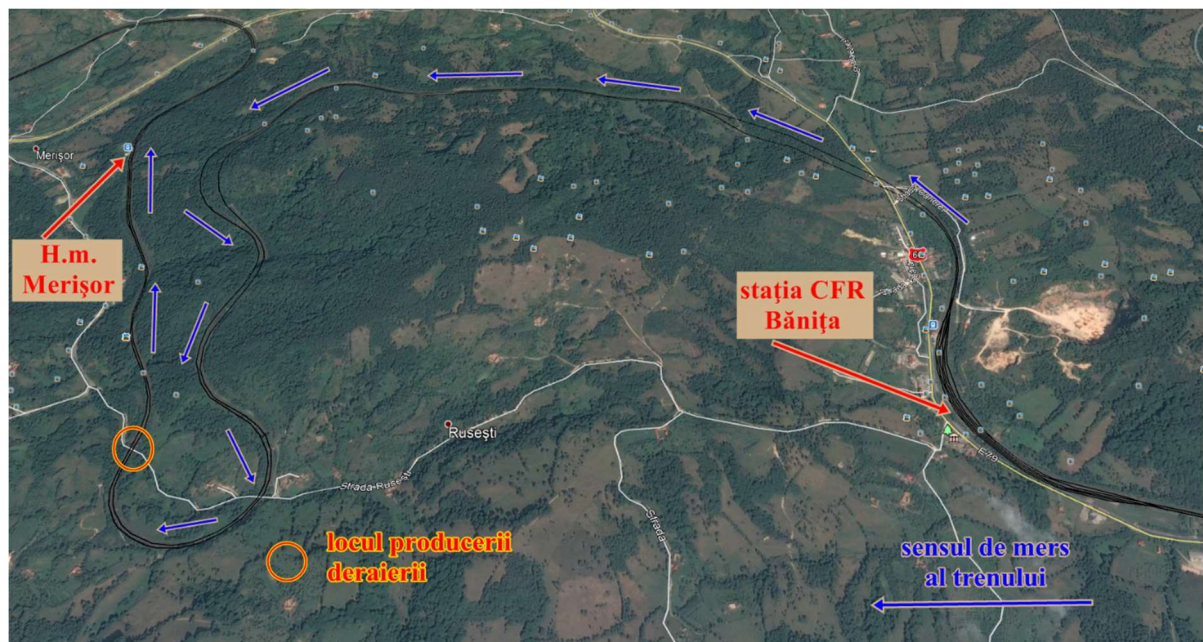
Marking of the track on the site at the derailment site

Picture no.3 - Merking of the track on the site
