INVESTIGATING REPORT

of the railway accident
occurred on the 24th of September 2014, in the railway station Halmeu, in the running of the freight train no. 3651/48651, through the derailment of the second bogie in the running direction, from the wagon no. 52623642 (last from the train)

Final edition
December 2014

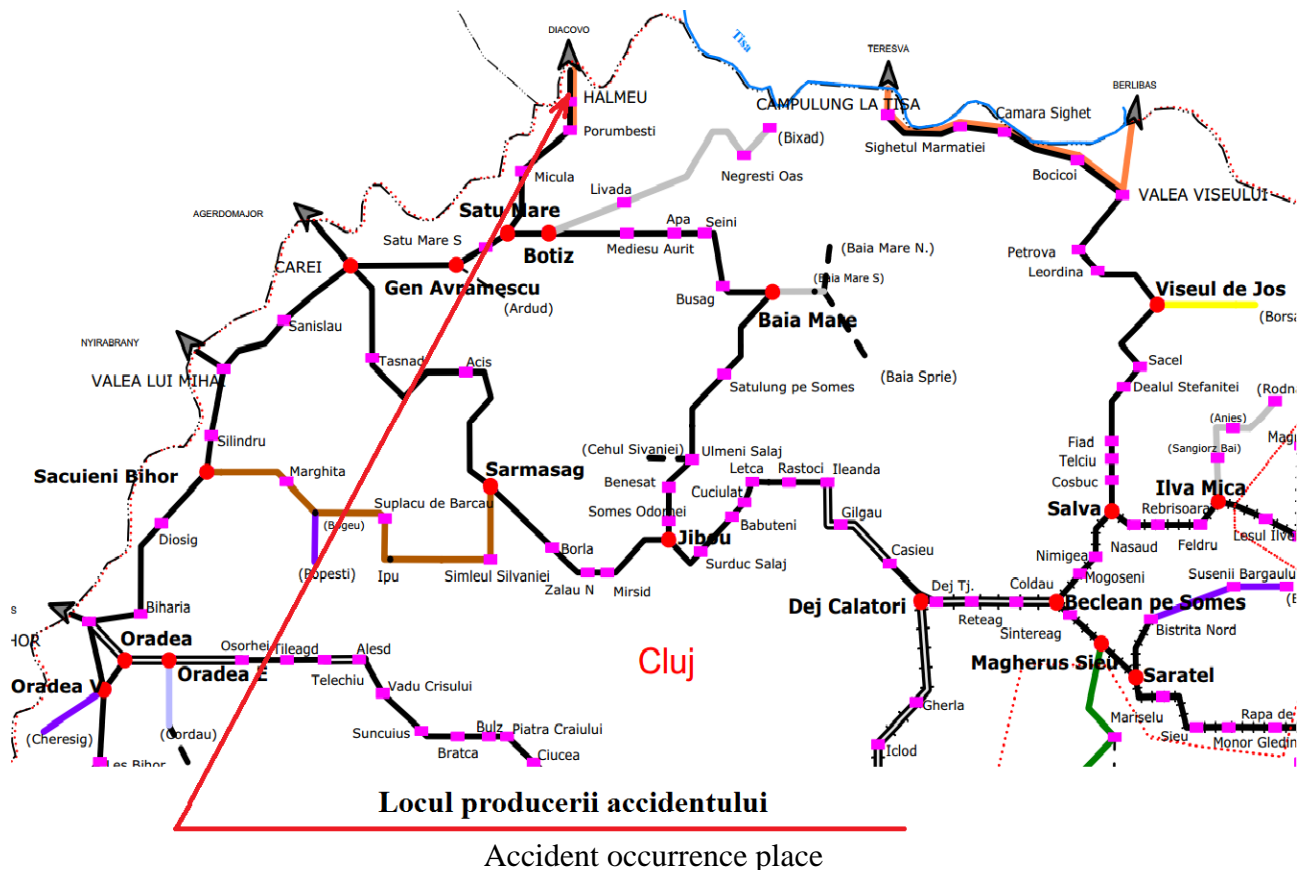
At 13.50 o'clock, after the train passed completely the entry signal from the railway station Halmeu, occurred the derailment of the second bogie, in the running direction, from the wagon no. 52623642, last from the train.
