## NOTE

*for the railway incident happened on the 24th June 2019,  
in the railway county Iași, on the running line Dărmănești – Cacica,  
at the level crossing from km 4+925, flooded dangerous point,  
consisting in the derailment of all 4 axles of the locomotive EC 078,  
hauling of the passenger train no.5731*

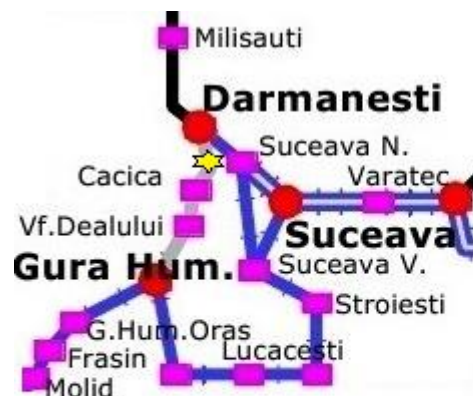
*Drawing no.1 – incident site*

On the **24th June 2019**, at 03:20 o'clock, in the **railway county Iași**, track section **Suceava – Cacica** (electrified single-track line), at the level crossing, (provided with road sign), km.4+925, in the running of the passenger train no.5731 (got by the railway undertaking SNTFC „CFR Călători” SA), hauled with the locomotive EC 078, its all four axles derailed.

★ **Locul producerii incidentului,  
km 4+925**
