MINISTRY OF TRANSPORTS AND INFRASTRUCTURE
ROMANIAN RAILWAY AUTHORITY - AFER

INVESTIGATION REPORT

**of the serious railway accident that occurred on May 10, 2008 to Valea
Călugărească**

Final edition
May 08 2009

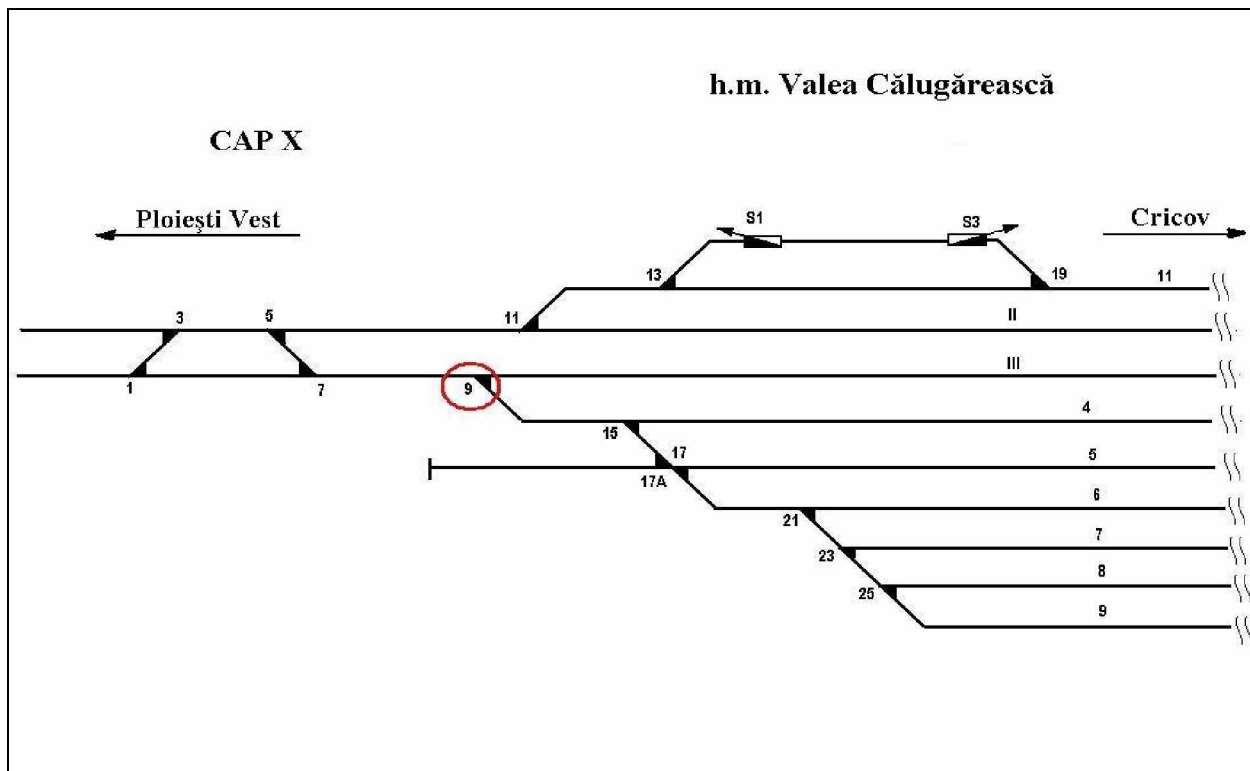
photo 1

On May 10, 2008 the train no.1661 that was put into service on the route Bucuresti Nord –Iasi, left from CFR Ploiesti Sud railway station and passed without stopping, according to the schedule on the track no.6B from CFR Ploiesti Est railway station. When passing through all railway stations, the train was surveyed by the movement's inspector (IDM). According to the schedule after leaving CFR Ploiesti Sud railway station the next stop was supposed to be Mizil railway station (photo no.1).
