1. **PERFORMER:** Romanian Railway Notified Body – Laboratories Department
2. **CLIENT:** Romanian Railway Investigating Body – OIFR
3. **TESTING OBJECT:** broken axle journal, end B, in the connection point of stress relief with the obstructing area, with the order number 14, charge 311561, series CFR 3836632, belonging to the wagon no. 31535494306-2, involved in the railway incident from Zavideni, occurred on the 13th of March 2008.

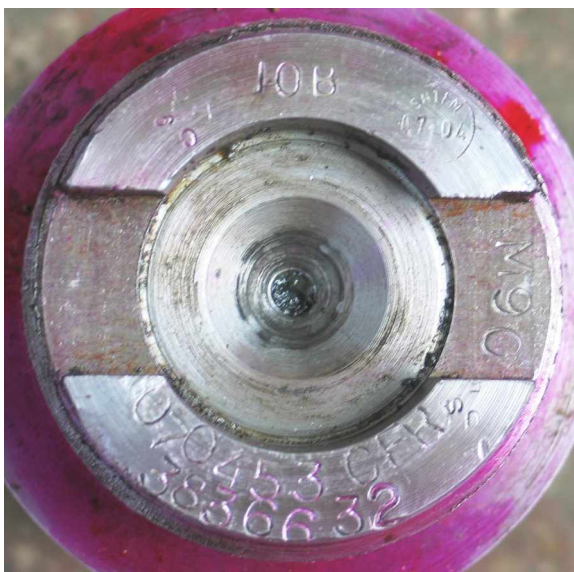
Picture 3

The broken axle journal of 220 mm length has the end threaded, and at about 35 mm from the breaking point is emphasized a circular area, with an increased height of about 0,15 mm, picture 3. The visible marks on the end of the broken axle journal are: IOB SNTFM 07 04 M90 070453 CFR 38366 32 – picture 4.

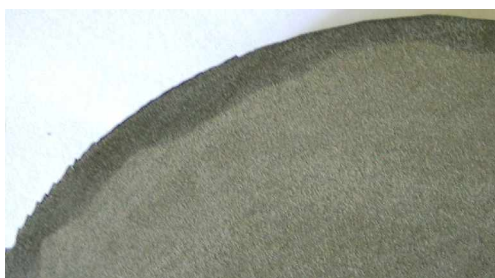
Picture 16

Characteristic type	Conclusions on the analysed characteristic	Picture	Conditions established by the UIC Leaflet 811/1-87 for the analysed characteristic
Macrographic and macroscopic analysis			
Baumann stamp	h Sulphur uniform ditribution on the cross section, without segregations. The image ranges among the limit images included in the enclosed album at the leaflet.	14	Point 6.2.2.4 – The image obtained has not to present failures more visible than those presented in the limit images included in the enclosed album at the leaflet
Macro aspect of the cross section after the heat attack in substance of 50% HCL	h Without macro-failures type flakes, material overlaps, segregations, macro-inclusions, cracks	15	Point 6.2.2.3 – After polishing, the examined surface has not to present any continuity solution
	One can notice a central porosity with points= 1	16	
	On the section outline one can see, detailed, a thermic influence area, without interruptions, of dark colour, on a breadth of about 4 mm	17
