**MINISTRY OF TRANSPORTS AND  
INFRASTRUCTURE  
ROMANIAN RAILWAY AUTHORITY – AFER  
ROMANIAN RAILWAY INVESTIGATING BODY**

## **INVESTIGATING REPORT**

**Of the railway incident occurred on March 13, 2008**

**Final edition  
May 18, 2009**

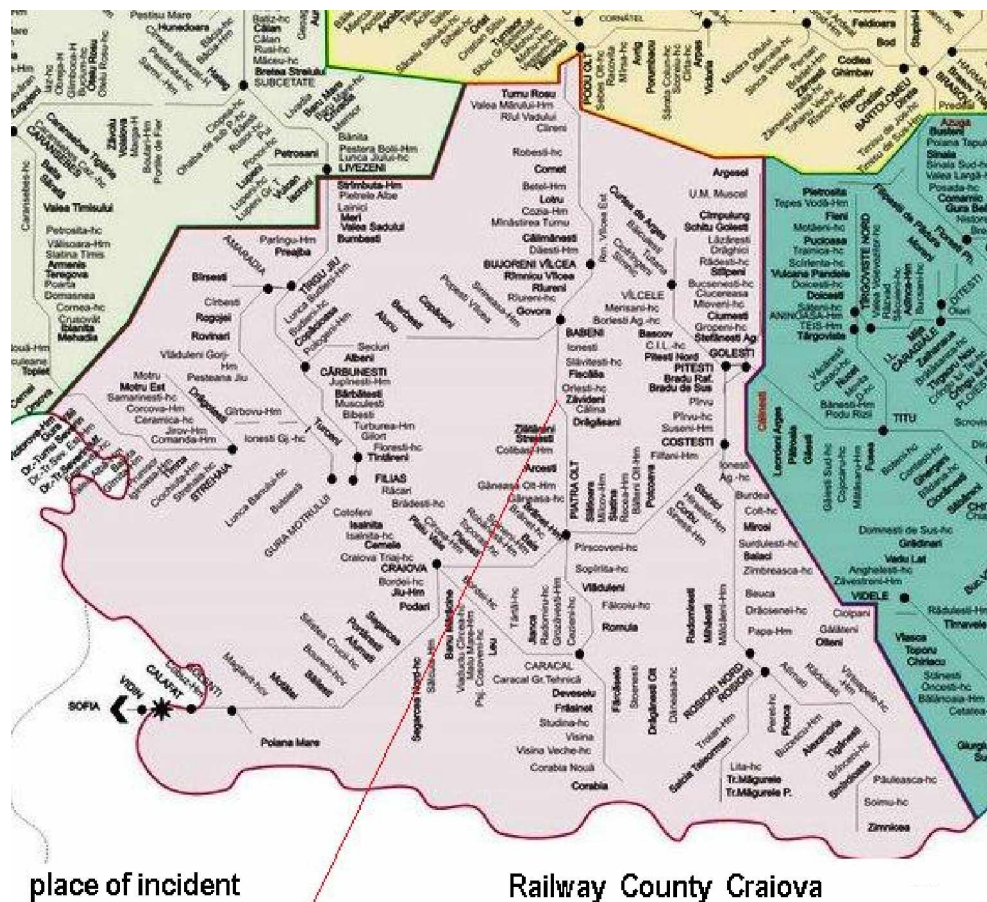
After the train stopped the driver's assistant performed the inspection and together with the movement inspector of Zavideni railway station noticed to the wagon no.31535494306-2 (the sixth from the locomotive) that the axle journal no. 5 was broken.

The direct cause of the railway event occurrence is the breaking of the wheel set no. 3836632 from the wagon no. 31535494306-2 in the area of the stress relief clearing between the axle journal and shutter as result of the decrease of the material fatigue strength against the development of micro cracks in the areas with high density of the networks with manganese sulphide.

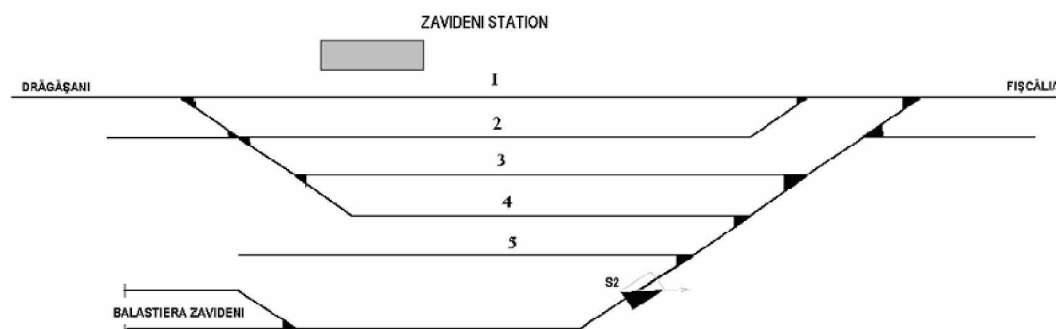
The driver's assistant together with the movement inspector of Zavideni railway station examined the wagons from the train composition and to the sixth wagon no.31535494306-2 found that the axle journal no. 5 was broken and the axle box corresponding to the same journal was based on the part T.
