# Summary of Security Investigation Report

## DERAILMENT OF A FREIGHT TRAIN WETTEREN - 4 MAY 2013

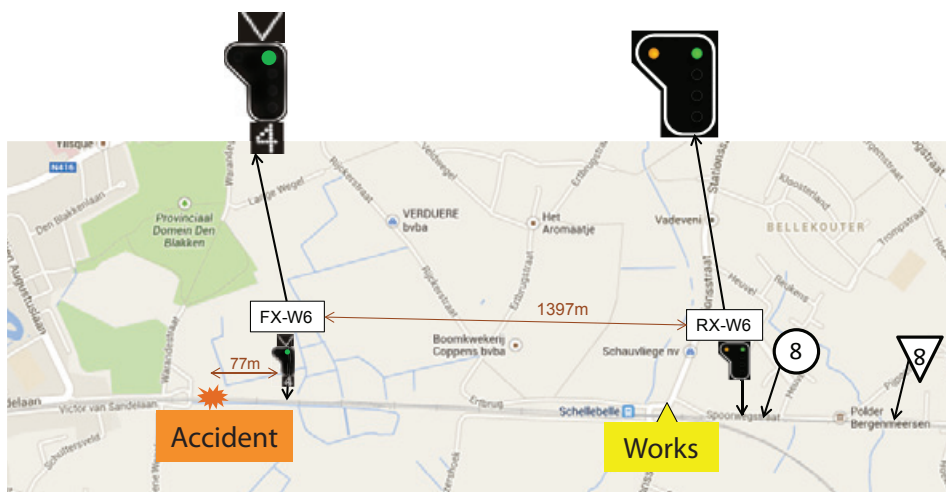
The driver encounters 9 consecutive green flashing signals. Then he encounters a green-yellow horizontal flashing warning signal (RX-W.6) that informs him of the aspect of the following signal (FX-W.6). In the absence of a speed indication (on the signal RX-W6) the train is permitted to travel at a restricted speed of 40km/h from the next dangerous point.
