Rail Accident Investigation Branch

Rail Accident Report

Report on the runaway manually propelled trolley between Larkhall and Barncluith Tunnel 2 November 2005

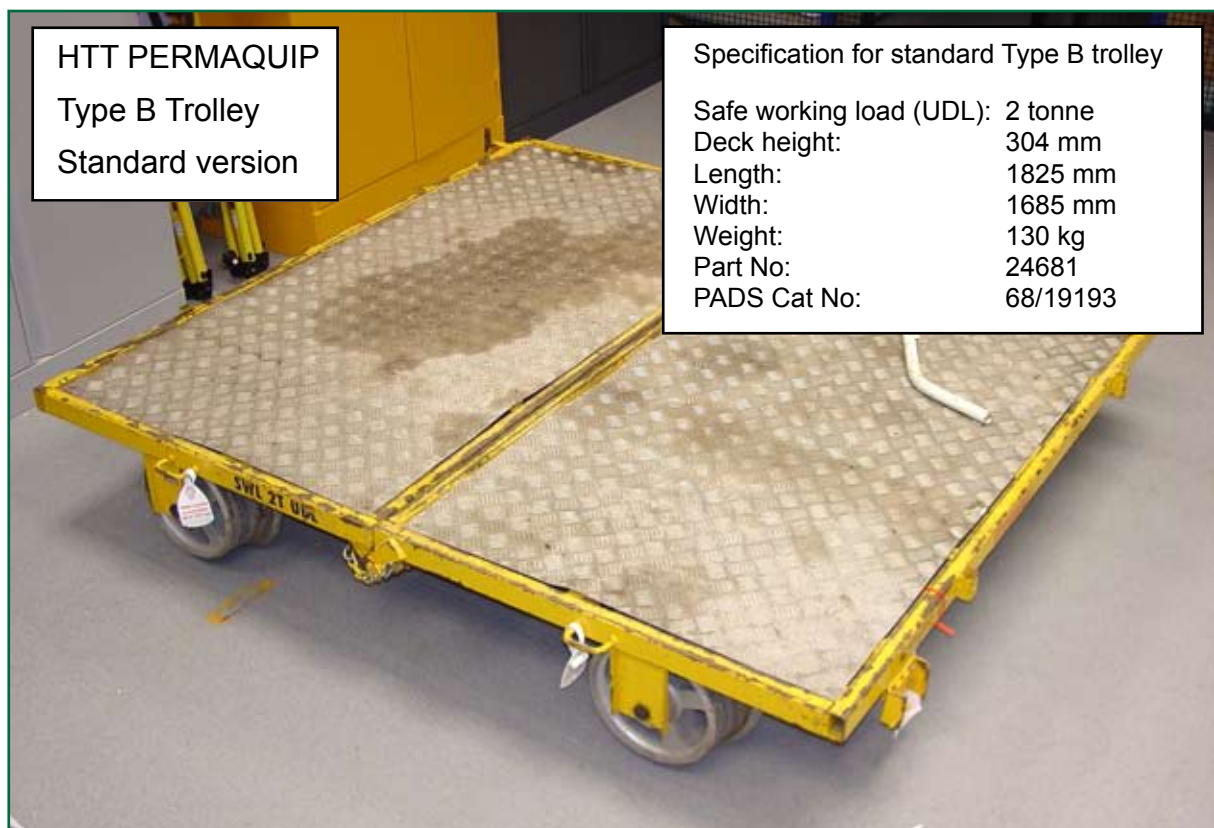
Figure 5: HTT Type B trolley

- 30 The incident trolley (see Figure 5) was a Type B portable trolley serial number RT10574, manufactured by Harsco. It is also known as a *standard* design trolley. It was commonly referred to as a '*bogie*' by the local work force.

- 33 At the time of the incident the weather was windy and raining, although not as severe as experienced during the previous hours. The poor weather had disrupted the scheduled work, in particular the time needed for *Thermit* welding of the rails. The temperature at the time of the incident was not recorded. There were no reports of frost or icy conditions affecting the work.

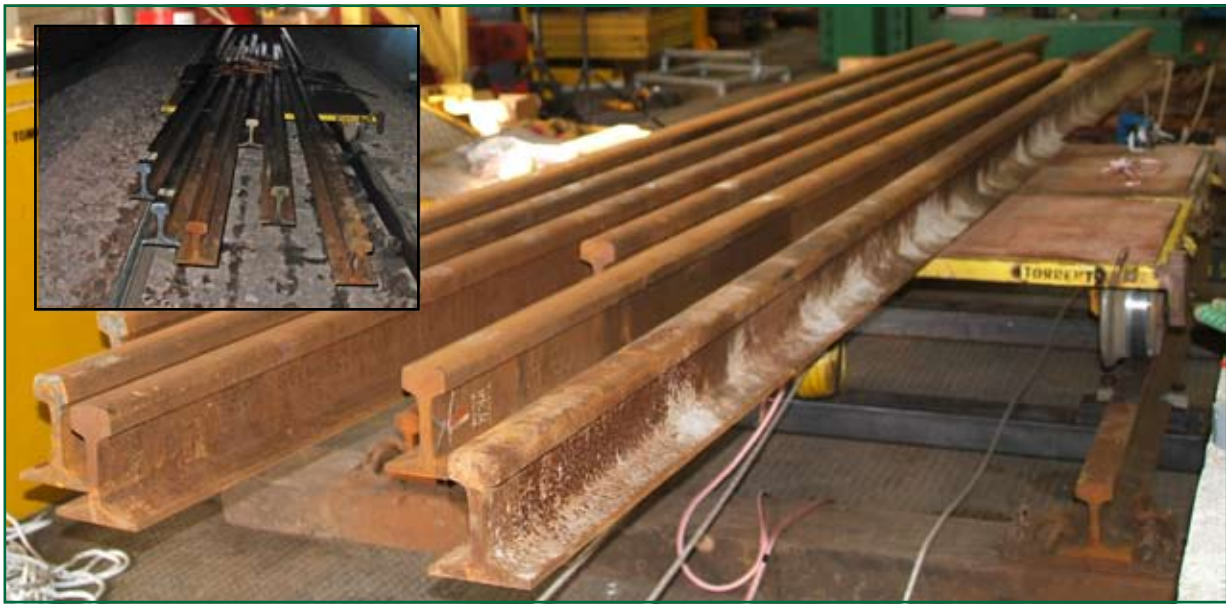
Figure 6: The incident trolley showing rails and relationship to 'as found' condition in Barncluith Tunnel

- 100 It was observed that one side of the trolley was ‘dipped’ due to the securing pin between the two halves having become loose and detached. It cannot be established when the two halves became separated, although it may have been caused by the impact when the trolley ran through the points at Haughhead Junction.

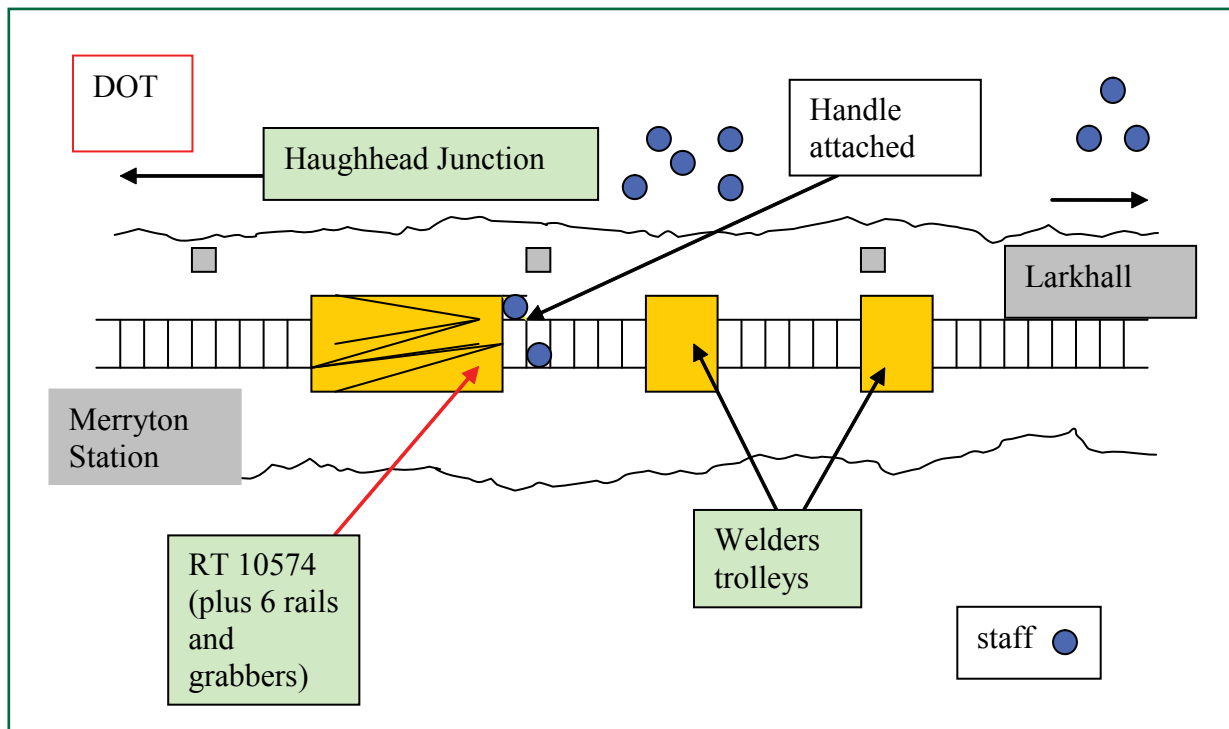
Figure 8: Merryton Worksite

- 63 As previously described (see paragraph 33) the weather at the time of the incident was poor. The weather had affected the work being undertaken and some work had been delayed or abandoned.
- 64 The area near Merryton where rail recovery was undertaken was on a gradient of 1 in 48. The Railway Rule Book and Carillion ISM section I.01 both prohibit using a trolley on a gradient steeper than 1 in 50 unless specially authorised by local instructions. A load limit of 2 tonnes is painted on the trolley. There were no special or local instructions contained or referenced within the generic method statement that would have directed the COSS to a process that would enable the work to continue using a trolley. The decision to continue work was taken by the Carillion SS.
