Rail Accident Investigation Branch

Rail Accident Report

**Freight train derailment at Hatherley, near
Cheltenham Spa
18 October 2005**

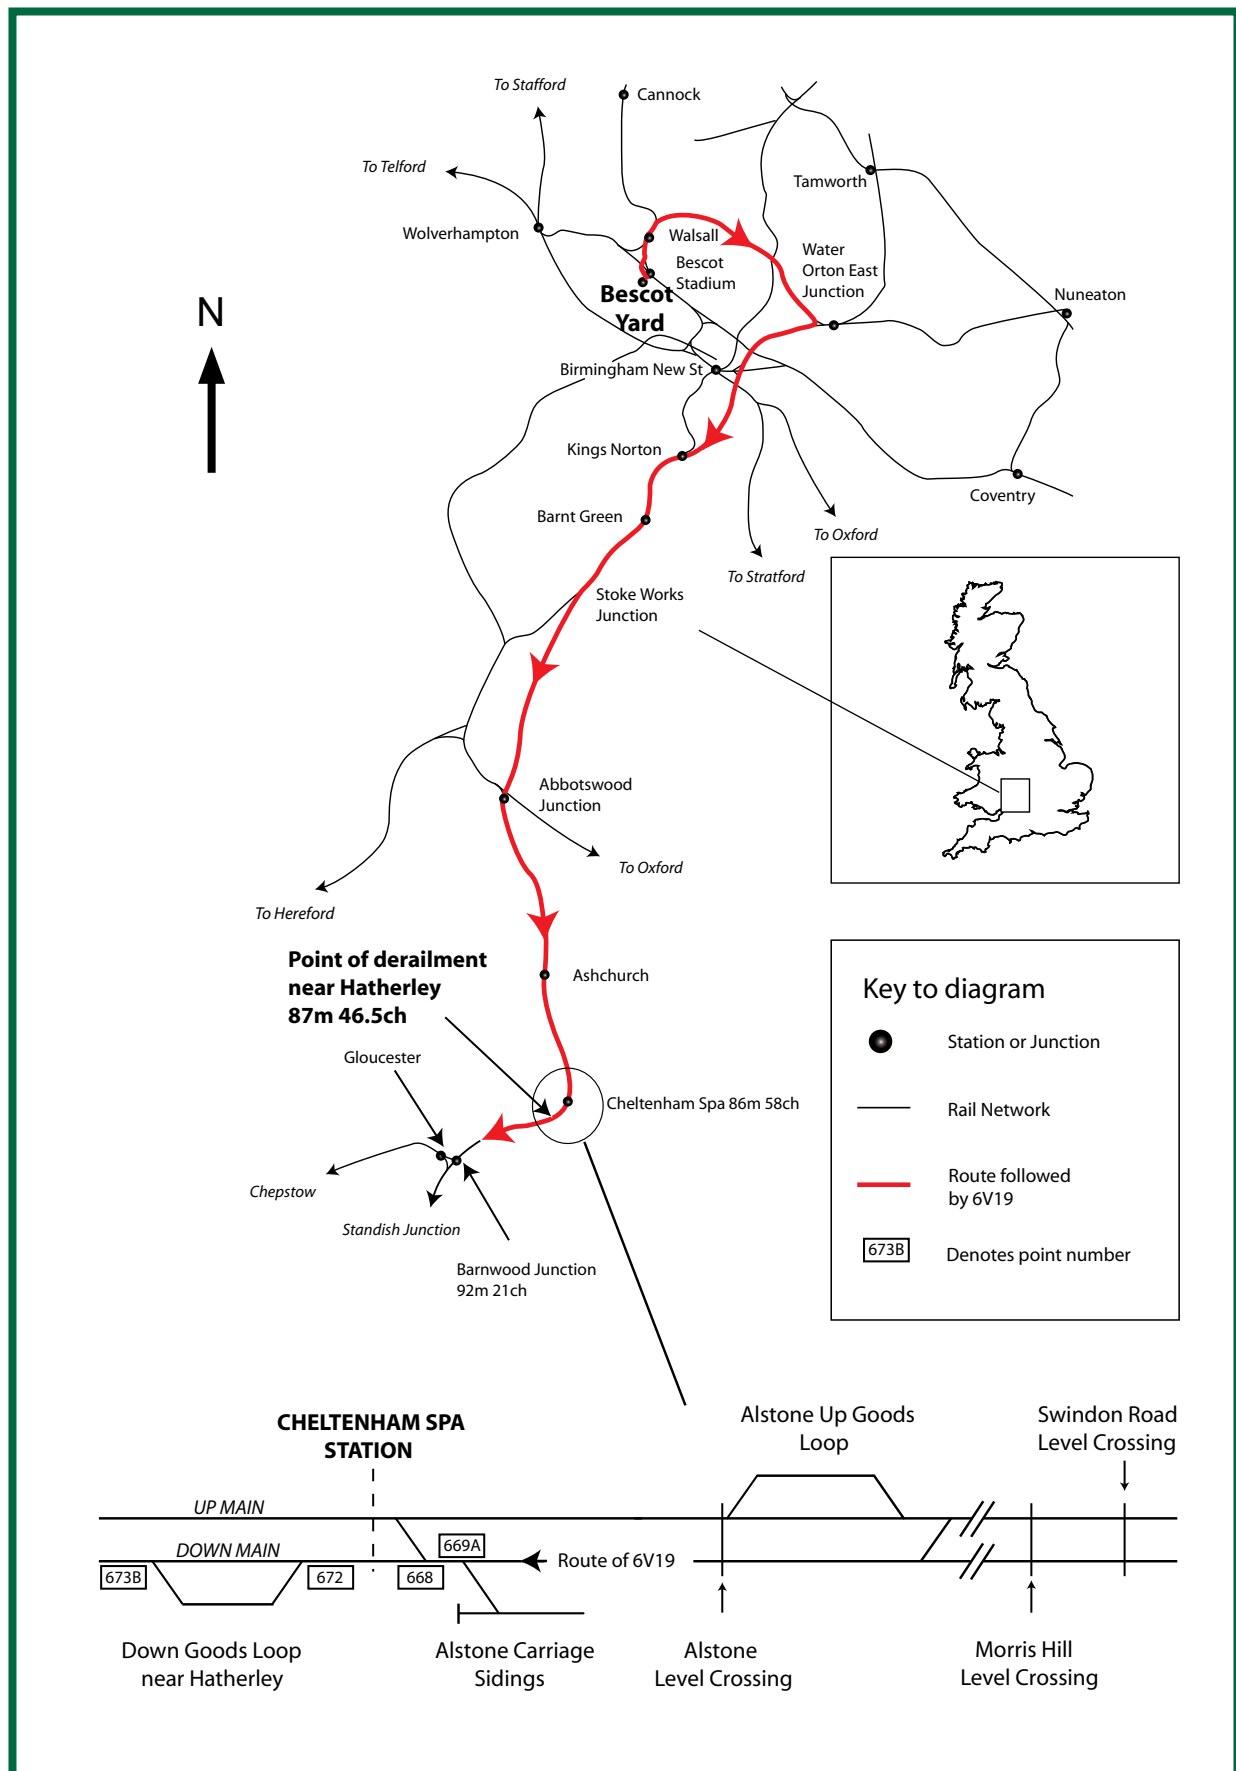
Figure 3: Map of the route taken by train 6V19

- 27 A train travelling southwards over the Down Main line negotiates four sets of points in this area (Figure 3); 669A (*trailing*) and 668 (*facing*) forming the exit to Alstone Carriage sidings and a crossover between the main lines respectively, and 672 (*facing*) and 673B (*trailing*) forming the entrance and exit respectively to the Down Goods Loop near Hatherley.

- 44 There were no fatalities or injuries as a result of this accident.
- 45 Pre-derailment infrastructure damage was caused to 669A points, 672 points and 673B points (Figure 3).

- 58 Evidence from wheel/rail contact marks indicated that wagon SSA 470028 had derailed momentarily whilst traversing 669A points (Figure 3) in the trailing direction. The mechanism of this partial derailment was similar to that observed further down the track at 673B points (paragraph 60). However, the resistance of the rails to overturning at 669A points was sufficient to prevent full derailment, and the leading wheelset rerailed itself as it passed beyond the toes of the points. 669A points comprise flat bottomed rail on concrete bearers.

- 72 The signaller had no reason to suspect that train 6V19 might be derailed until it left a track circuit showing occupied after the whole train had passed through. Although train 6V19 had caused significant damage to 669 and 673 points (Figure 3), they had shown no immediate indication of any problem. It was only when the signaller attempted to call another route through 669 points that a light on the panel flashed to indicate a fault. Therefore, the activation of the HABD alarm (by which time train 6V19 had derailed) was the first indication of a problem with train 6V19, followed by the failure of track circuit DM90B to clear after the passage of the train. By this stage, train 6V19 was already on the approach to Signal G50, which had been placed to danger by the signaller in response to the activation of the HABD at Churchdown.

- 52 Limited single line working was implemented between Gloucester (Barnwood Junction) and Ashchurch on the unaffected Up line from 12:20 hrs on 18 October, before SSA 470028 had been re-railed. A more intensive service over the Up line was possible from 16.30 hrs after train 6V19 was moved into Barnwood Yard. On 19 October, the single line working section was shortened, with Barnwood Junction and Cheltenham Spa (Alstone) representing the limits, following the repair of 669A points (Figure 3).

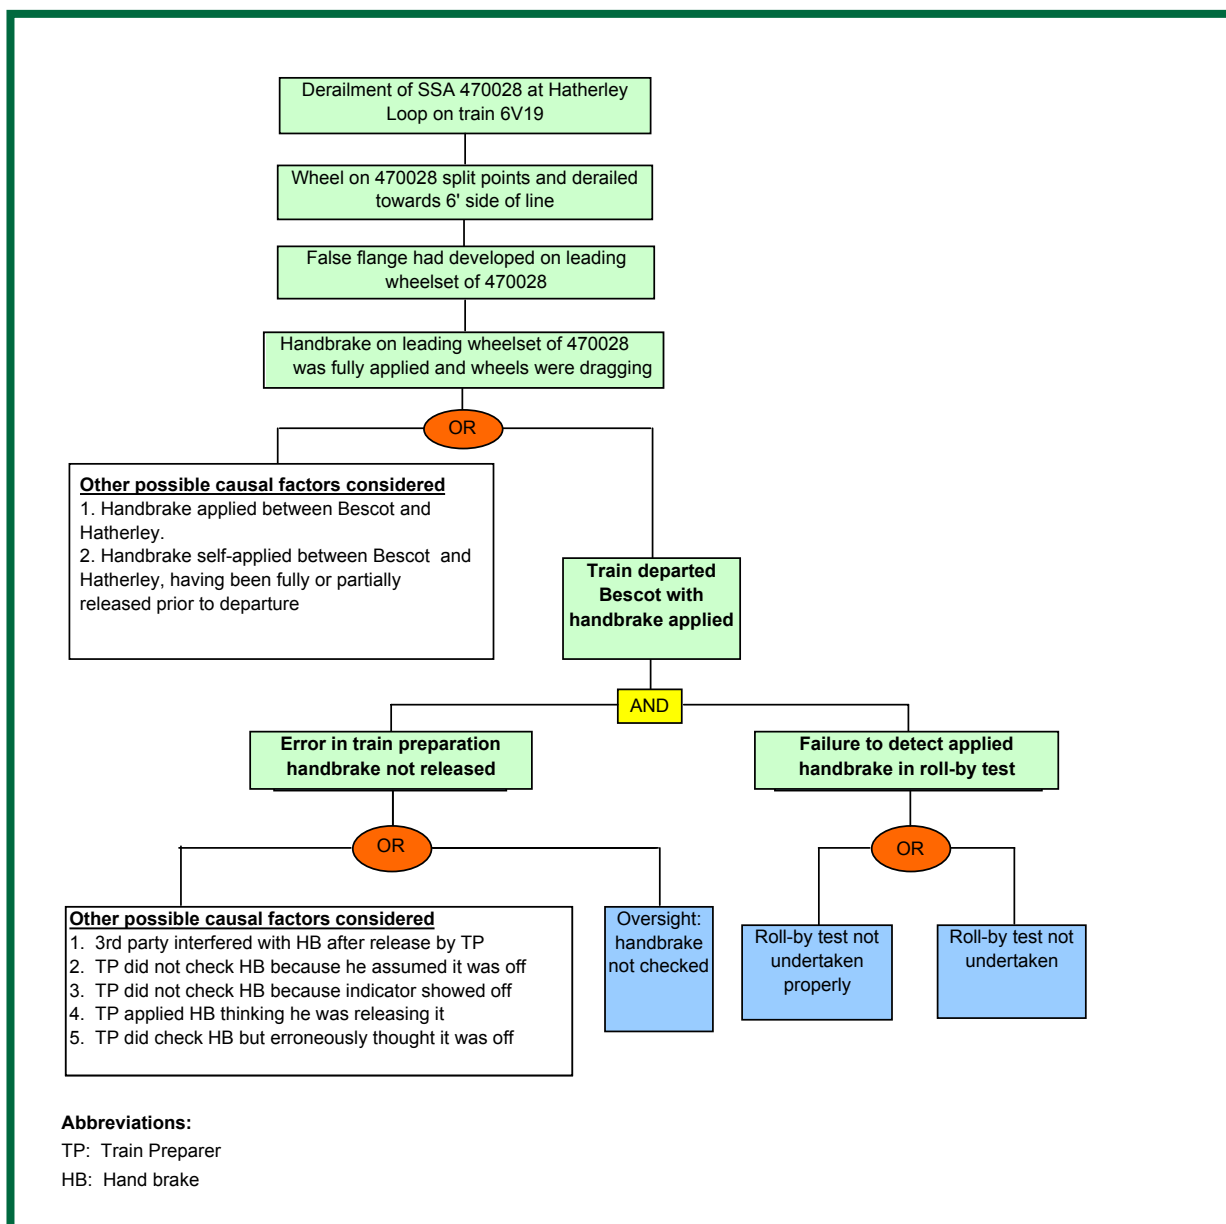
Figure 21: Causal analysis diagram

157 A summary of the causal chain analysis undertaken is shown in Figure 18. Working downwards from the derailment, each box contains the reason why the preceding event occurred or is considered to have occurred. The colour coding of the boxes is as follows:
