Rail Accident Investigation Branch

Rail Accident Report

**Collision at New Addington on
Croydon Tramlink,
23 November 2005.**

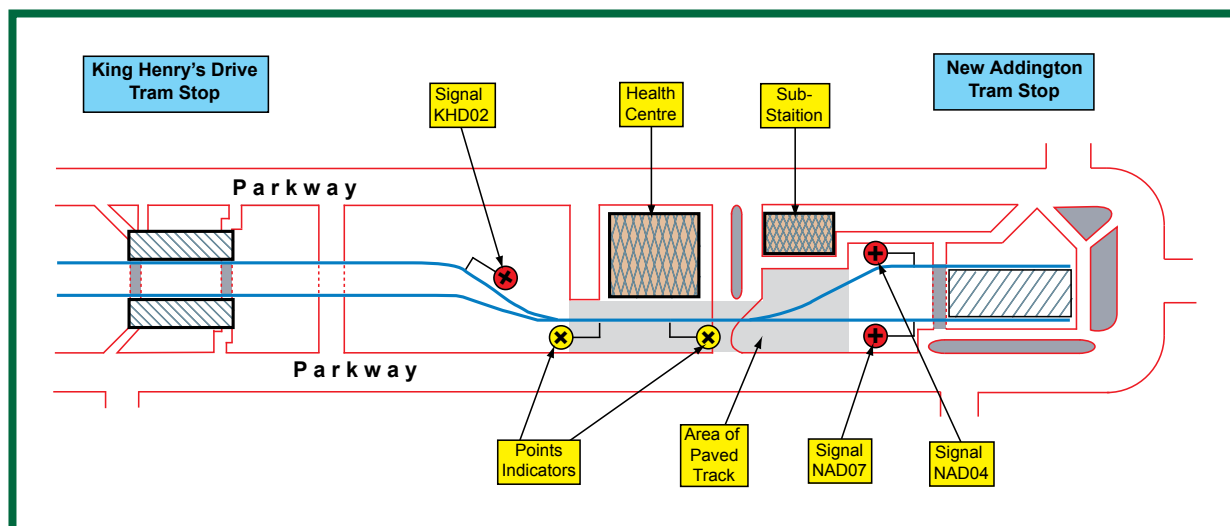
Figure 4: Diagrammatic representation of the line between King Henry's Drive and New Addington

- 21 The single track section is located immediately north-west of the New Addington terminus; the reason for this is its proximity to a building (used as a Health Centre) where there is inadequate room for double track. It is located on the apex of 0.68% and 0.63% rising gradients from New Addington and King Henry's Drive respectively. A shallow right hand curve is apparent on departure from New Addington. The entry to the single line is controlled by a motorised point and NAD04 and NAD07 signals at New Addington and a *spring point* and KHD02 signal from King Henry's Drive. *Points Indicators* are provided at both ends of the single line. Good sighting of the collision point is possible from at least 50 m distance under conditions of moderate visibility.

- 22 The entry to the single line at New Addington is controlled by signals at each end. The controls are triggered by track-located sensors, one at King Henry's Drive tramstop and one adjacent to KHD02 signal. Similar sensors are provided at New Addington. Apart from the sensor at King Henry's Drive tramstop which operates automatically, a proceed request is activated by the driver initiating a 'Ready-to-Start' signal from the cab. The system normally operates on an automatic first come – first served basis, although manual over-ride from the control centre at Therapia Lane Depot is possible.
