Rail Accident Investigation Branch

Rail Accident Report

**Collision at Black Horse Drove Crossing, near
Littleport, Cambridgeshire
19 October 2005.**

Collision at Black Horse Drove crossing, near Littleport, Cambridgeshire, 19 October 2005

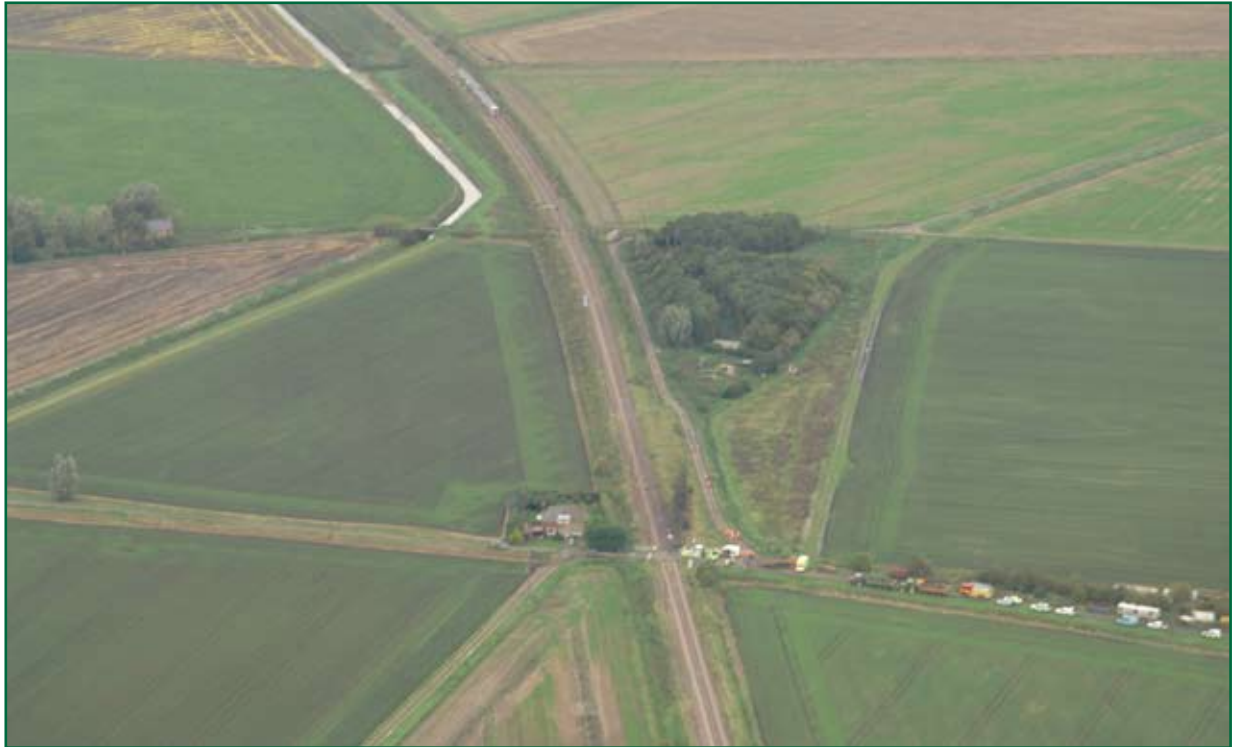
Figure 1: Aerial view of level crossing area

- 4 The accident occurred when a train travelling between Littleport and Downham Market collided with a tractor hauling a trailer over a user worked level crossing.
- 5 The accident took place at Black Horse Drove crossing in Cambridgeshire just after midday at 12:04 hrs on Wednesday 19 October 2005. Figure 1 shows an aerial view of the crossing and Figure 2 is a map of the area.

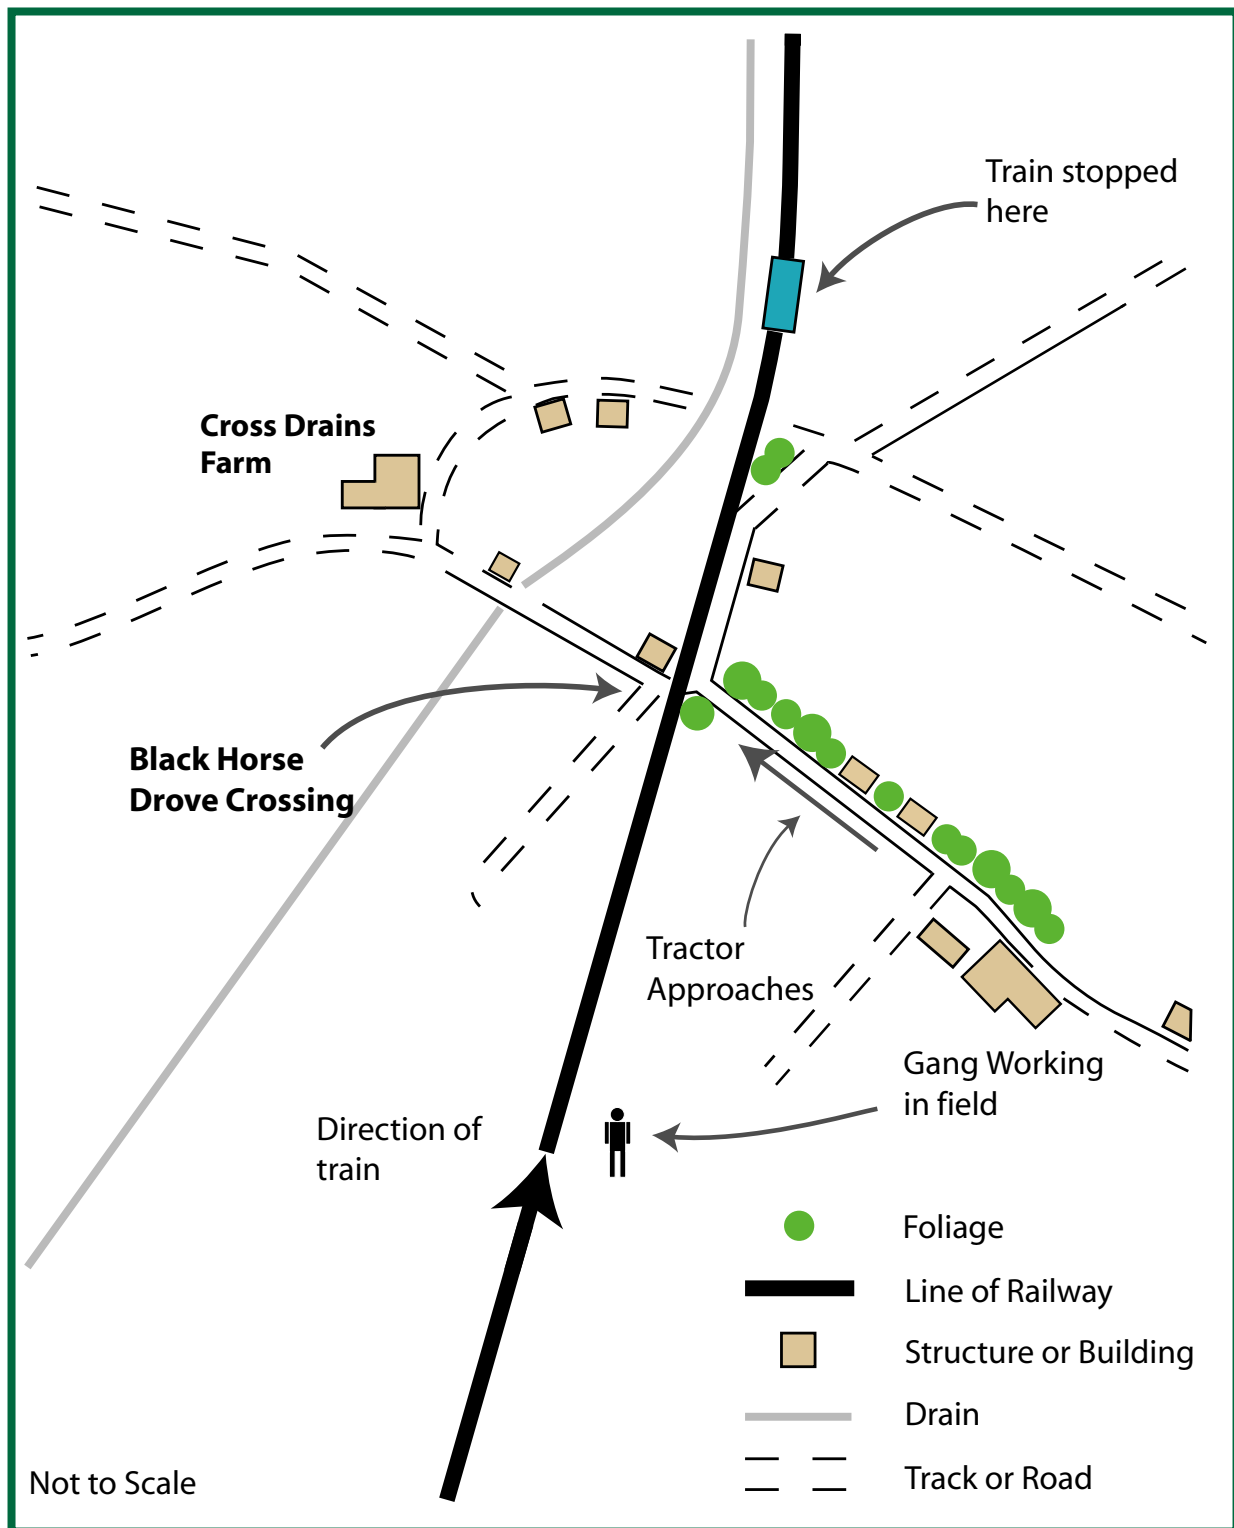
Figure 3: Plan of site

- 34 The railway consists of a single track on a former double track formation and the line is electrified with 25 kV overhead equipment. The level of the railway on a low embankment means that the road approaches to the crossing slope up towards the line. The east side approach has a gradient of 1 in 17. The railway on the Littleport side of the crossing is straight and the railway on the Downham Market side of the crossing is on a shallow radius curve. The *linespeed* at the crossing is 90 mph (144 km/h) for *electric multiple unit* (EMU) trains and 75 mph (120 km/h) for others. Figure 3 shows a plan of the site and Figure 4 shows the east side road approach.

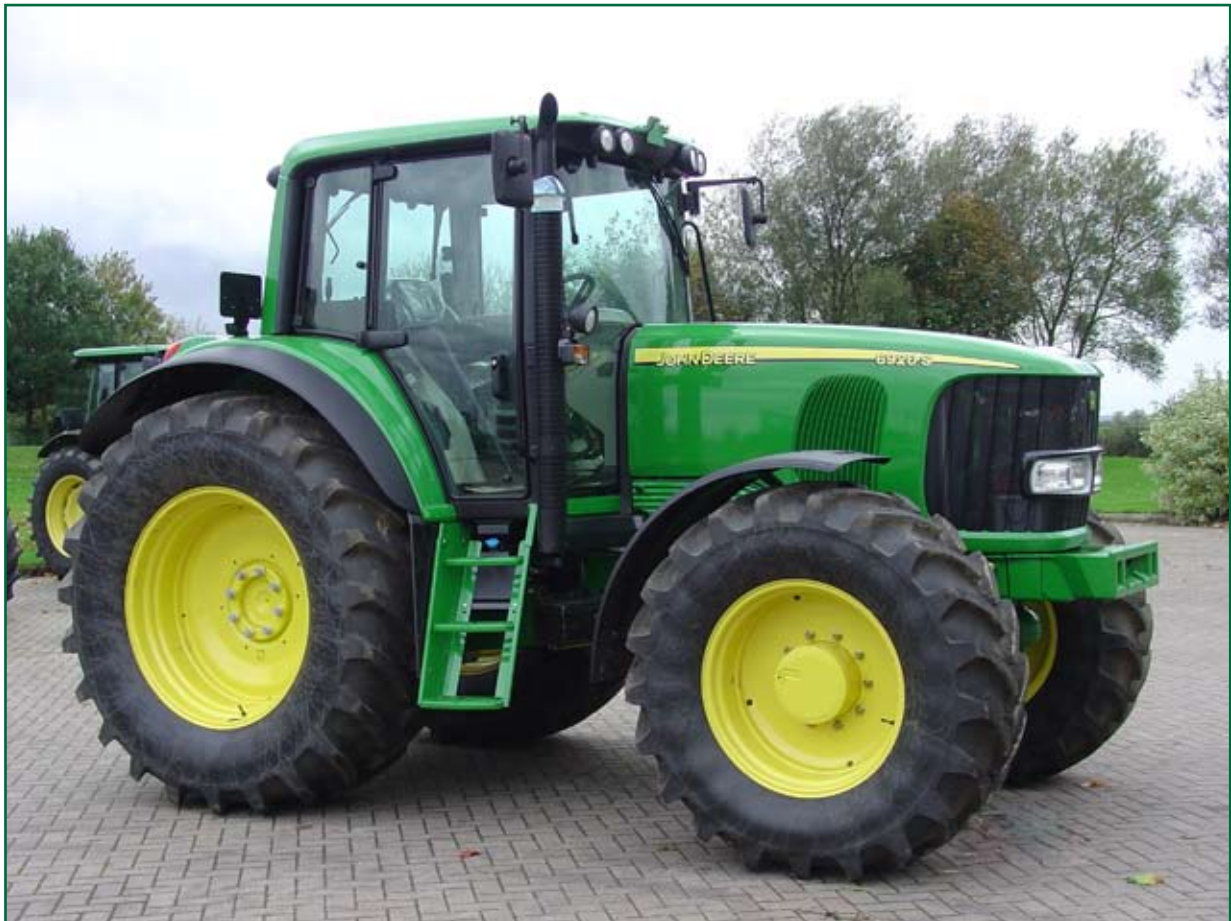
Figure 5: John Deere 6920 tractor

- 41 The tractor was a John Deere 6920 type delivered to its first owner on 28 April 2003. The tractor was fitted with a set of John Deere counterweights at the front and was towing a Richard Western 'Suffolk rootcrop' trailer. The tare weight of the tractor was 5.88 tonnes and the total weight, including an estimated amount of fuel, was 7 tonnes. The trailer was almost fully loaded with potatoes and its total weight was 16.5 tonnes. Figure 5 shows an identical tractor, but without the front counterweights fitted.
