Rail Accident Report

Derailment near Liverpool Central underground station **26 October 2005**

Derailment near Liverpool Central underground station, 26 October 2005

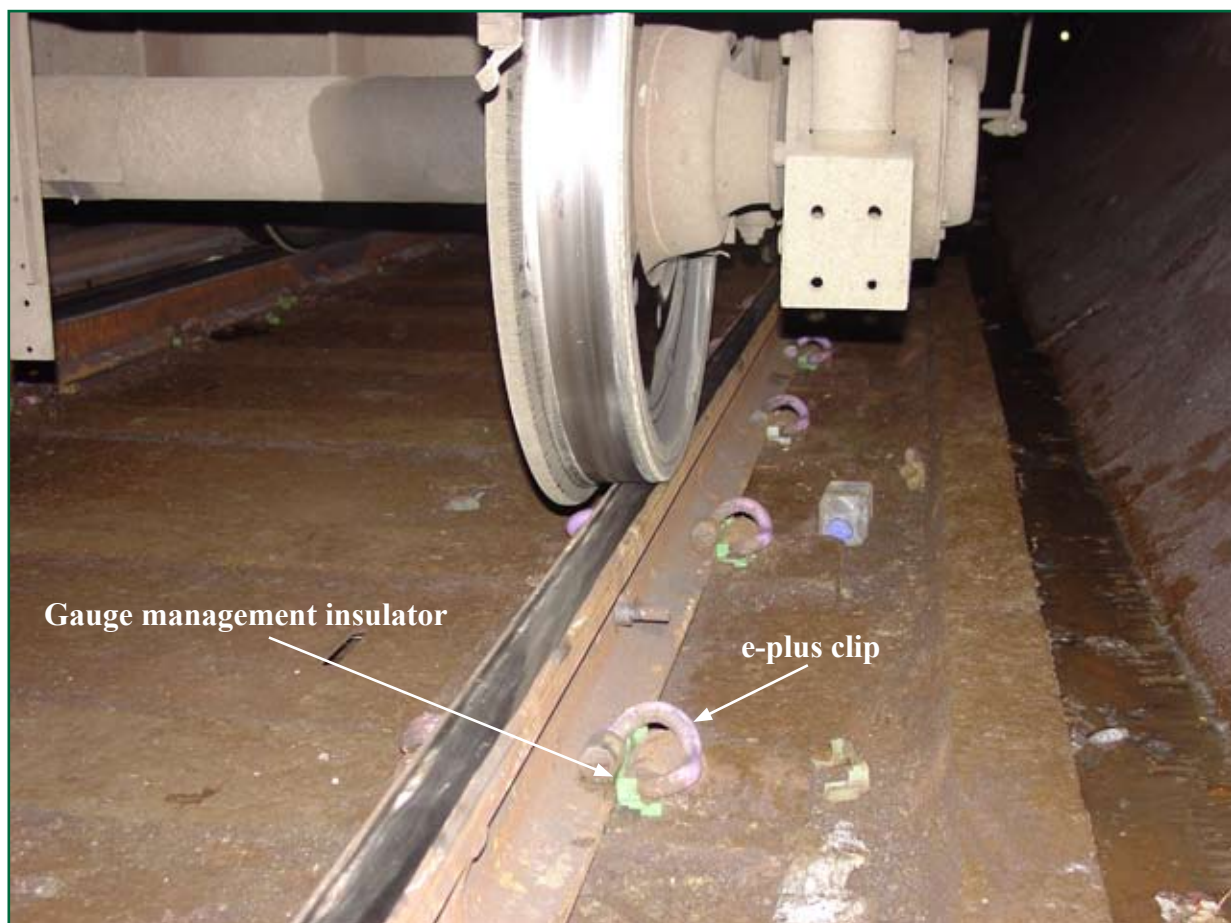
Figure 6: Pandrol e-Plus clips

- 62 Around the end of 2004, Network Rail sought the advice of Pandrol UK Ltd, the UK subsidiary of Pandrol Rail Fastenings Ltd, on the type of track fastening best suited to the tunnel environment. Pandrol advised the use of their *e-Plus clips*, in conjunction with *toe insulators* and *gauge management insulators* as a stopgap measure, pending complete renewal of the track. The e-Plus clips have the benefit of providing a high *toe load* on the rail foot, with the aim of preventing movement. Network Rail decided to fit e-Plus clips to the Loop, but they had not completed the programme of fitment between Lime Street and Central, and they had not been fitted where the derailment occurred. Figure 6 below shows fitted Pandrol e-Plus clips and gauge management insulators beyond where the derailment occurred.

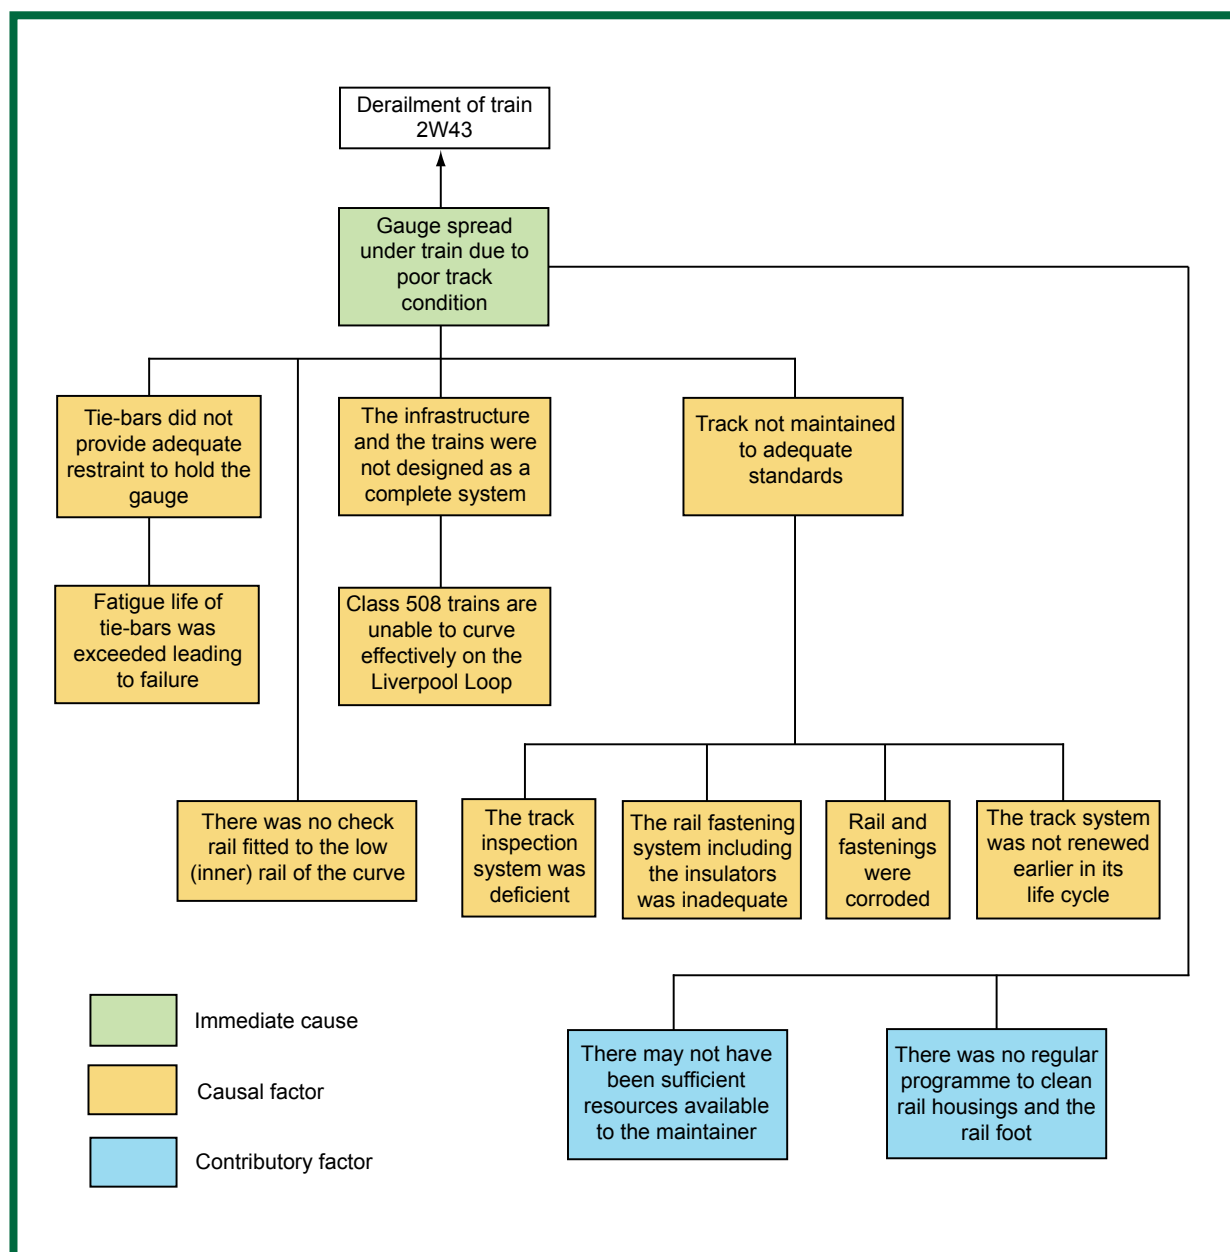
Figure 14: Causal analysis diagram

181 A diagram showing the immediate cause, causal factors and contributory factors is summarised in Figure 14.

- 185 The causal analysis diagram at Figure 14 showing the causal and contributory factors that led to the derailment has already been referred to.
- 186 Neither the handling of the train nor the signalling system contributed to the derailment.

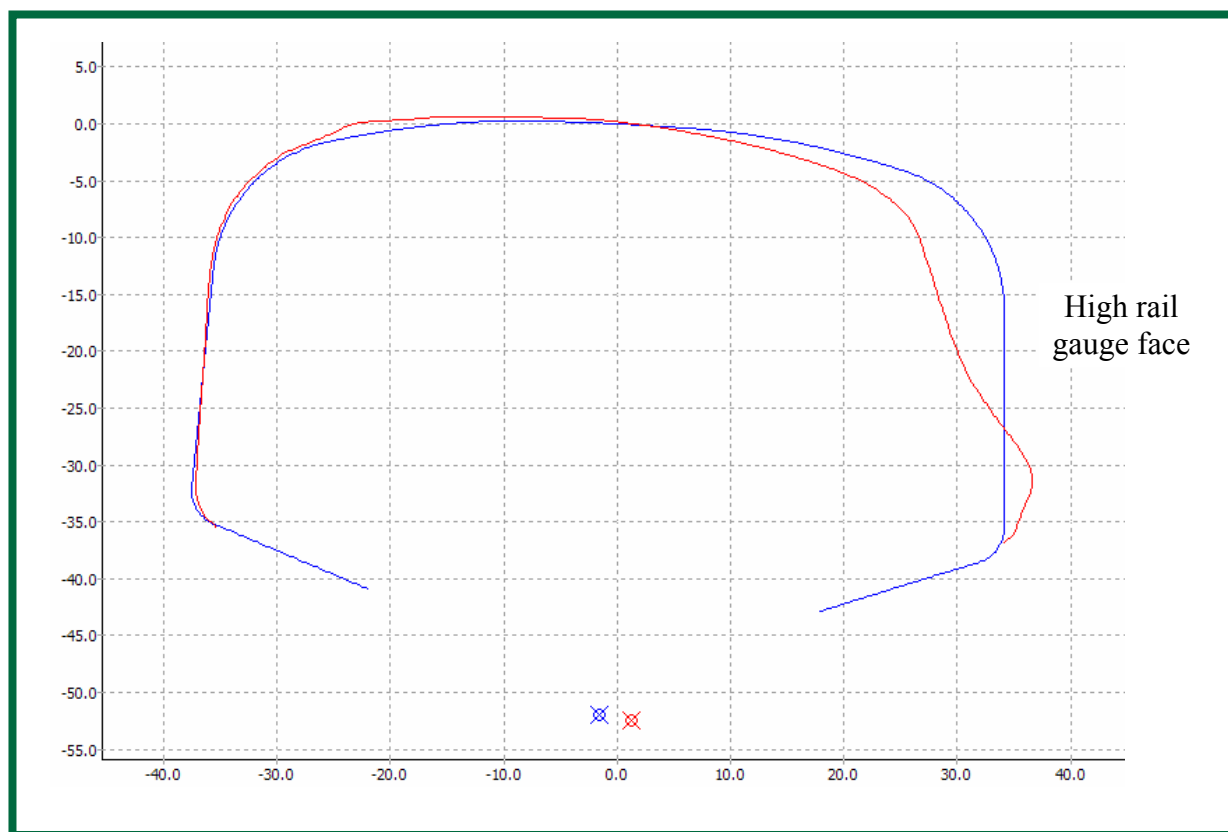
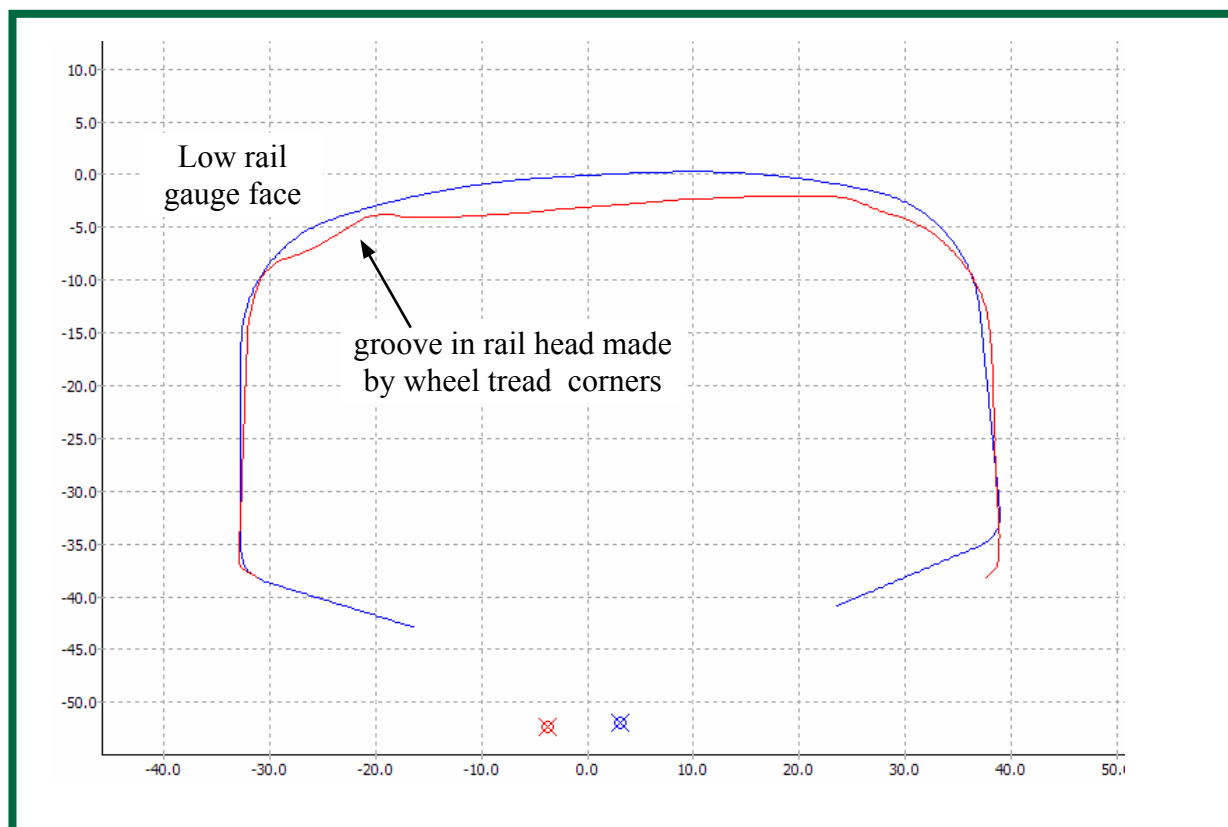
Note: the red outlines are the rail profiles as measured at the derailment site
