Rail Accident Investigation Branch

Rail Accident Report

**Cutting of rail from a line that was still open to traffic, near Thirsk station, East Coast Main Line.
11 January 2006**

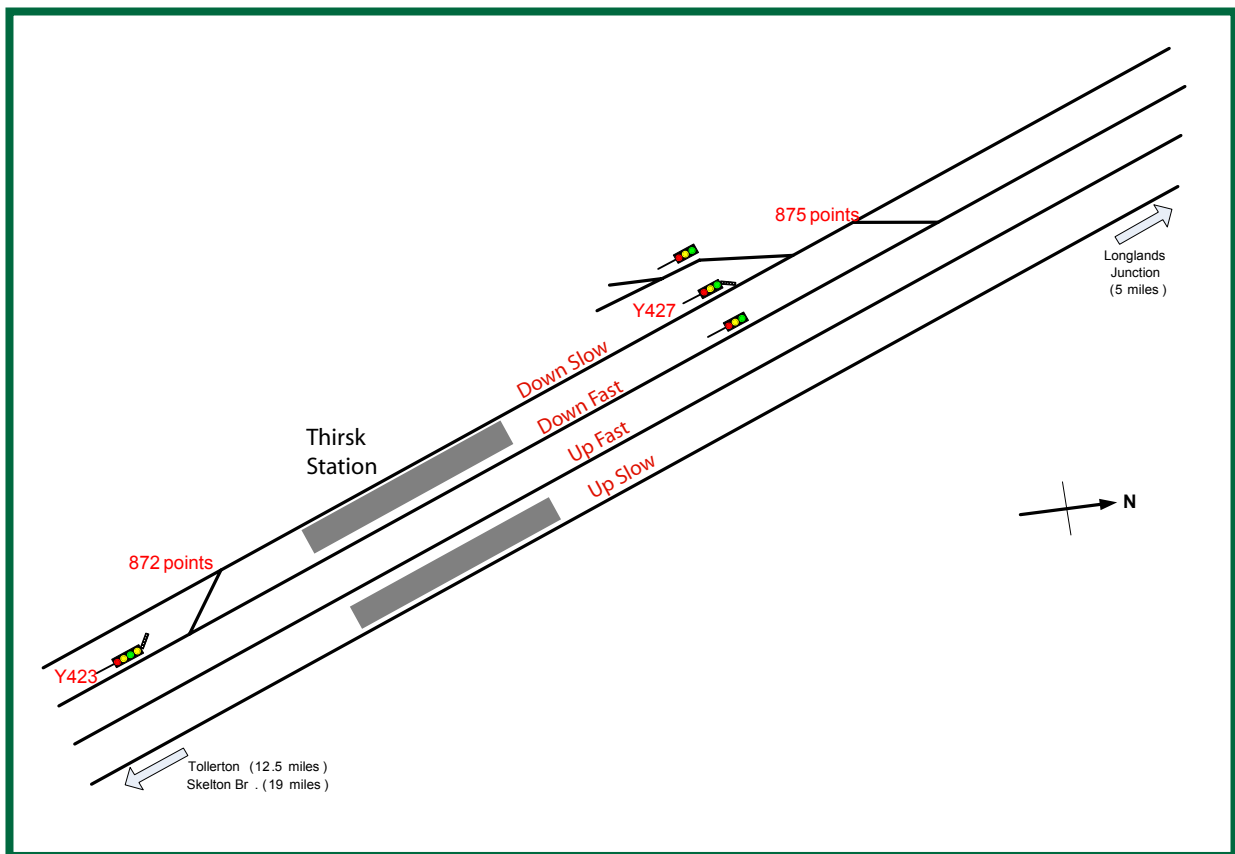
Figure 2: General view of Thirsk and locality

- 11 This incident occurred on a four track section of the East Coast Main Line (ECML), in the vicinity of Thirsk. The designation of the lines in this area is shown in Figure 2.
