Rail Accident Investigation Branch

Rail Accident Report

Derailment near Moy, Inverness-shire on 26 November 2005

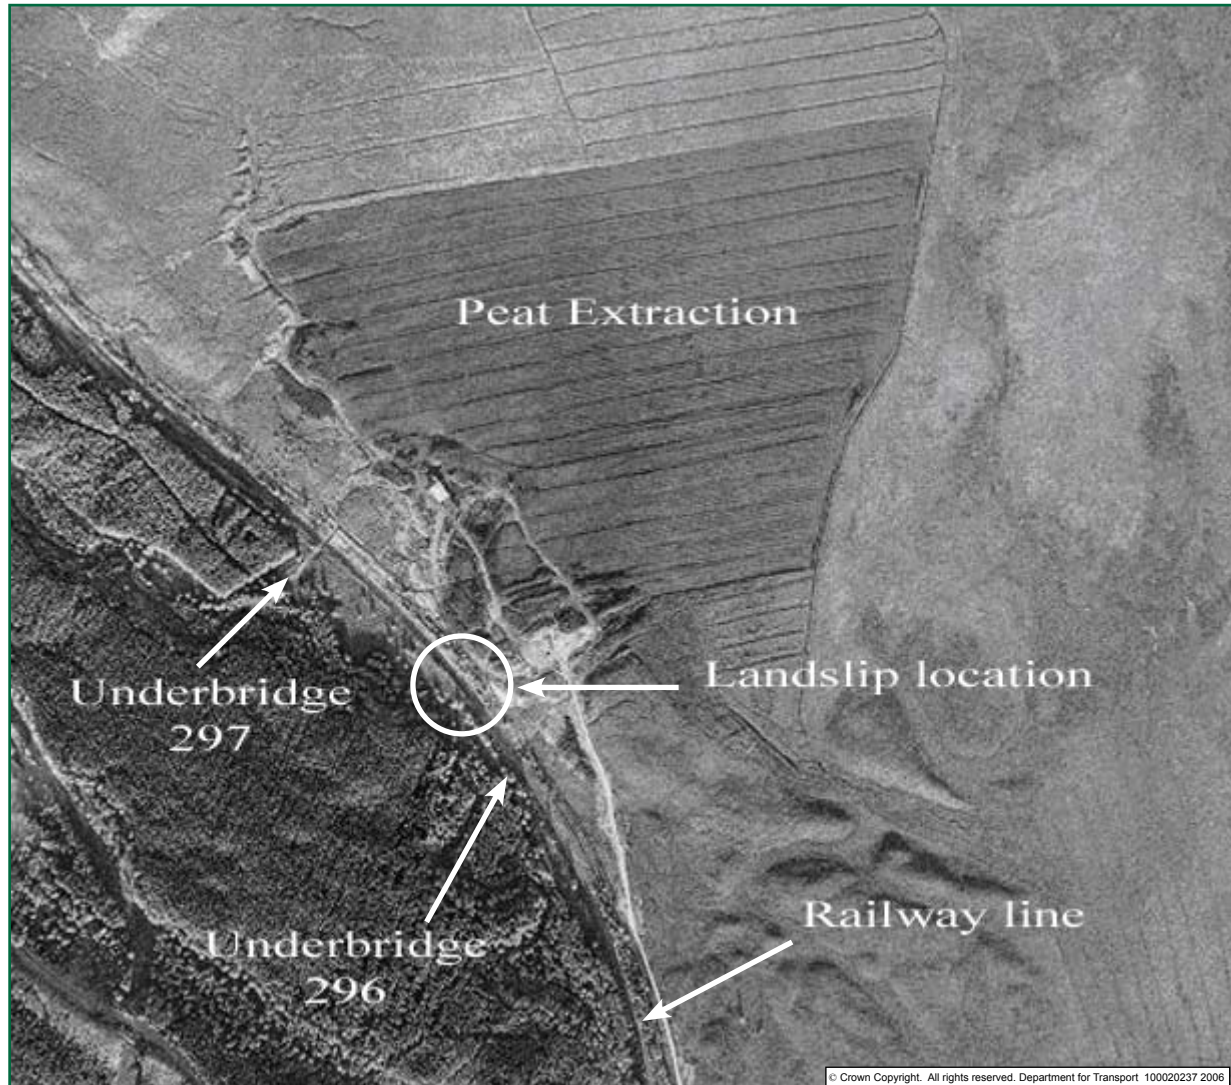
Figure 3: Historic aerial photograph of the site and surrounding area.

57 Historical maps and aerial photographs of the site and surrounding area show that the cutting slope lies within the catchment of watercourses which drain into streams running under underbridges 296 and 297. The bridges are located to the south and north of the cutting slope respectively. See Figure 3.

58 They also show that the majority of the catchment comprises land on which industrial peat extraction has taken place.

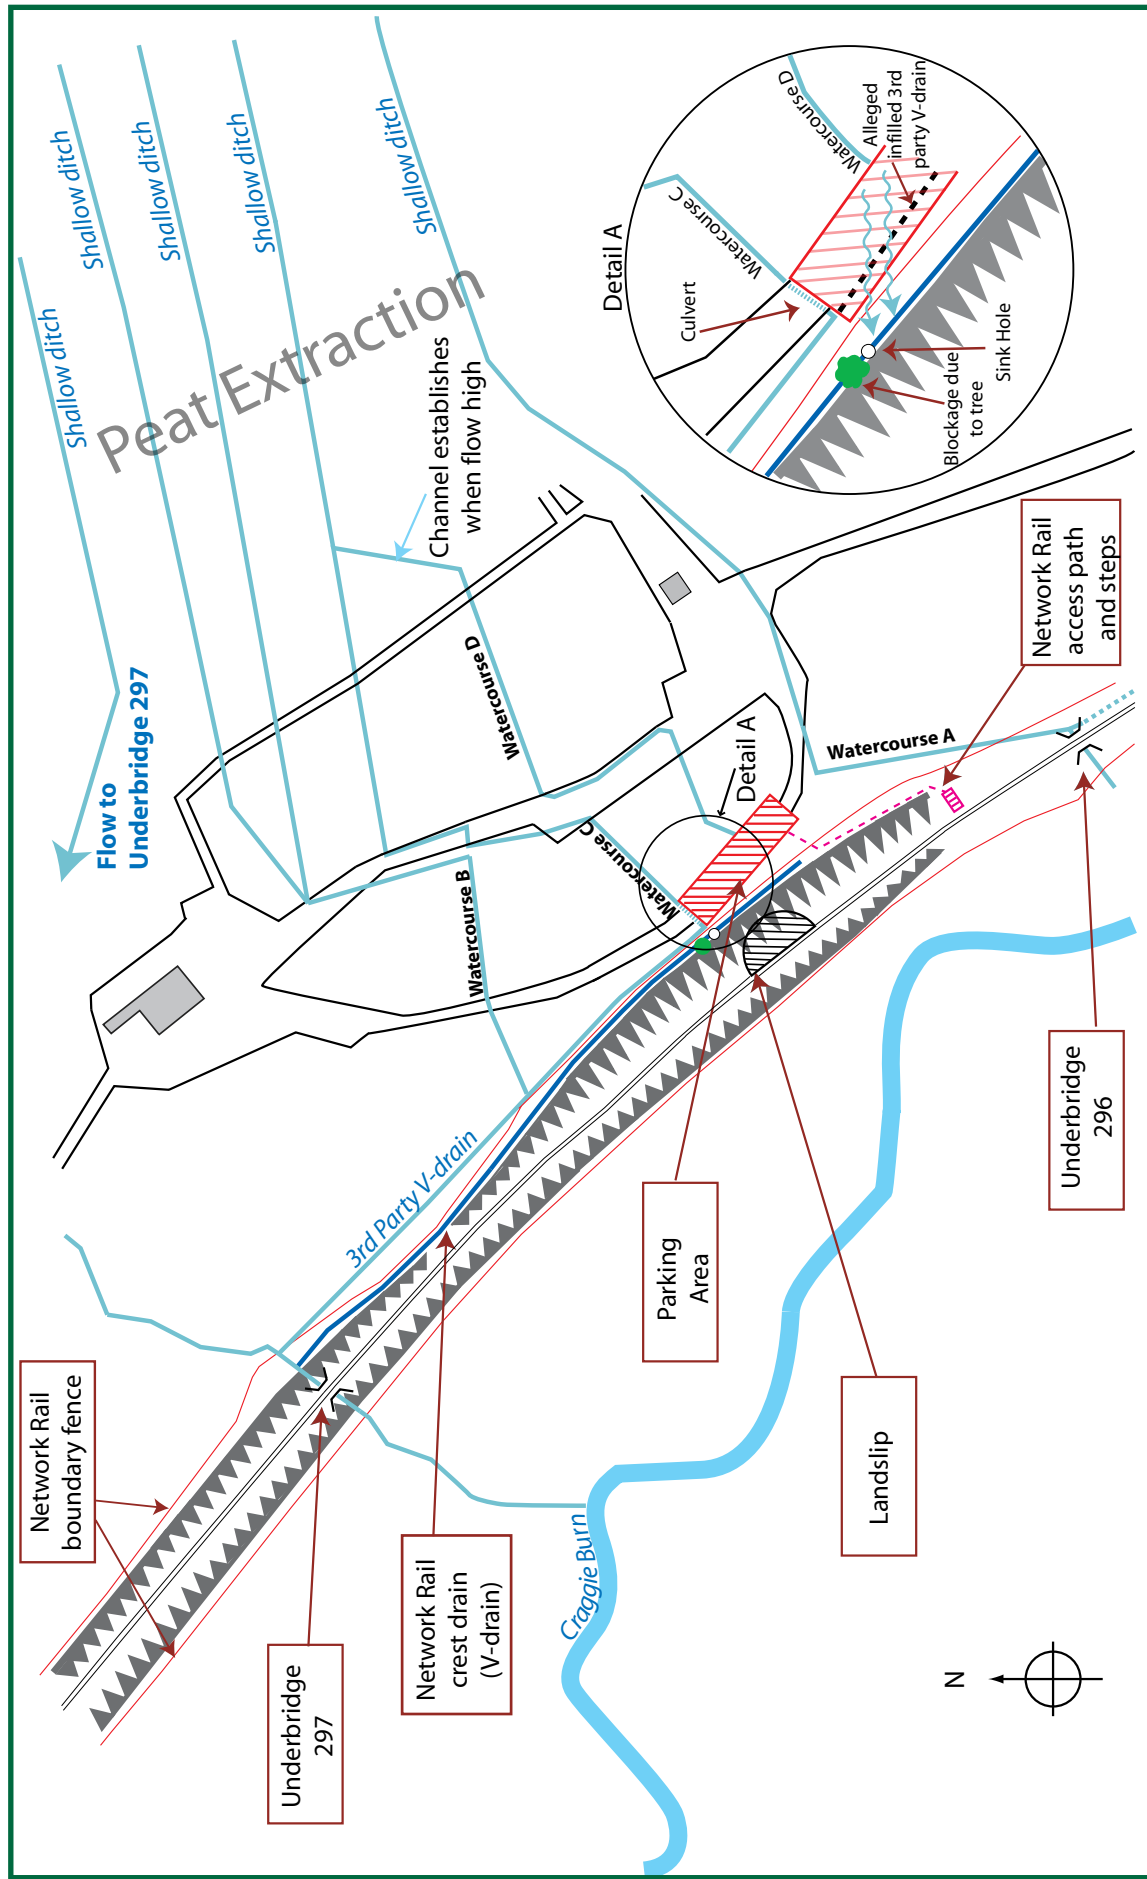
Figure 4: Site plan.

59 These features are shown on the site plan, Figure 4.

- 61 It reported that the *crest drain* directly above the site of the failure, and also adjacent to the Parking Area (see Figure 4) was covered in snow and pine needles.

- 63 Some surface water runs off the northern end of the Parking Area. There is evidence that a portion of the run-off then breaches the boundary fence and enters the Network Rail crest drain, as shown diagrammatically on Figure 4 and also on the video image at Figure 5. Just north of this location, a tree was found growing which blocked the drain. No water flowed past the blockage; it was observed to infiltrate into the ground via an apparent 'sink hole' in the drain invert. There was no evidence of ponding due to the blockage or water then overspilling onto the cutting slope. (A portion of the remaining run-off was observed to enter the 3rd party V-drain indicated on Figure 4. Water overflowed from this drain and entered the Network Rail crest drain via an additional breach of the boundary fence north of the tree blockage. However, at this location both drains appeared to be free-flowing and therefore effective in taking the water away from the cutting slope).

- 65 A geotechnical site survey, conducted on 12 January 2006, identified four watercourses, designated Watercourse A, B, C and D, which flow towards of the cutting slope. These are shown on the site plan, Figure 4.

- 177 Surface run-off is collected by Watercourses A, B, C and D, see Figure 4.
- 178 Watercourses A and B discharge water away from the cutting slope and do not present an infiltration risk to the slope. Watercourse C takes water toward the cutting slope but its subsequent discharge into a free flowing V-drain means that it too does not present an infiltration risk.
