# Rail Accident Report

## The blowback of a locomotive fire at Grosmont on the North Yorkshire Moors Railway 16 April 2006

# **The blowback of a locomotive fire at Grosmont on the North Yorkshire Moors Railway 16 April 2006**

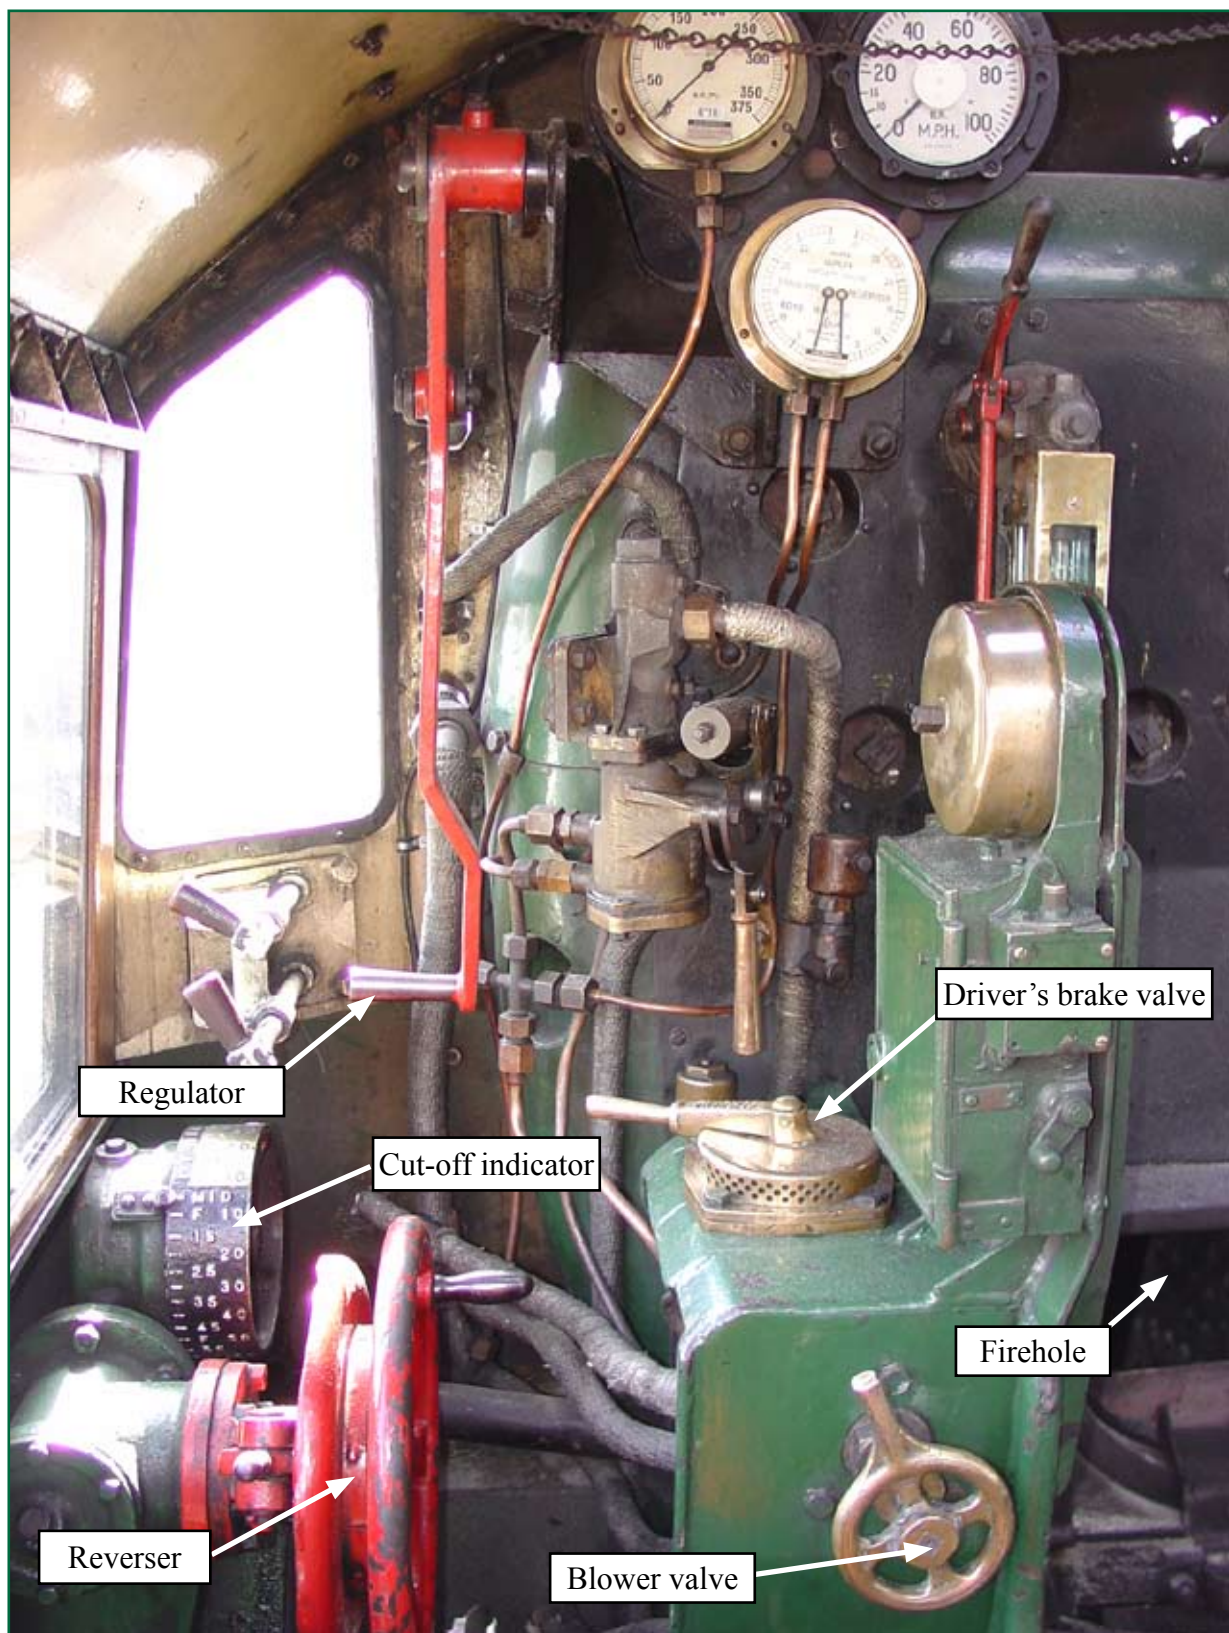
Figure 5: Locomotive 75029 footplate showing the driver's controls

- 44 On hearing the warning, the driver turned back towards the footplate and saw the flames. The driver immediately shut the regulator, opened the blower and applied the train brake, the last action causing him to receive a minor burn to his right hand. The flames started to abate and the fireman was then able to kick the firehole doors shut finally stopping the blowback. By the time the train had stopped, the blowback had finished. The firehole doors and driver's controls are pictured in Figures 4 and 5.
