# Rail Accident Report

## Derailment near Waterside, East Ayrshire 21 January 2006

# **Derailment near Waterside, East Ayrshire**

## **21 January 2006**

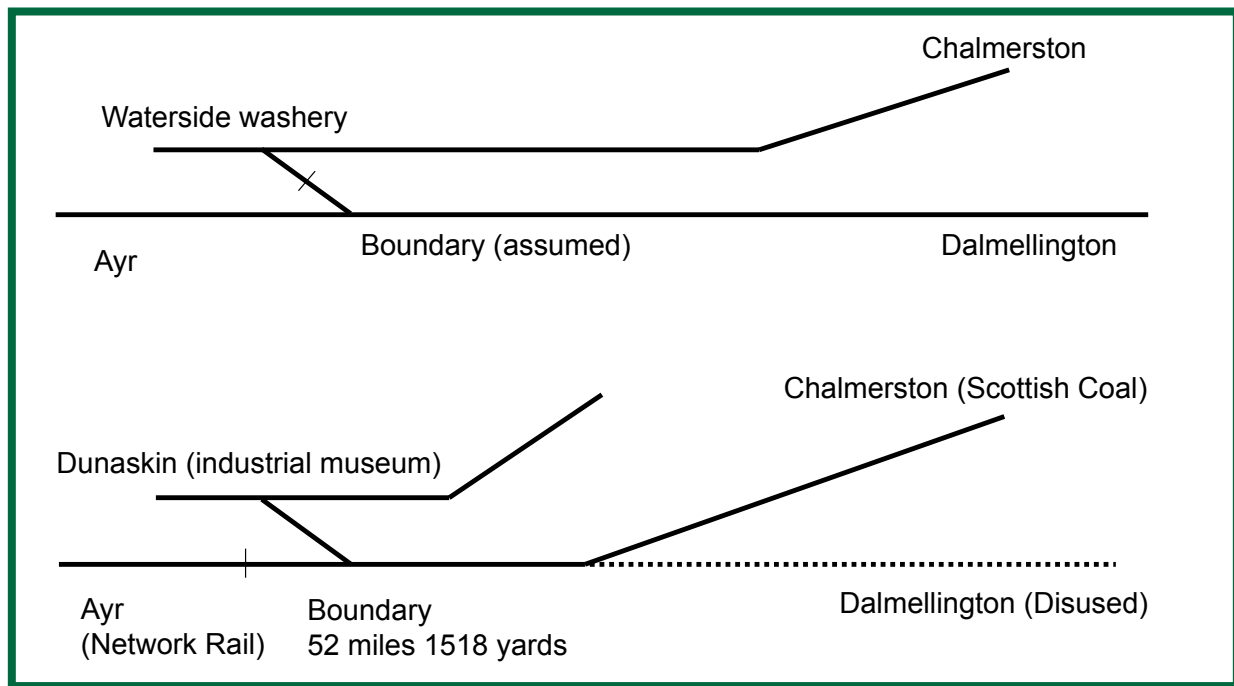
Figure 2: Schematic track layout at Waterside (pre-1964 and present).

- 33 After derailing, the leading wheelset of wagon 310724 continued to run to the left, close to the edge of the rail chairs, equating to a bogie rotation (*yaw* angle) of 7-10°. This behaviour continued until *facing points* were encountered at Dunaskin (Figure 2), located immediately before the Network Rail boundary at Waterside, giving access into sidings located to the right of the running line in the direction of travel. Flangemarks and other consequential damage consistent with the position of the derailed wheelset were observed at this location.

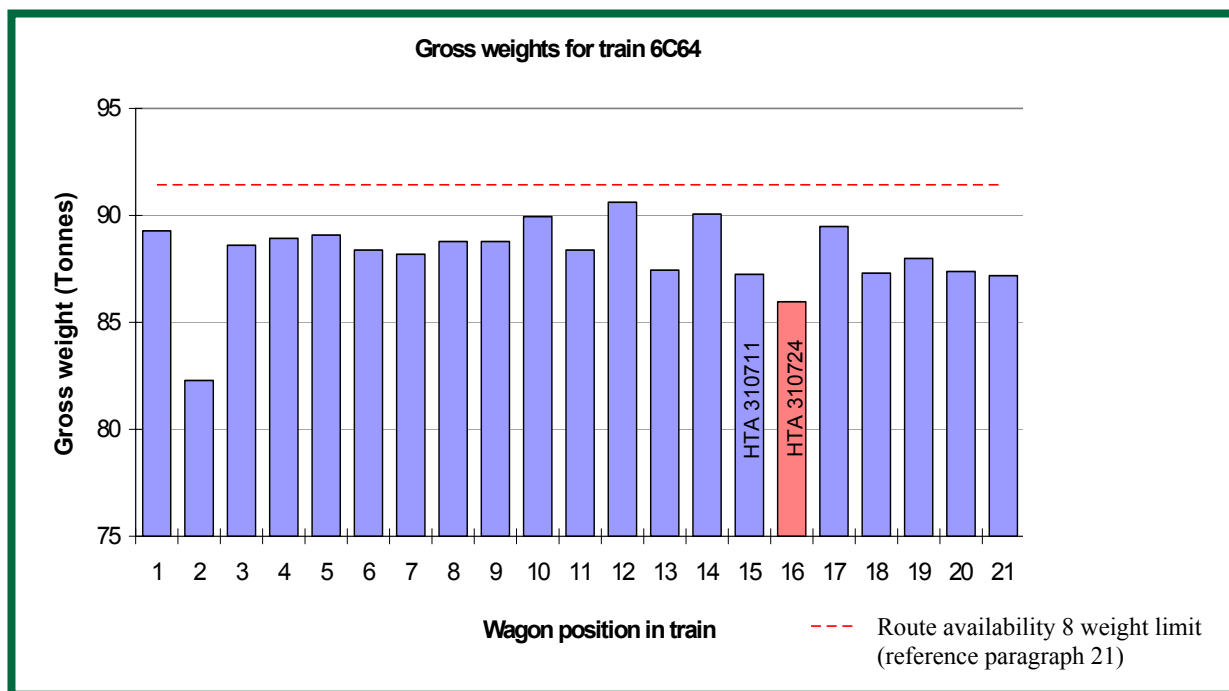
- 96 Loading records for all wagons forming the train have been examined (Figure 17). Wagons 310711 and 310724 were reweighed following the incident prior to transhipping their loads. There is no evidence that any wagon in this train was overloaded, although it was noted that wagon 310724 was relatively lightly loaded compared with most other wagons in the train. This is not considered to be a significant factor, however.

Figure 17: Gross loaded weights for each wagon forming train 6C64. The position of the first derailed wagon, HTA 310724, is highlighted.
