# Rail Accident Report

## Huntingdon train door incident 15 February 2006

# Huntingdon train door incident

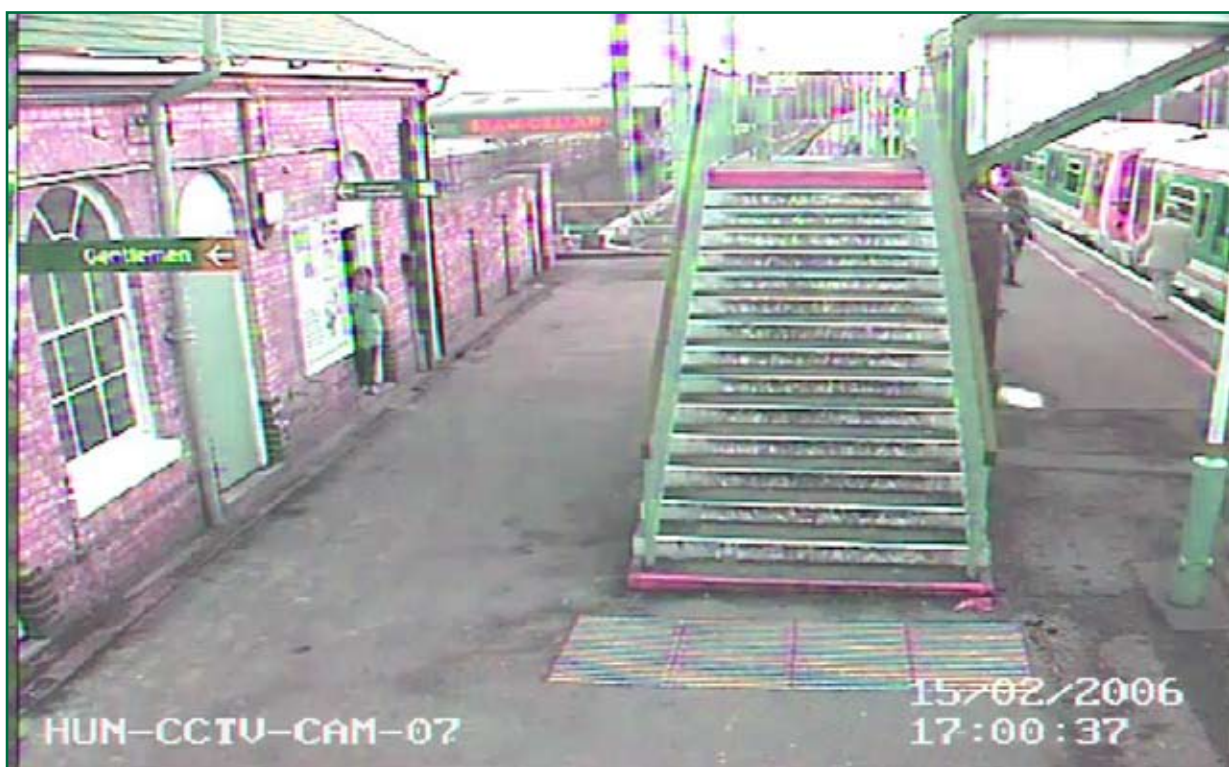
Figure 2: General view from security camera 7 – platform two

- 21 The view of platform two from security camera 7 is shown in Figure 2. The camera is looking south towards the London end of the platform. This frame was taken approximately one hour after the incident and shows an eight-car Class 365 Unit at a stand in the platform before travelling on towards London. Figure 3 is a schematic showing platform two and the train immediately before the incident. The key persons and the arrangement of security cameras are shown. Also shown are the positions of the relevant DOO cameras and monitors.

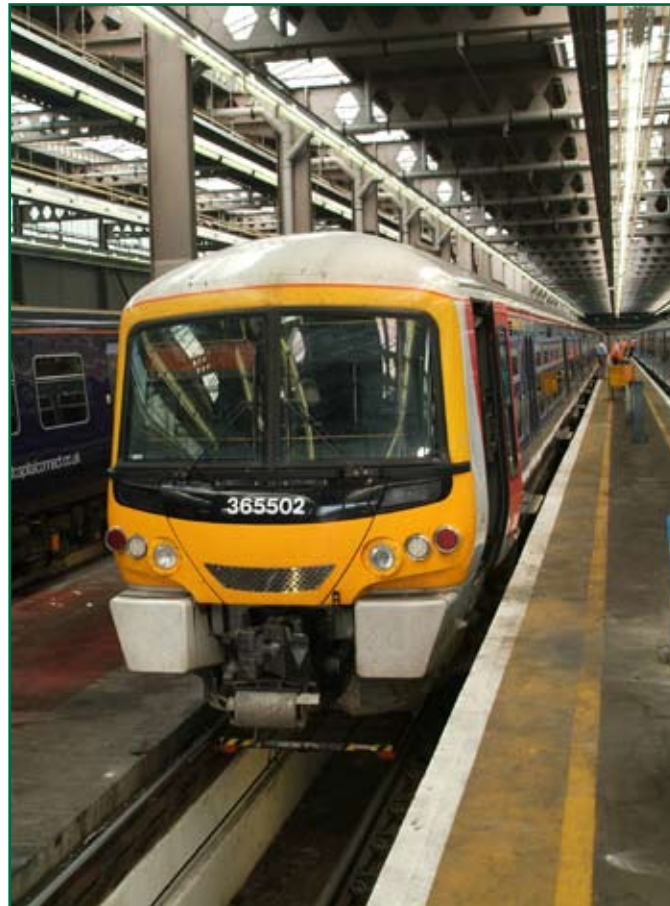
*Figure 4: Unit 365502 at Hornsey depot*

- 22 The train involved in the incident was a Class 365 *Electric Multiple Unit* (EMU) (Unit 365502) (Reference 1). The unit, shown in Figure 4, was a four-car set comprising:

- 65936 – Driving motored vehicle (leading end);
  - 72242 – Trailer vehicle;
  - 72243 – Trailer vehicle (with pantograph); and
  - 65895 – Driving motored vehicle (trailing end).

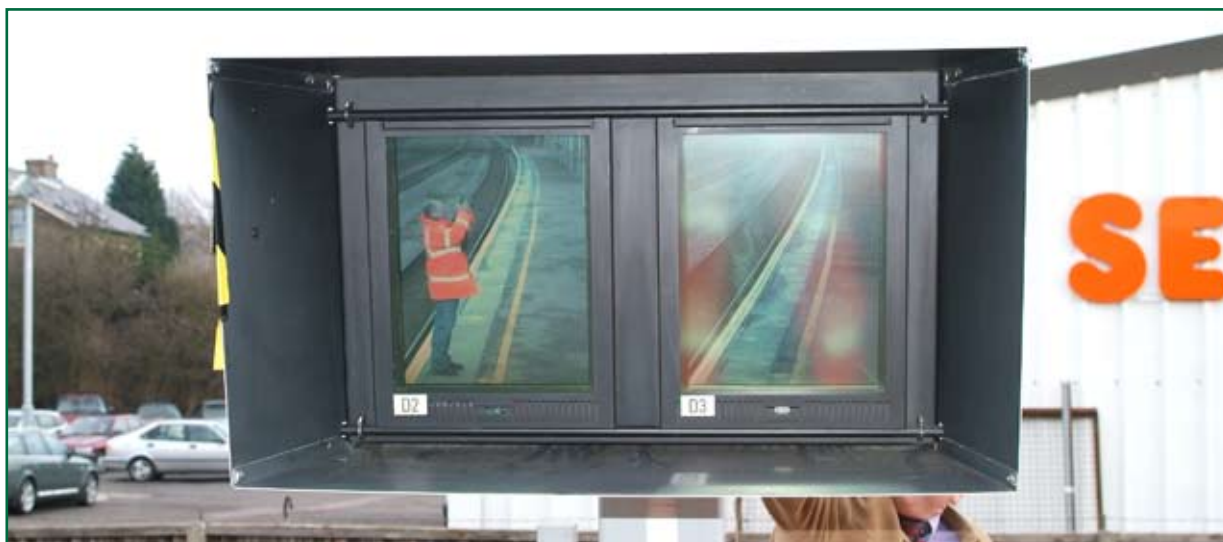
Figure 9: The four-car DOO monitor bank – monitors screens D2 and D3

58 The four-car monitor bank, as viewed from the left-hand side driver's window, is shown in Figure 9. Drivers are instructed, trained and assessed on their abilities to bring their train to a stand alongside the monitor banks with good visibility of the DOO monitor screens and what to do in the event of an overrun (Reference 7). The side view of this monitor bank looking towards the platform buildings is shown in Figure 10. This view shows the angle of the monitor bank.

- 70 The two monitors showing the images from two separate cameras are shown in Figure 9. Monitor D2, the left-hand side, shows the image from a camera mounted on the platform in front of the stationary train driver's cab and is set up to cover the first two vehicles of a four-car unit. The right-hand monitor, D3, is set up to show an image of the last two vehicles of a four-car unit. The position of the camera covering the first two vehicles is shown in Figure 15 with the position of the second camera covering the last two vehicles shown in Figure 16. Images from these cameras, with a person stood at the leading door of the third vehicle of a four-car unit, are shown in Figure 17. It should be noted that the photograph has been edited to remove the photographer from the scene. This was done to improve picture clarity.

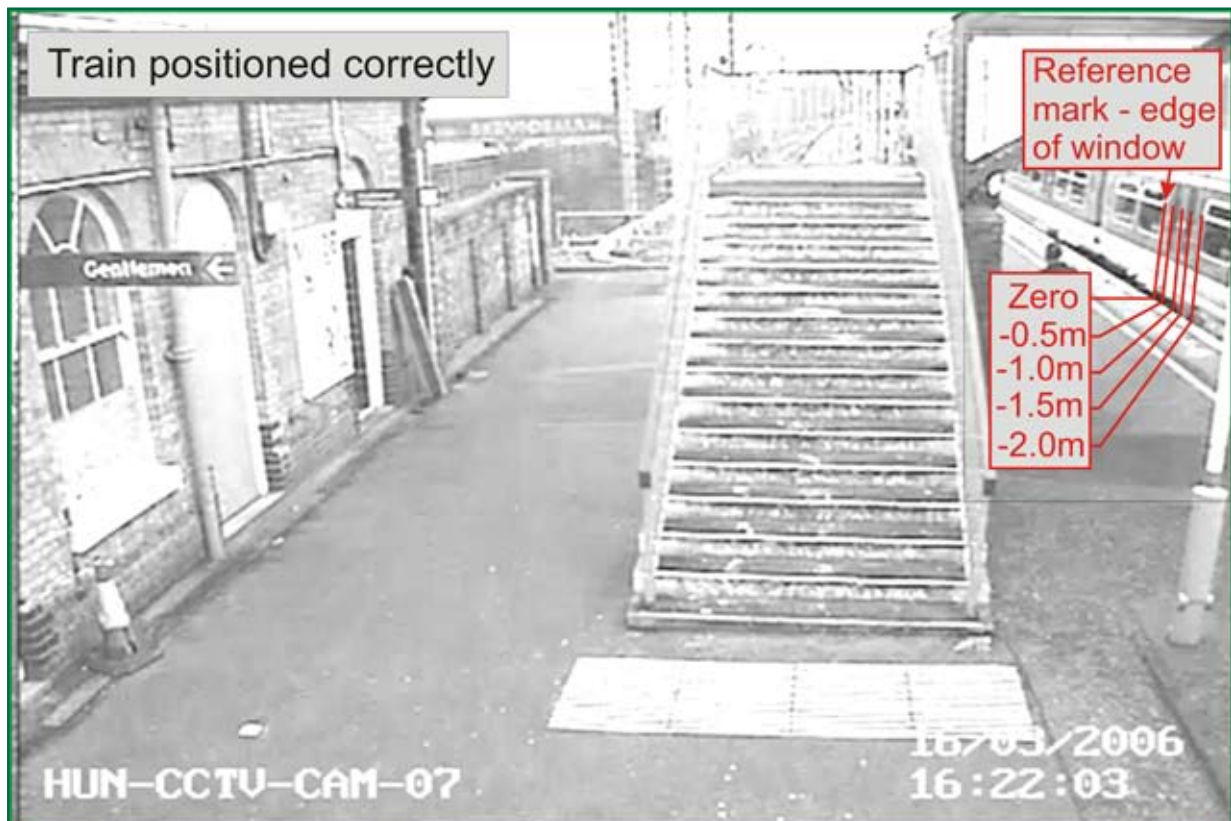
Figure 11: Image from security camera 7 showing train at optimum stopping point

- 60 The recorded images from security camera 7 were then downloaded. These images were first of all checked to ensure that the camera position and lens setting had not changed since the incident. From the downloaded images suitable frames were extracted. These frames were then overlaid using proprietary image handling software. Figure 11 shows an image of this test train in the correct position, that is, with the driver's left-hand window alongside the four-car monitor bank. Figure 12 shows the test train at a stand 1.5 m before the correct position.

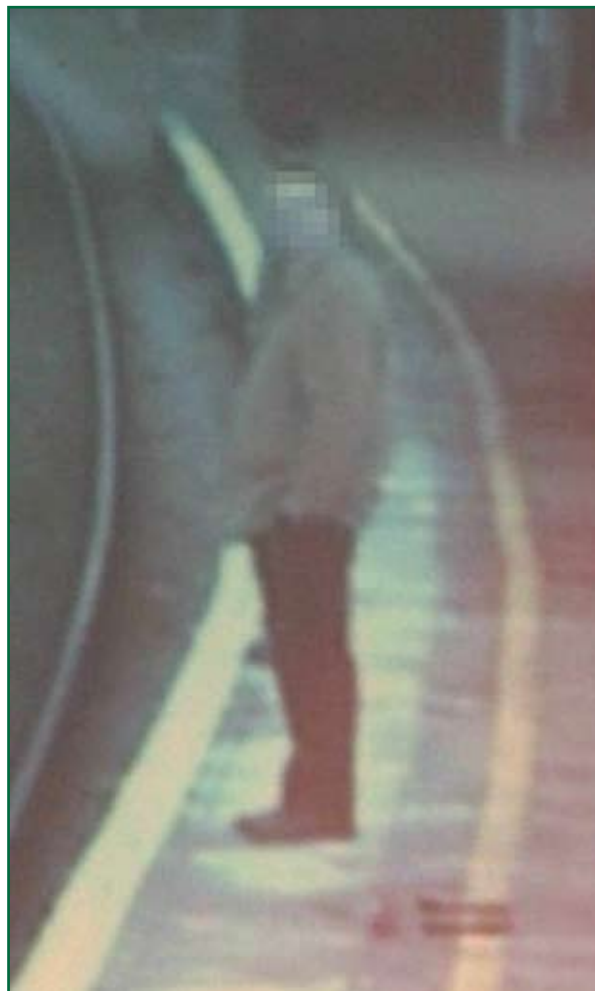
*Figure 20: Enlargement of image showing on monitor  
- with two persons evident*

- 77 One set of observations is shown in Figure 19. In the image on the D2 monitor only one person appears to be in view and that person appears to be within the edge of the platform edge and the yellow line and well clear of the door/platform edge. The view from the right-hand D3 monitor also indicates that only one person is present but this person is now in closer proximity to the edge of the platform edge. For clarity the image of the photographer has been removed from the D2 monitor image. Figure 19 shows that the person at the trailing door of the second vehicle can readily obscure the driver's view of a person at the leading door of the third vehicle. The effect is highlighted further in Figure 20 which is an enlargement of the image from the D2 monitor with two persons in view.

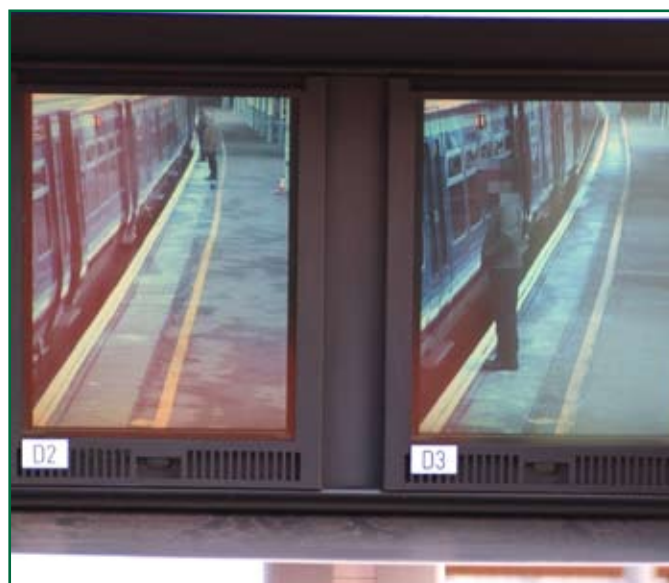
*Figure 21: Monitor bank images with volunteers in position and a service unit at the platform*

- 78 The exercise was then repeated when an in-service unit arrived. Photographs were taken showing what appeared on the monitor bank (Figure 21), ie what the driver could observe through his open window as shown in Figure 22.

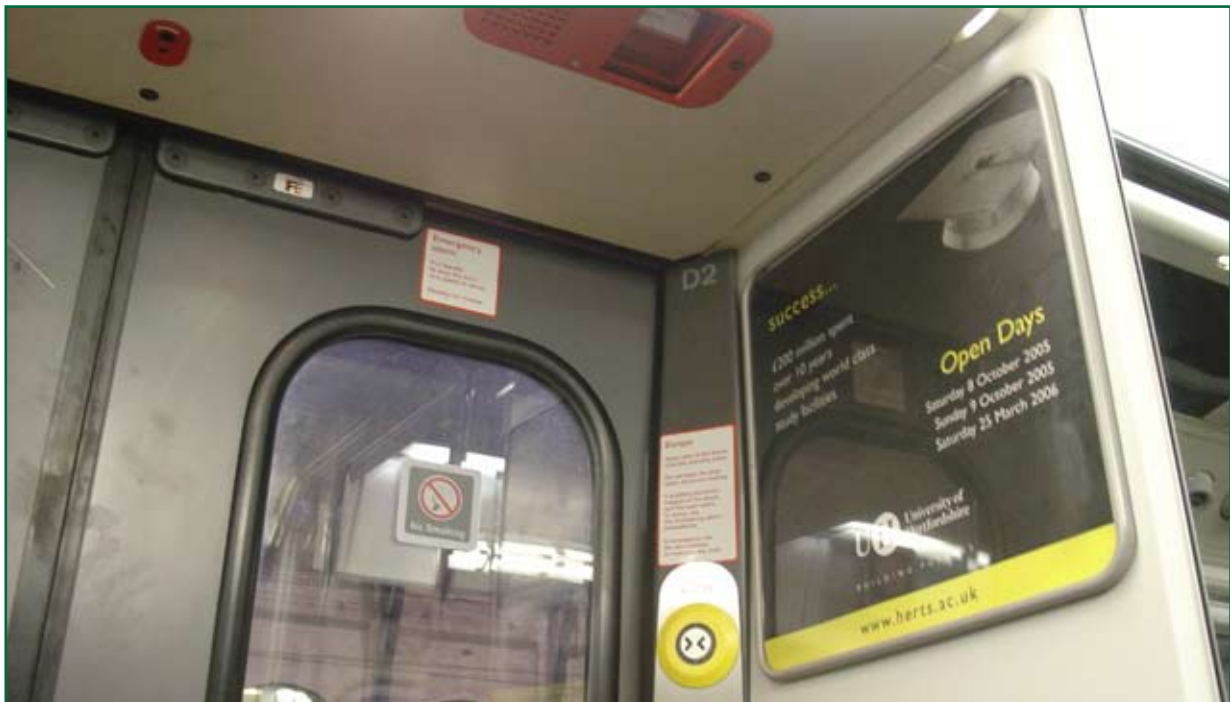
Figure 26: Signage right-hand side of the Class 365 Unit door

- 93 Immediately following the point where P2 became trapped, there was considerable confusion within the train as to how to stop it in the emergency.
- 94 Figure 25 and 26 show the immediate view a person would have of the inner door panels of the leading door of the incident Class 365 Unit. The warning notice located above each of the door closing controls has been enlarged for clarification and is shown in Figure 27. This notice refers to using the 'Emergency Alarm' in the event of a person being trapped in the doors.

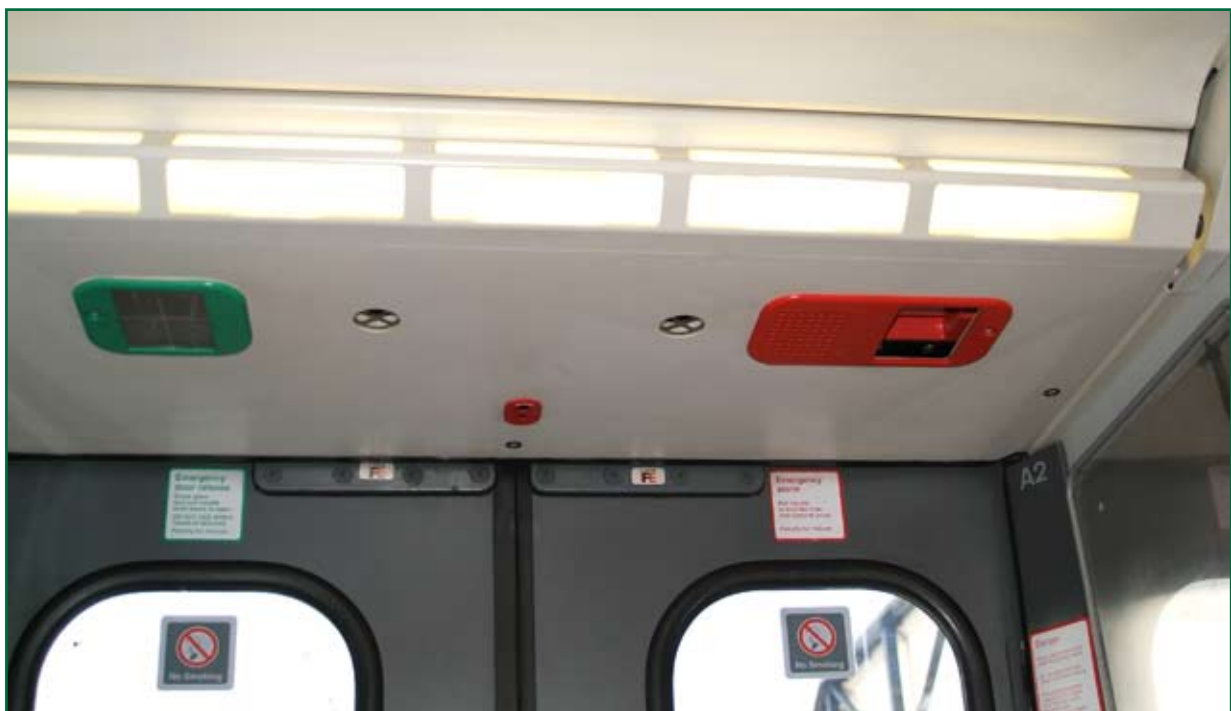
Figure 28: Door release and emergency controls over the Class 365 Unit door

- 95 Signs identifying the location of the 'Emergency Alarm' and to the 'Emergency Door Release' were attached to the upper portion of the door leaves D1 and D2 respectively and on the red alarm handle located in the horizontal panel immediately above the right-hand door. Figure 28 shows the location of these controls for the Class 365 Unit. The position of these labels and the Emergency Alarm and Emergency Door Release controls are shown in Figure 28.

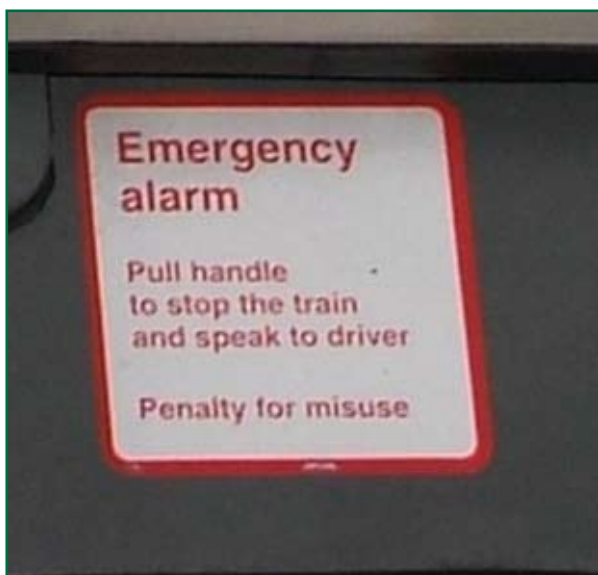
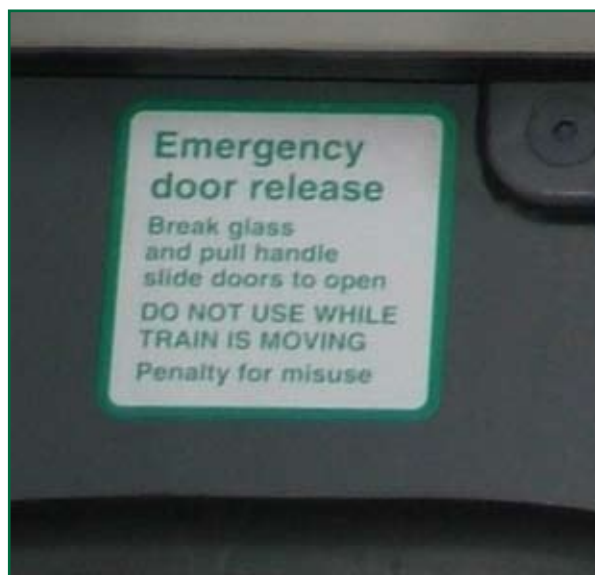
*Figure 29: Labels on closed door leaves*

- 96 The only sign in the vicinity of the incident door relating to the Emergency Door Release is found on the left-hand door leaf (D1). If this release had been activated the train would have stopped immediately; however, passengers are instructed not to use this release if the train is moving. Figure 29 shows the text associated with both the 'Emergency Alarm' and the 'Emergency Door Release'.
