Rail Accident Report

Runaway permanent way trolley at Notting Hill Gate 24 May 2006

Report on a runaway permanent way trolley at Notting Hill Gate, 24 May 2006

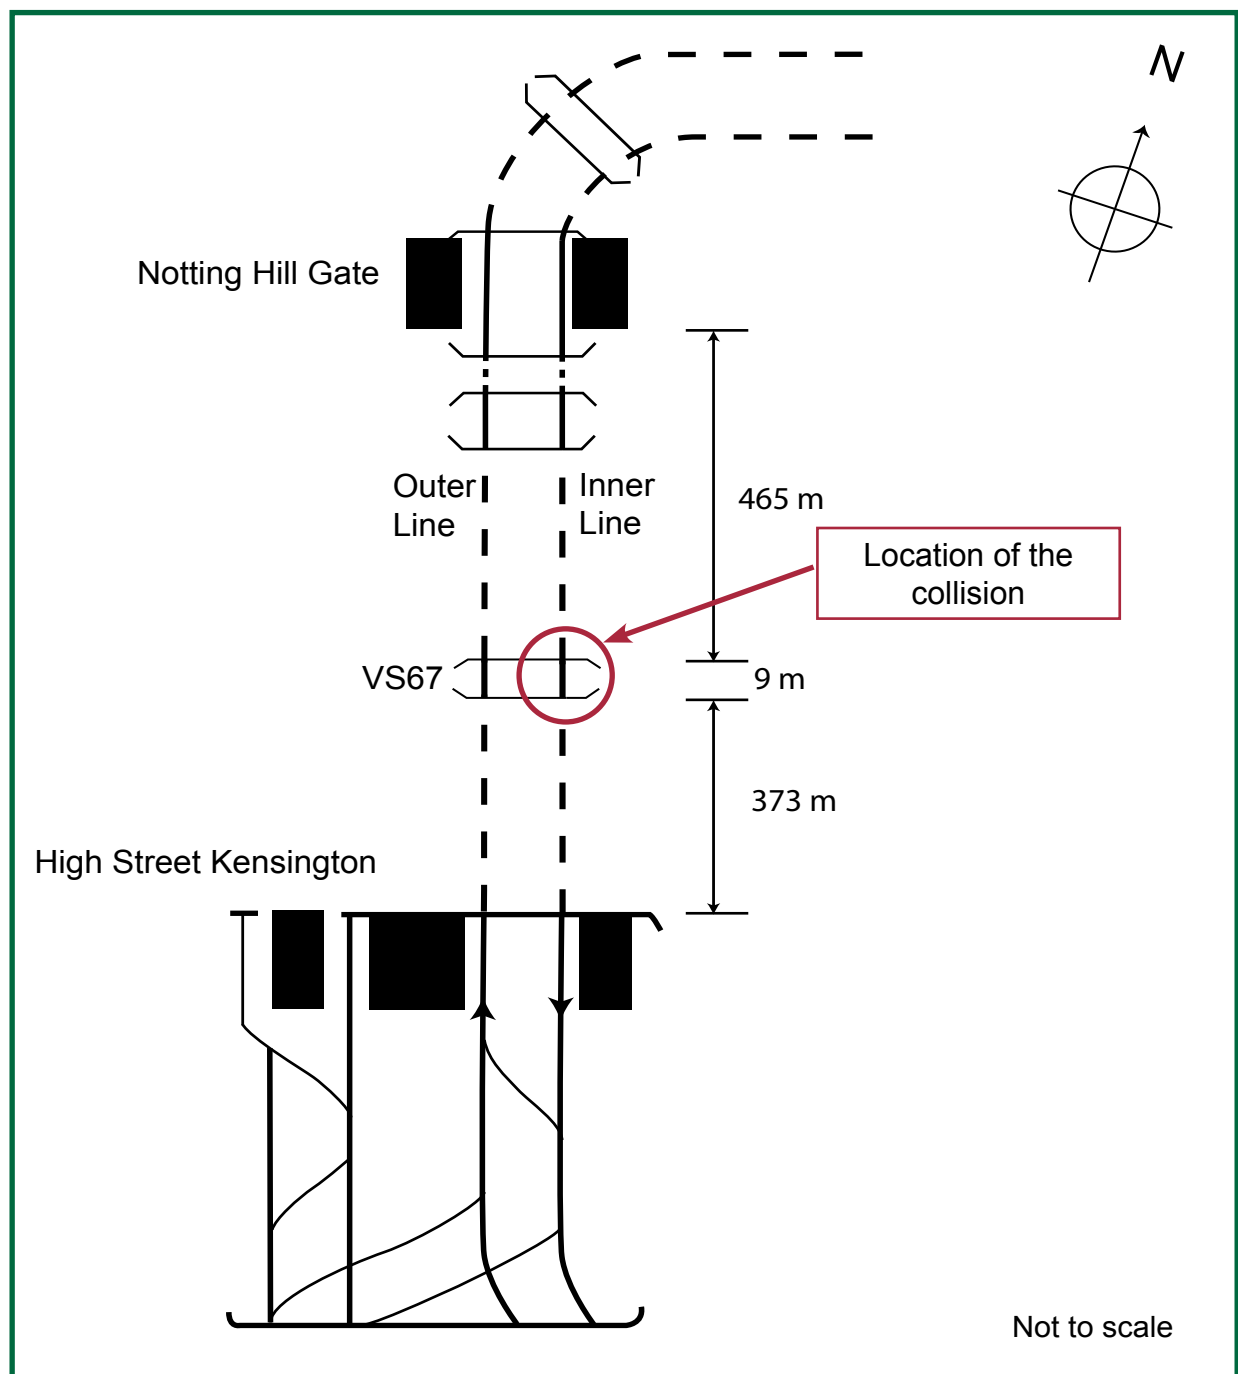
Figure 2: Diagram of the location.

- 18 The incident took place on the inner track of the Circle Line between Notting Hill Gate and High Street Kensington. Figure 2 shows the location.
- 19 The Circle Line is a *sub-surface route* of the London Underground network. Traction power is supplied via a *conductor rail* system. The line is double track and at this location it consists of *bullhead* rail carried in *chairs* on timber *sleepers* with limestone *ballast*. The underground sections of the line include *ventilation shafts* (VS) open to the surface. The location where the work was to be carried out was adjacent to VS67.

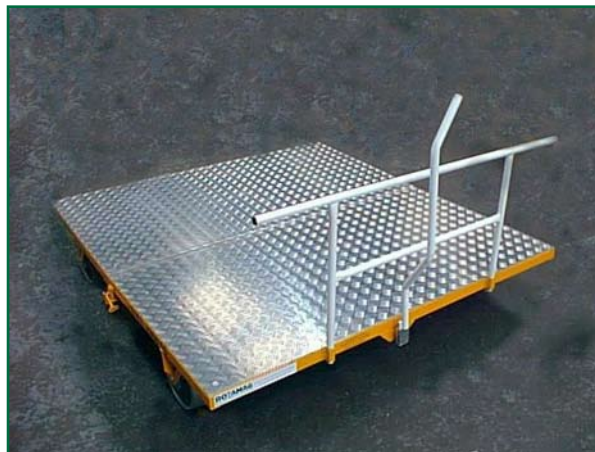
Figure 3: A Rotamag split trolley.

- 26 The trolley involved was a Rotamag split trolley (manufacturers number UD524-13). This type of trolley has been in service with LUL and the main line network for many years. A Rotamag split trolley is shown in Figure 3.
