Rail Accident Investigation Branch

Rail Accident Report

Locomotive runaway near East Didsbury 27 August 2006

27 August 2006

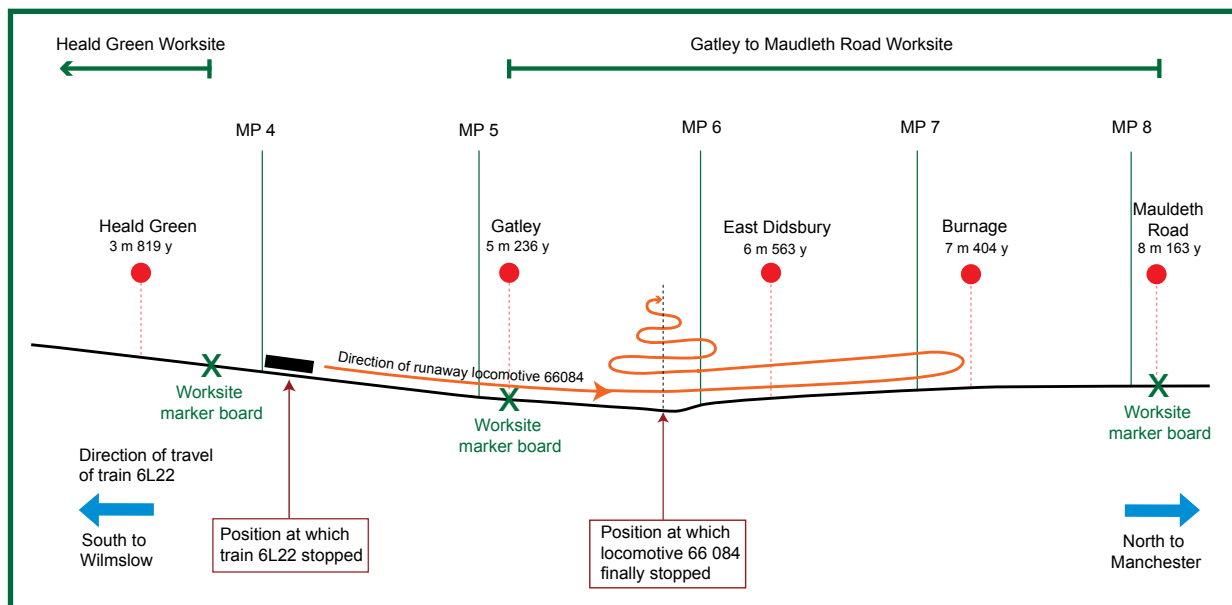
Figure 2: Locations and track gradients associated with the incident

- 17 The locomotive then ran back and forth through a trough in the alignment to the south of East Didsbury station and was brought to a stand as a result of the gradient profile and workers wedging a wooden post in front of one of the locomotive's wheels. The station locations and the track gradient profile of the area are shown in Figure 2.

- 23 Figure 2 shows the location of the incident. The front (south end) of locomotive 66 084 was 384 m north of milepost 4 on the Styal line when the runaway started. At this location, the locomotive was on a 1 in 141 gradient, falling to the north.
- 24 The locomotive ran northwards to Burnage station, stopped, ran southwards and then oscillated about the low point just to the south of East Didsbury station. It was finally stopped 150 m south of milepost 6, by a combination of the gradient profile and workers pushing a wooden post in front of a wheel.
- 25 The total distance covered by the runaway locomotive was around 5 miles (8 km).

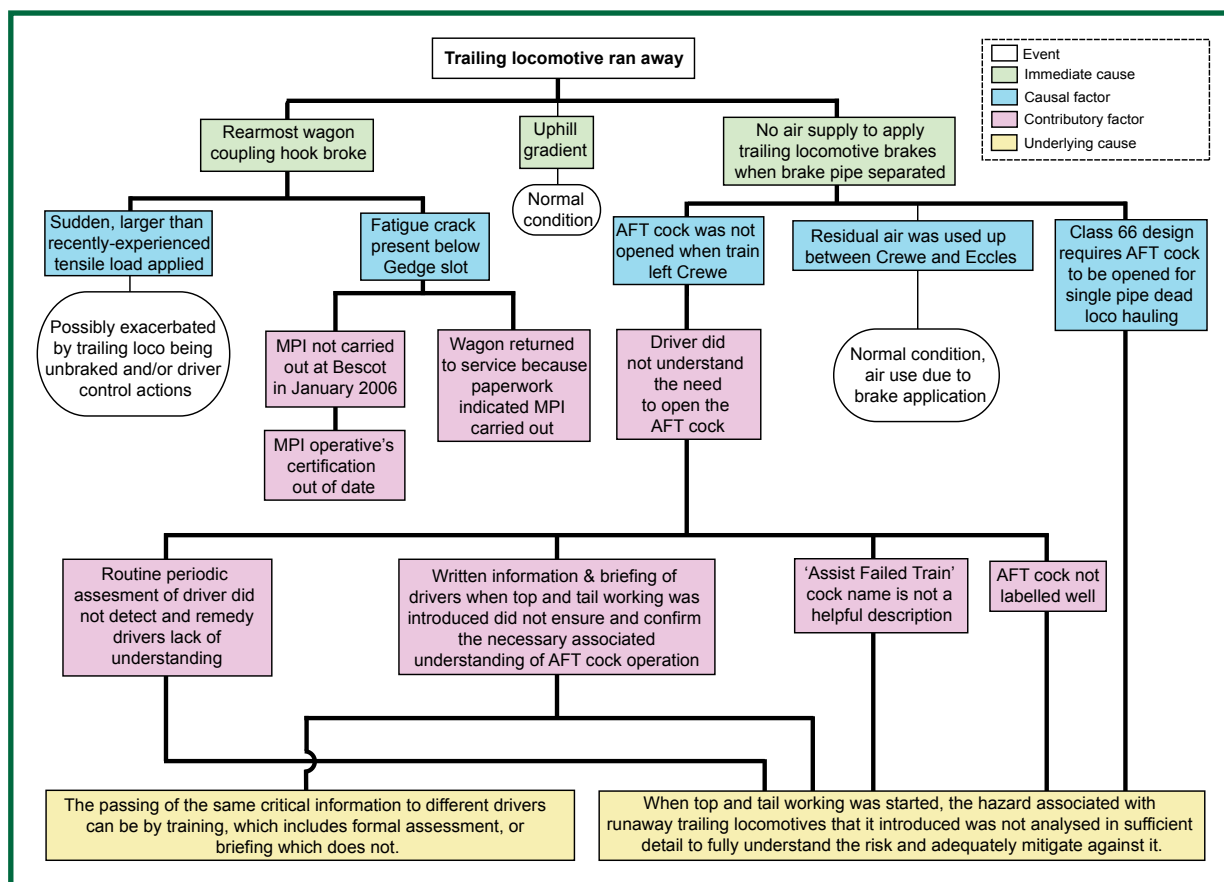
Figure 9: Diagram showing chain of events and factors

93 The diagram shown in Figure 9 illustrates the causal, contributory and underlying factors graphically.

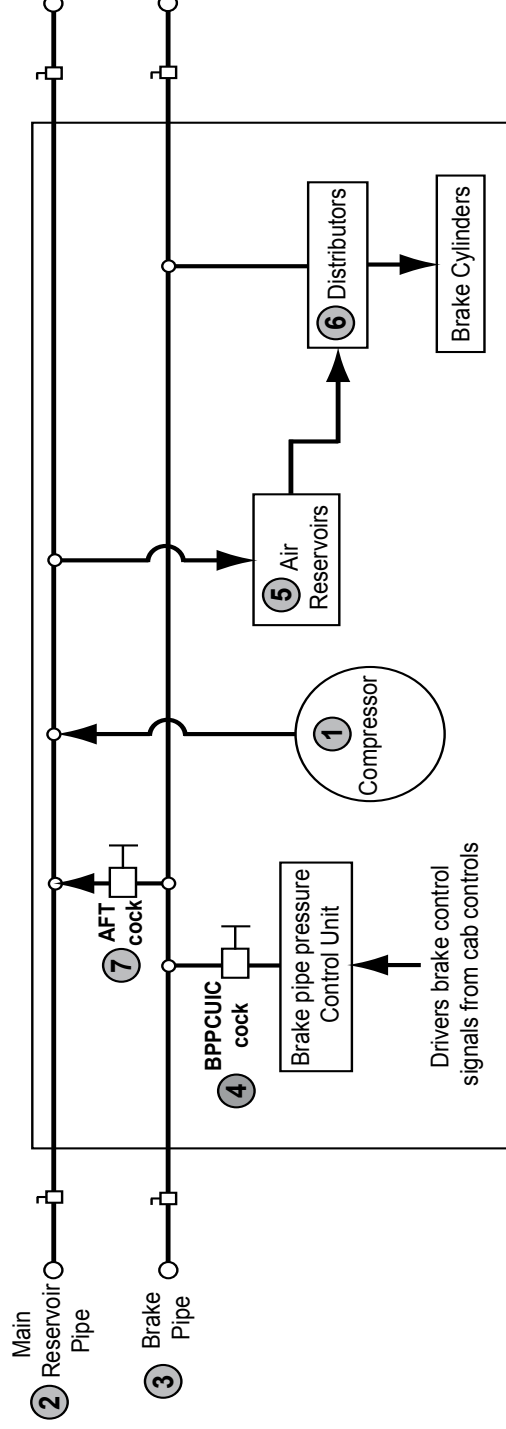
1) COMPRESSOR

When the locomotive engine is running the compressor charges the main reservoir pipe and the air reservoirs on the locomotive. If the engine is dead the compressor does not operate.
