Rail Accident Report

**Fatal accident involving a train driver, Deal
29 July 2006**

Fatal accident involving a train driver, Deal

29 July 2006

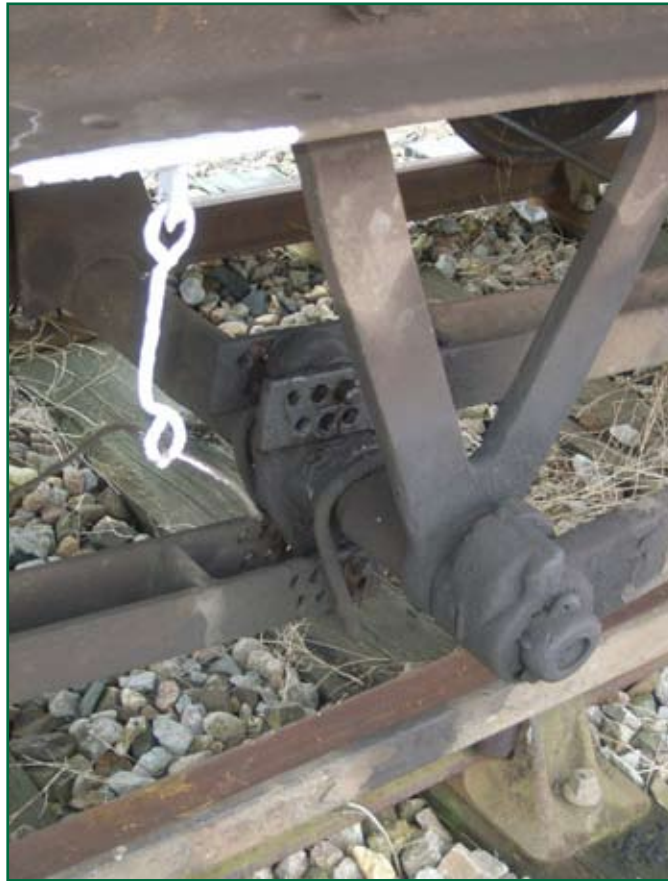
Figure 8: Adjustment of the push rod on ZBA type wagons

- 140 All of the wagons on train 6Z25 were of the ZBA type. These wagons are all fitted with a simple air brake system. This comprises a distributor feeding a single large cylinder. When air is fed into the cylinder from the distributor it drives a piston. Each brake block is connected to this piston by mechanical linkages.
- 141 The application of an even brake force at each wheel is dependant on the correct adjustment of the mechanical linkages. This adjustment is performed by moving pins along a series of holes in the *push rod* associated with each individual brake block (see Figure 8).
- 142 Typically the adjustment of the push rod will be performed when a new brake block is fitted. This is necessary if the new brake block is not to be forced too hard against the wheel tread.
