Rail Accident Report

Derailment at Starr Gate, Blackpool **30 May 2006**

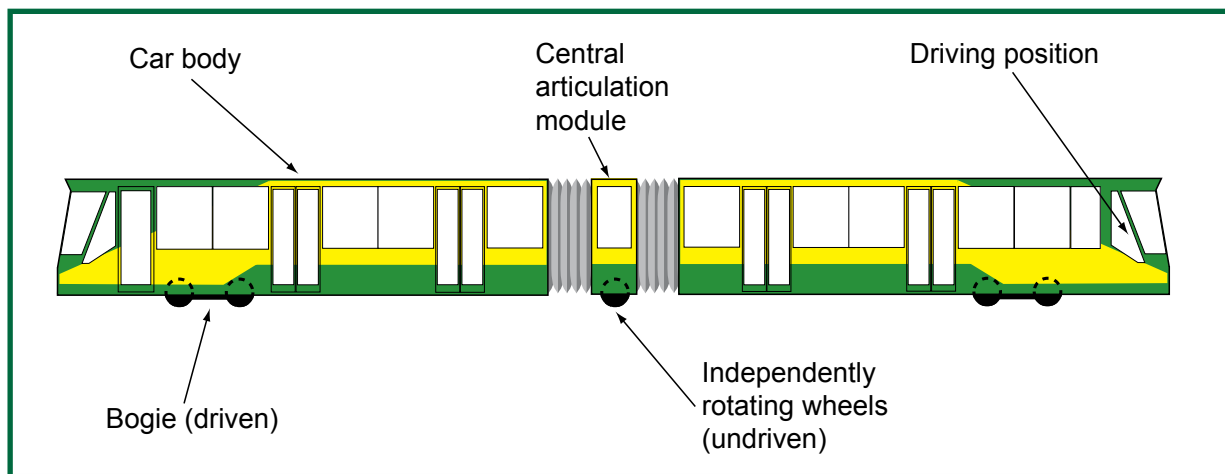
Figure 2: Principal arrangement of the tram

- 16 Tram 611 was owned and being developed by Tram Power. Other organisations were involved in the earlier stages of design and construction.
- 17 The tram comprises two car bodies which are connected together by a central articulation module. The outer end of the each car body is carried by a single four wheel *driven bogie* which incorporates automotive axle components. The articulation module is carried on a pair of wheels which are free to rotate independently of each other. Neither of these wheels is driven. All the wheels on the tram include rubber elements between the outer rim and wheel centre. The principal arrangement of the tram is shown in Figure 2. It is designed to be capable of traversing curves of radius 15 m and greater.

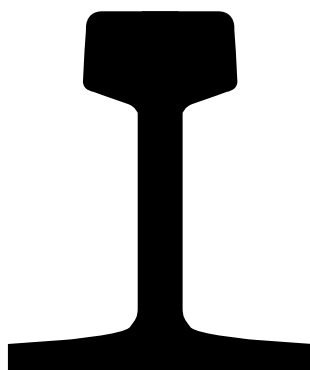
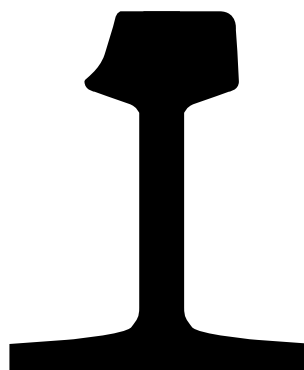
Figure 9: Side Wear

Sidewear is loss of section to one side of the rail head, it is similar to normal progressive rail wear but occurs on the outside rail of a curve or where dips in the track allow the flange of a wheel to be forced onto the rail either by centrifugal force or acceleration.

a. Full rail profile

b. Profile with sidewear

Rectification of any severe sidewear identified should be by replacing or (if possible) transposing the rails.
