Rail Accident Investigation Branch

Rail Accident Report

**Two near misses at Crofton Old Station No.1
Level Crossing, near Wakefield, West Yorkshire
1 and 18 May 2006**

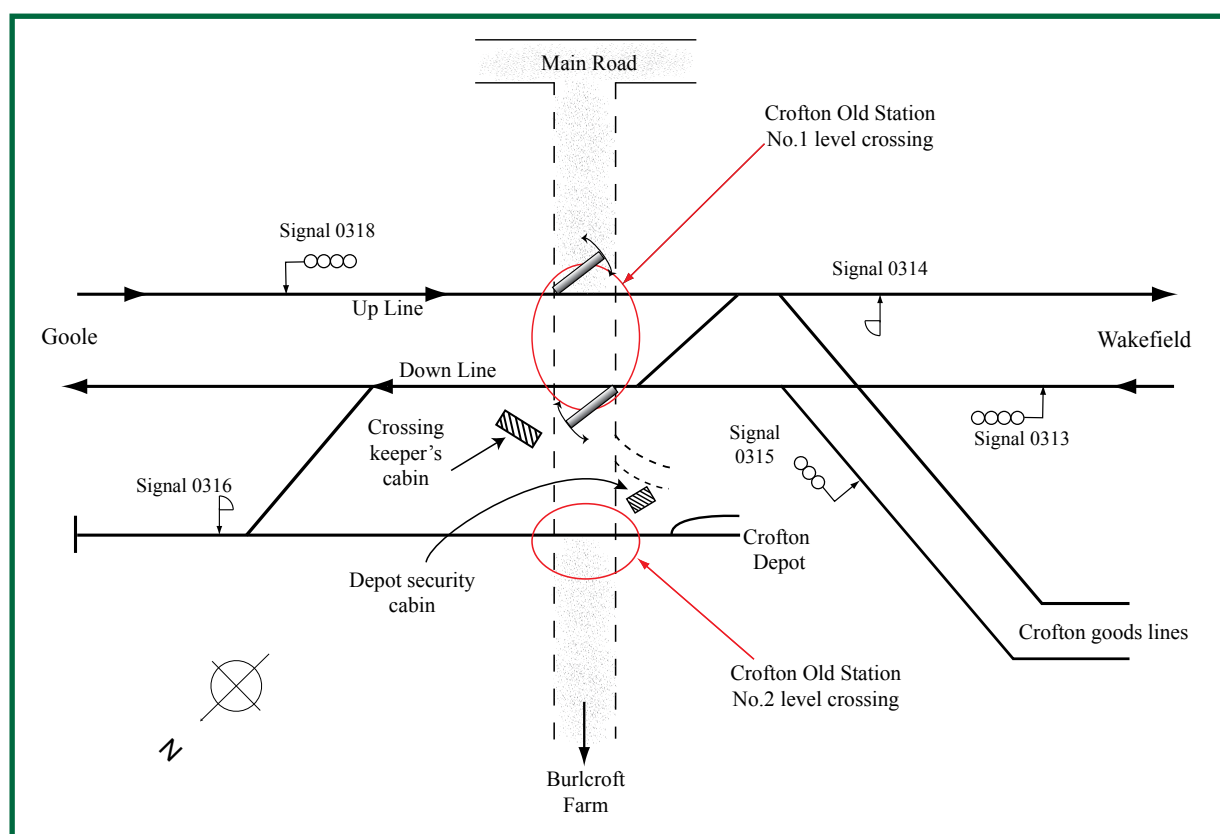
Figure 2: Simplified diagram of crossing layout and signals

- 30 The *protecting signals* for Crofton Old Station No.1 level crossing on the up and down Goole lines are O318 and O313 respectively (Figure 2).

- 35 Crofton Old Station No.2 level crossing is situated approximately 40 metres from No.1 level crossing and forms the rail access to and from the Bombardier train maintenance depot. It is connected to the main lines via a headshunt (Figure 2).

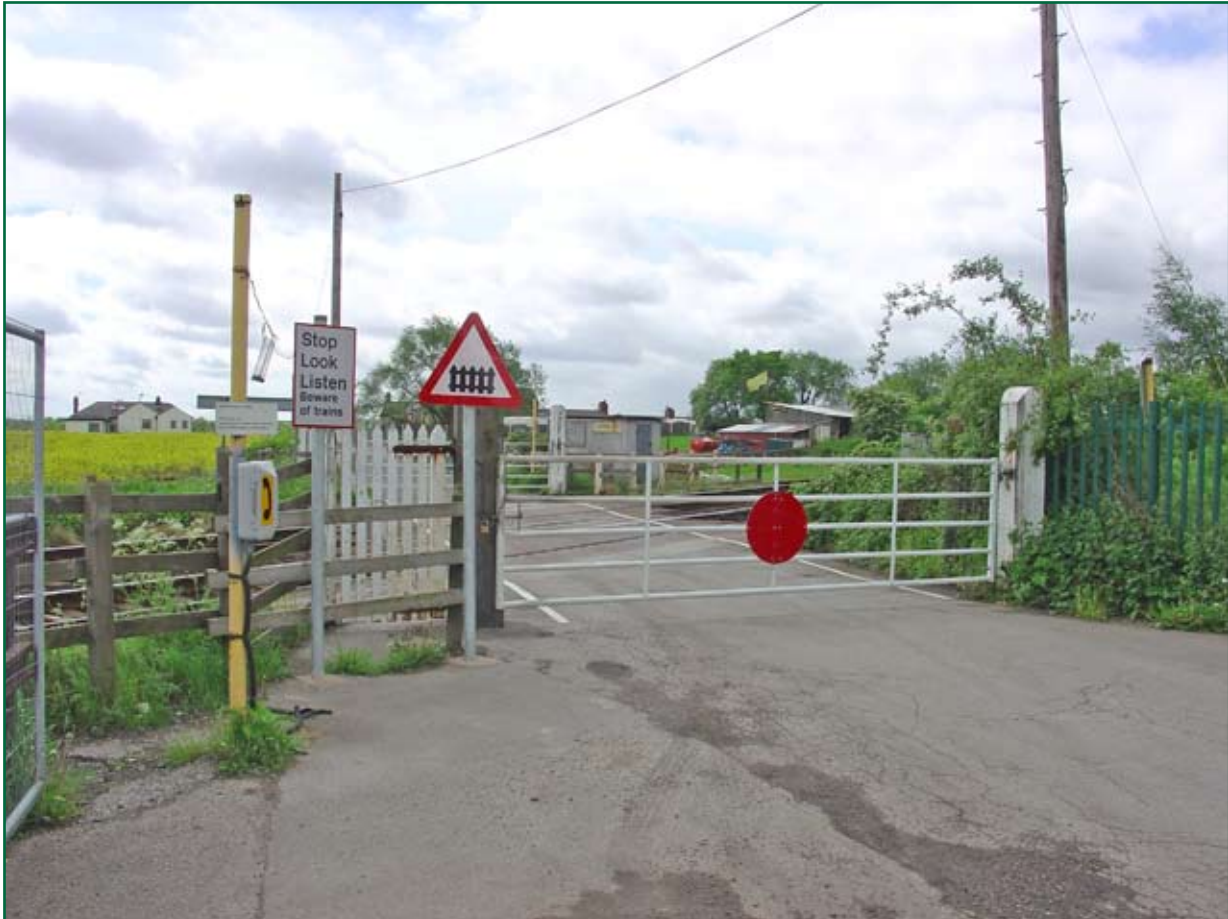
Figure 3: Crofton Old Station No.1 crossing

- 31 Crofton Old Station No.1 level crossing consists of hinged, full road gates which are normally open to road traffic. The gates open outwards to the road, away from the railway. Adjacent to each road gate is a wicket gate for use by pedestrians (Figure 3).
- 32 Rail traffic use over Crofton Old Station No.1 crossing at the time of both incidents consisted of an hourly passenger train in each direction during service times and up to twenty freight trains and light locomotives per day. This typically gave fifty operations of the level crossing gates per day. There could be up to six full operations of the crossing gates per hour during peak times, and the gates were often closed for more than one train to pass.
